Fire Safety in High-rise Buildings, Lessons Learned from the WTC

Dr. J. L. Torero

Prof. Dr. J. G. Quintiere

Dipl.-Ing. T. Steinhaus

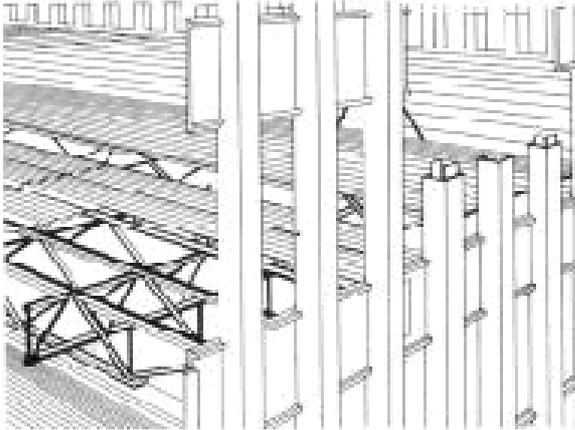
Figure 11 and Figure 12 give an additional insight in respect to how the structure of the two main towers of the World Trade Center was constructed. The floor-truss system was not supported by the columns directly, but was connected by bolts and welded flange connectors to the columns. These connections would only be able to support the combined load of several floors. They may have been the weakest link in the progressive collapse that occurred.

Figure 11 Isometric View of Floor and Exterior Wall System [17]

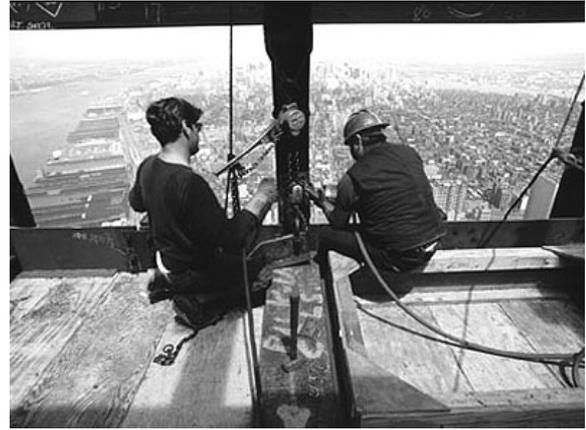
Figure 12 View of Floor and Exterior Wall System from within the building [15]

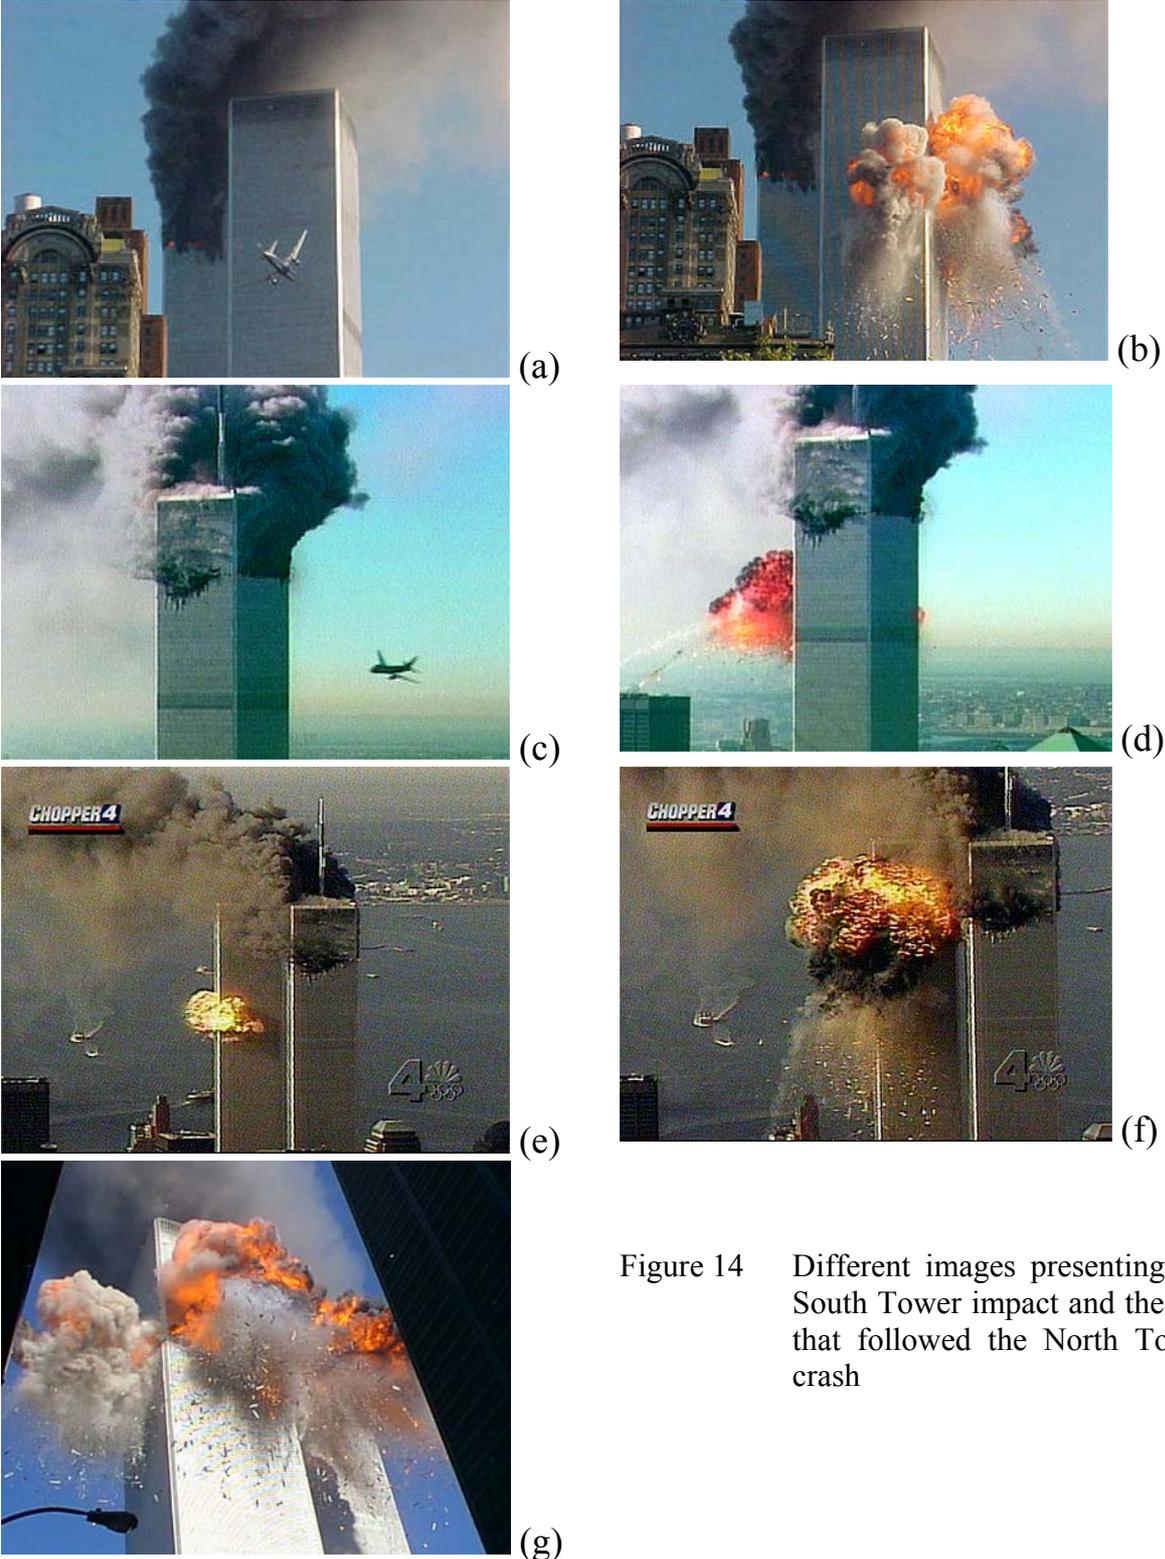
A sequence of images that describe the South Tower impact and the fire that followed the North Tower crash is presented in Figure 14. These images were extracted from reference [19].

Figure 14 Different images presenting the South Tower impact and the fire that followed the North Tower crash

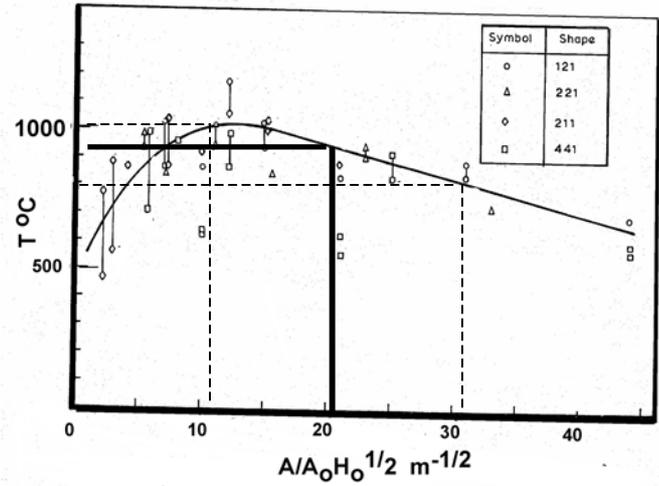
Using a 50 % variance, this gives a range on the CIB correlations in Figure 16 and Figure 17. Note that Figure 16 and Figure 17 were previously presented as part of the background. The results indicate temperatures of 800 to 1000 °C, and a burning rate of about 15 to 30 kg/s. As mentioned before, it is quite possible that the temperature could have exceeded those values estimated here.

Figure 15 Temperature from CIB [5].

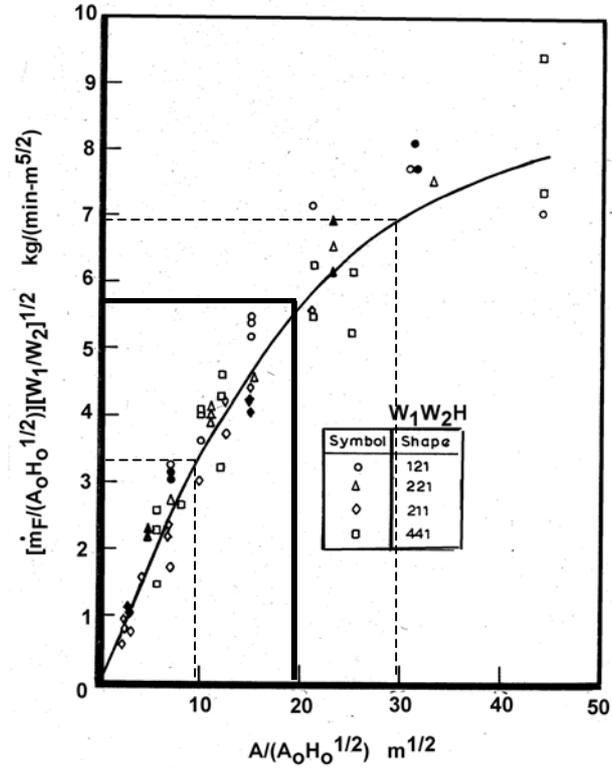
Figure 16 Burning Rate form CIB [5]

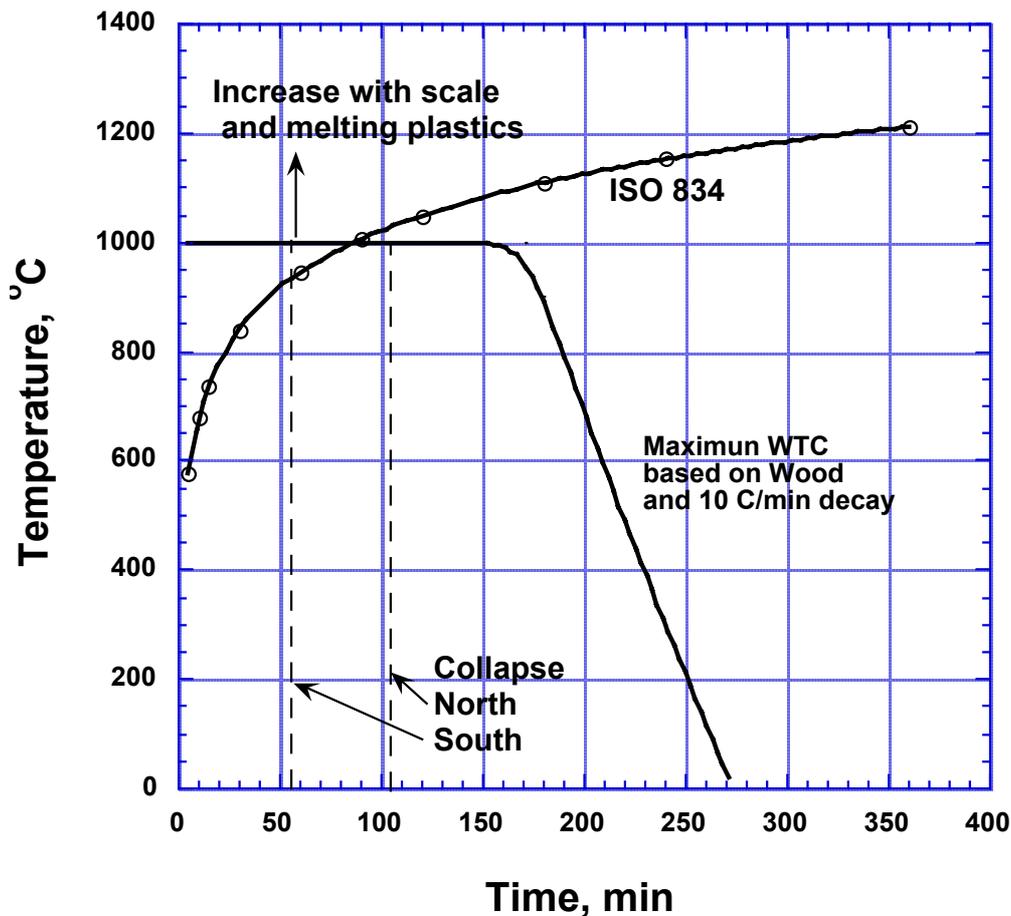
Figure 17 shows the estimated maximum temperature in the WTC office floors in comparison with the ISO 834 temperature curve. From the collapse times, the temperatures corresponding to the test are within the error of those estimated. It can be therefore argued that protection on the steel members was not adequate. The uncertainty, nevertheless, can go both ways, since the temperature could have been well in excess of ISO 834 or the values predicted here, or the uncertainty can be related to lack (or poor) of insulation due to the impact or original state of the protection. The actual state of the fire proofing at the time of impact is not known.

Figure 17 Estimation of WTC floor temperatures and ISO 834.
