The Dalmarnock Fire Tests: Experiments and Modelling
Edited by G. Rein, C. Abecassis Empis and R. Carvel

9. The Performance of Fibre Reinforced Polymer Strengthening in the Fire

By Tim Stratford, Martin Gillie and Jian-fei Chen

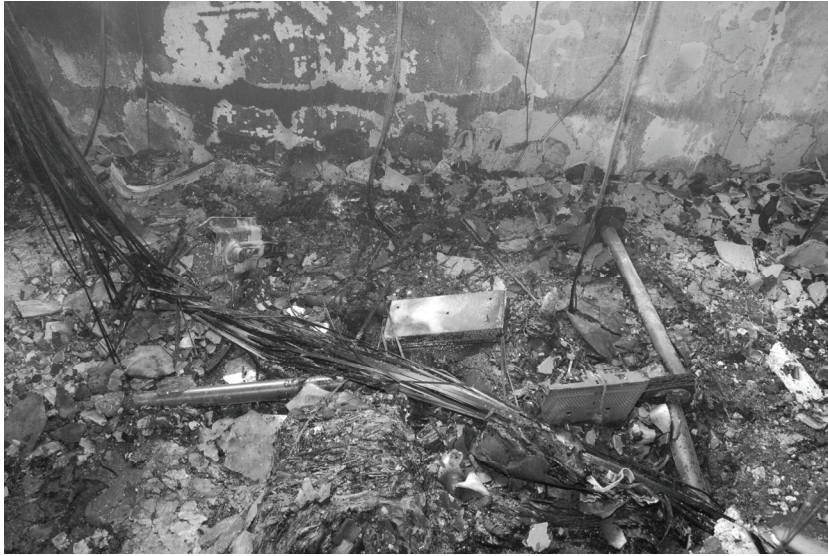
Figure 5a: Remains of unprotected plate

- The unprotected plate (Figure 5a) had completely separated from the concrete. Both the bonding adhesive and the matrix polymer had burnt away, leaving exposed concrete on the ceiling and the fibres exposed on the floor.

Where the adhesive or matrix polymers were exposed to the fire, they burnt or charred, and would have released toxic fumes. This occurred in the unprotected tests, and due to separation of the intumescent-protected plate from the concrete.

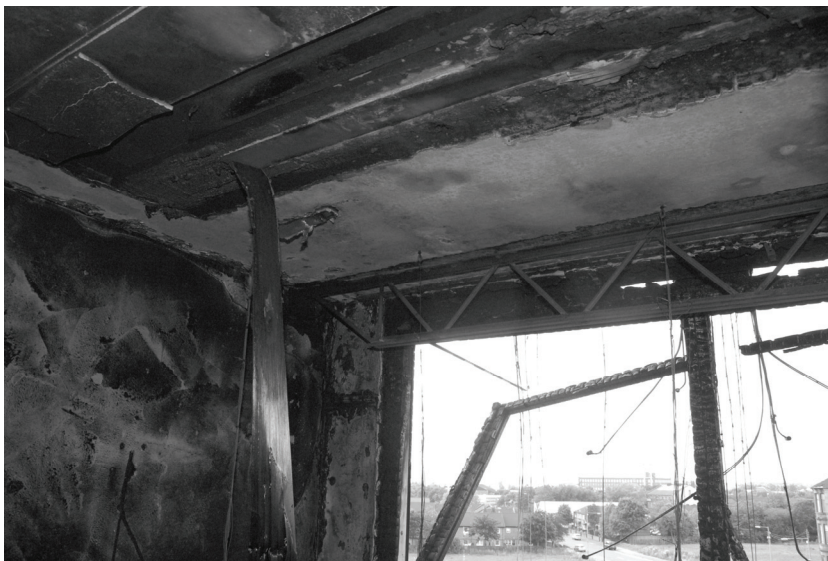
Figure 5b: Remains of intumescent-protected plate

- The intumescent protected plate (Figure 5b) separated from the concrete, except for a short length at its southern end, where it remained bonded to the concrete. Away from this end, the matrix polymer had burnt away to expose the fibres. The bonding adhesive was charred, but remained on the ceiling.

Nevertheless, the uncorrected strain evolutions in Figure 7 are useful. Separation of the intumescent plate from the concrete, for example, occurred about 10 minutes from the start of the test, but the plate remained in contact at the southern end (confirmed by Figure 5b). The gypsum board protected strengthening have complete strain traces. The negative strains for the north gypsum-protected NSM gauge suggest the FRP has slipped relative to the concrete slab due to adhesive viscosity at high temperatures, but solidified during cooling. Further work, however, is required to analyse these results.

The intumescent protection was ineffective, due to an activation temperature that exceeded the glass transition temperature of the adhesive. The plate strengthening separated from the concrete, and there was visible damage to the NSM bonding adhesive.

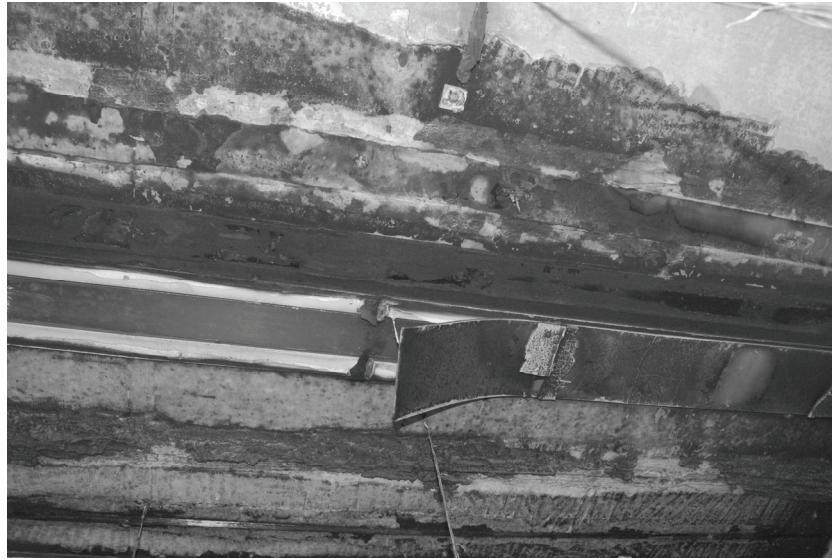
Figure 5c: Gypsum-board-protected plate (protection removed after fire to expose plate)

- The gypsum-board protection was inspected after the tests, and was fully intact. When the board was removed (Figure 5c), the plate was fully bonded to the concrete, and there was no *visual* damage to either the plate or adhesive.
- The adhesive around the unprotected NSM bar (Figure 5d) had burnt away, leaving the FRP exposed.

The gypsum board protected the FRP strengthening from visible damage. However, the strengthening would not have been mechanically active during the test, due to the glass transition temperature having been exceeded.

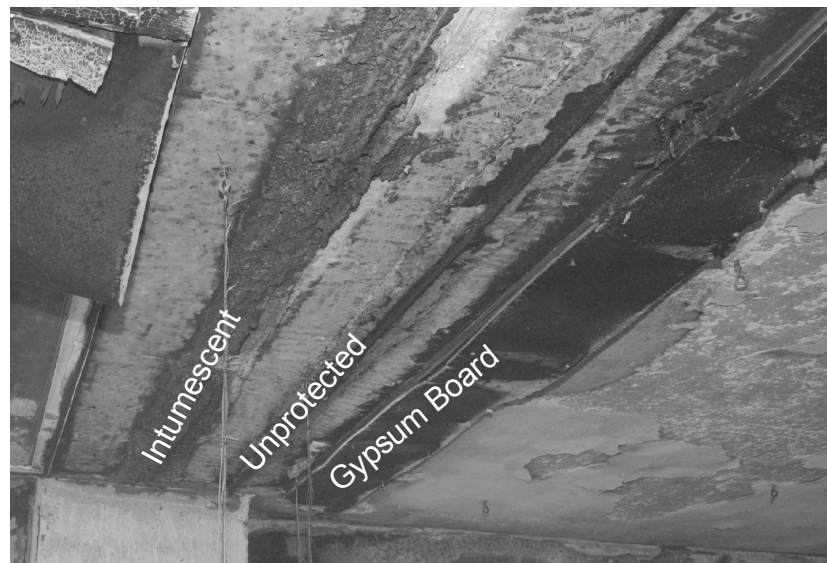
Figure 5d: NSM strengthening after the fire.

- The intumescent coating over NSM strengthening (Figure 5d) had activated. The strengthening beneath the intumescent was in place, although the adhesive was glazed and contained transverse cracks.
- The gypsum-board protected NSM (Figure 5d) remained intact, and the strengthening beneath was visually unaltered.

NSM strengthening has superior integrity to plate strengthening during a fire. The surrounding concrete would be expected to draw heat away from the adhesive, but further analysis of the test data is required to investigate this.
