EXPLOSION AT SIX BELLS COLLIERY  
MONMOUTHSHIRE

# EXPLOSION AT SIX BELLS COLLIERY, MONMOUTHSHIRE

On the causes of, and circumstances  
attending, the explosion which occurred at  
Six Bells Colliery, Monmouthshire,  
on 28th June, 1960

T. A. ROGERS, C.B.E., M.I.Min.E.  
H.M. Chief Inspector of Mines and Quarries

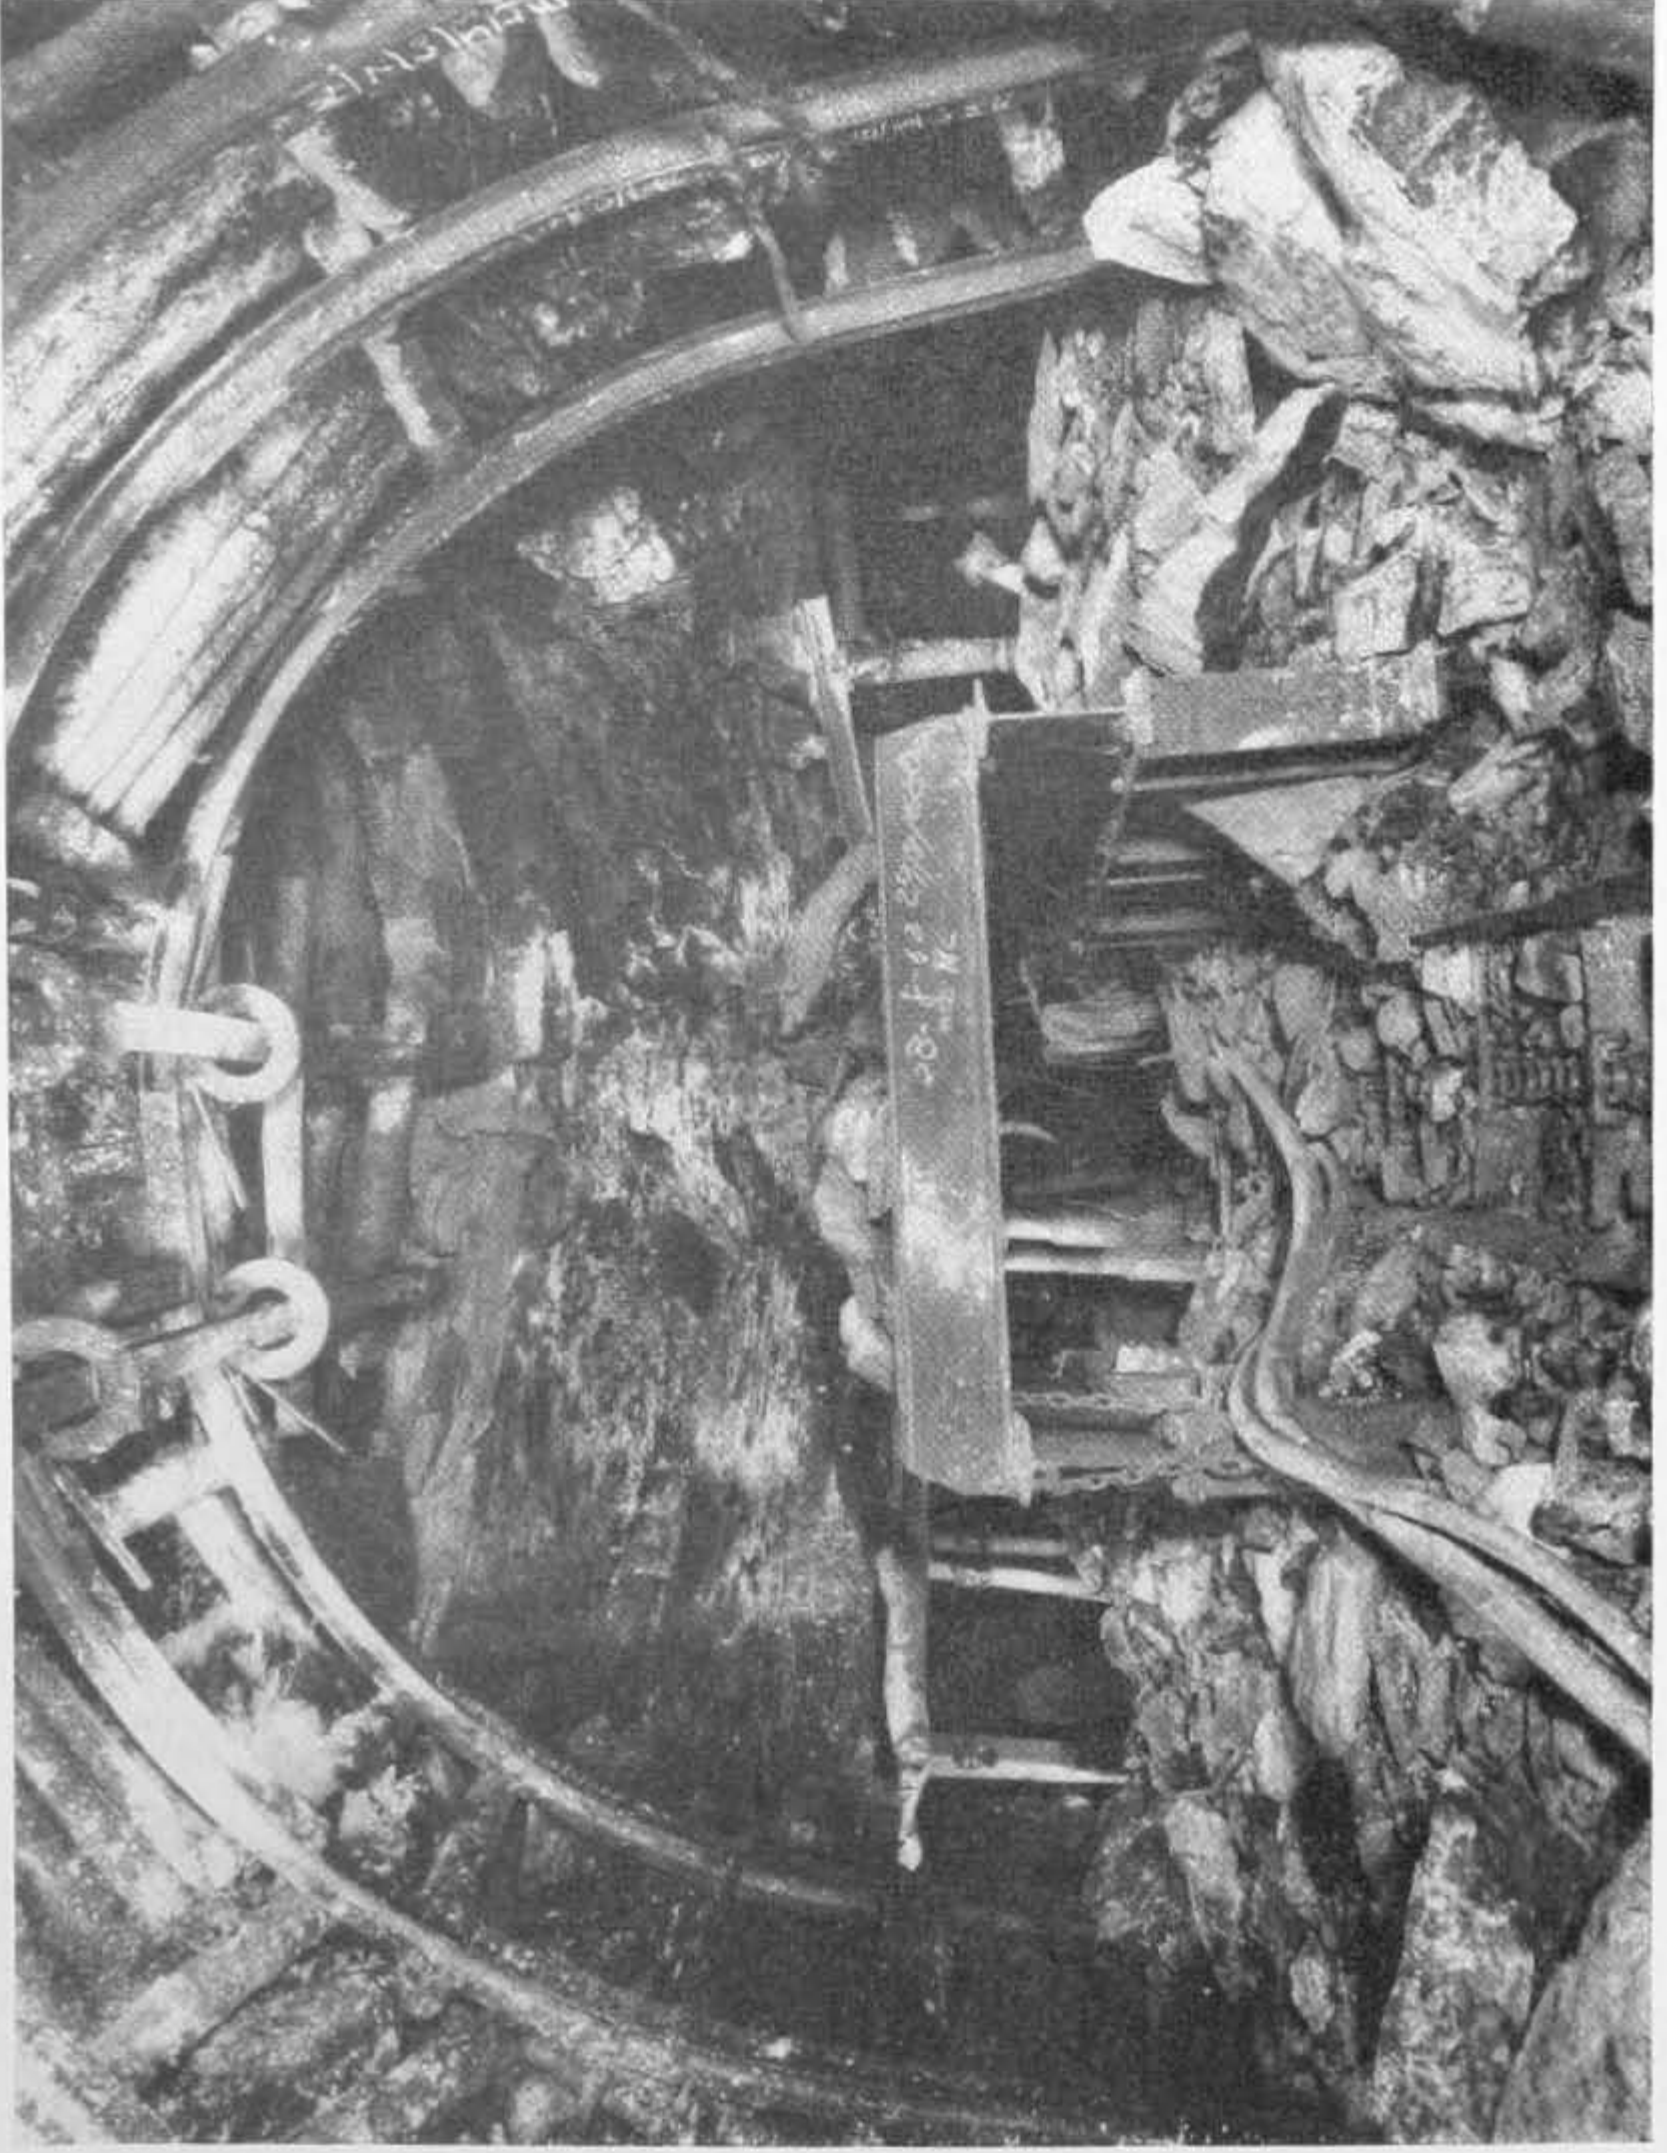
PLATE I. INTAKE (LOADER GATE) ROADHEAD OF O.10 UNIT

condition may result. Hartwell suggested that the impact of the mechanised pick used in the experiments he described would have been about equivalent to that of rock weighing 260 lbs. falling for a distance of three and a half feet onto a steel object. He thought that the most probable cause of the explosion was that there was a fall of rock bringing down with it firedamp that had accumulated at the ripping and that one of the larger pieces of rock struck the canopy in such a way as to produce an incendive condition and so cause inflammation of the surrounding atmosphere. Pieces of quartzitic rock, the largest being estimated to weigh about 240 lbs. were, in fact, found on the ground and on the canopy under O.10 intake ripping (Plate I). Some of it could have fallen a distance of six feet.

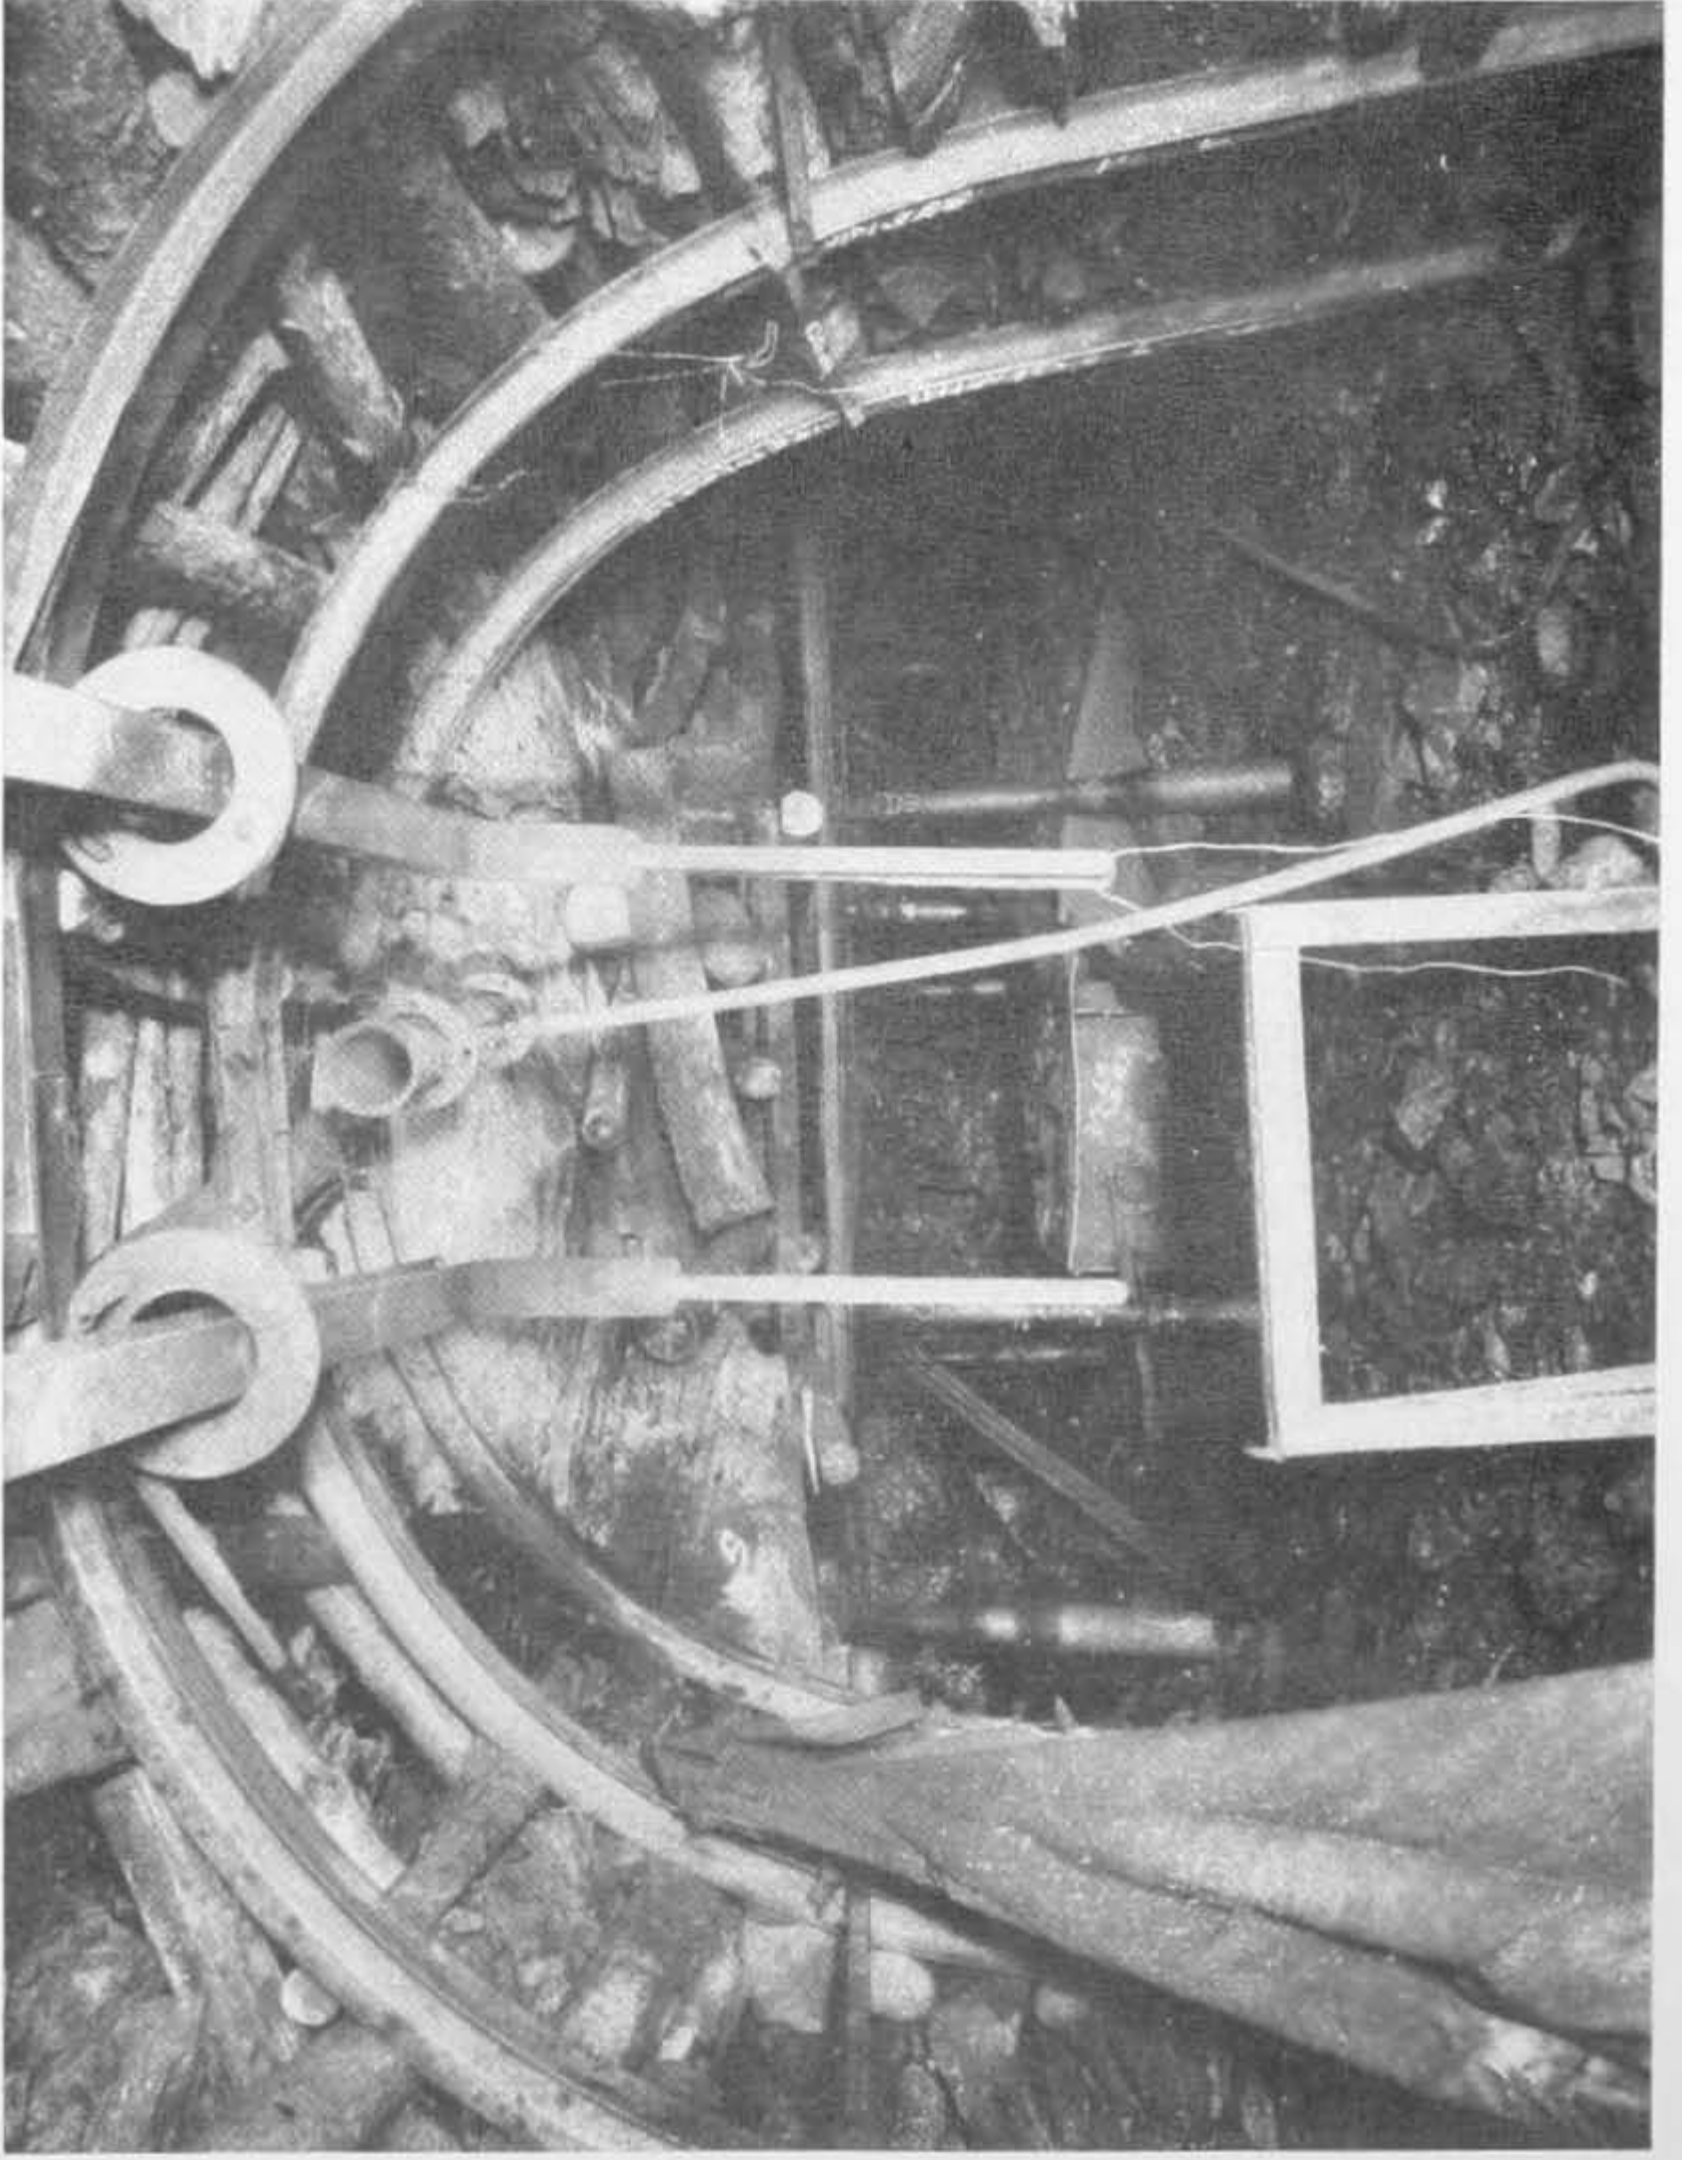
PLATE II. RETURN ROADHEAD OF 0.18 UNIT

died out on the tram haulage section of the main intake and on the main return. The prolonged burning at O.18 return roadhead could only have been due to the inflammation of firedamp from open breaks, together with some from the adjacent waste. The signs of extra violence found near O.10 supply roadhead might have been due to firedamp forced out of the waste by the explosion in the intake.

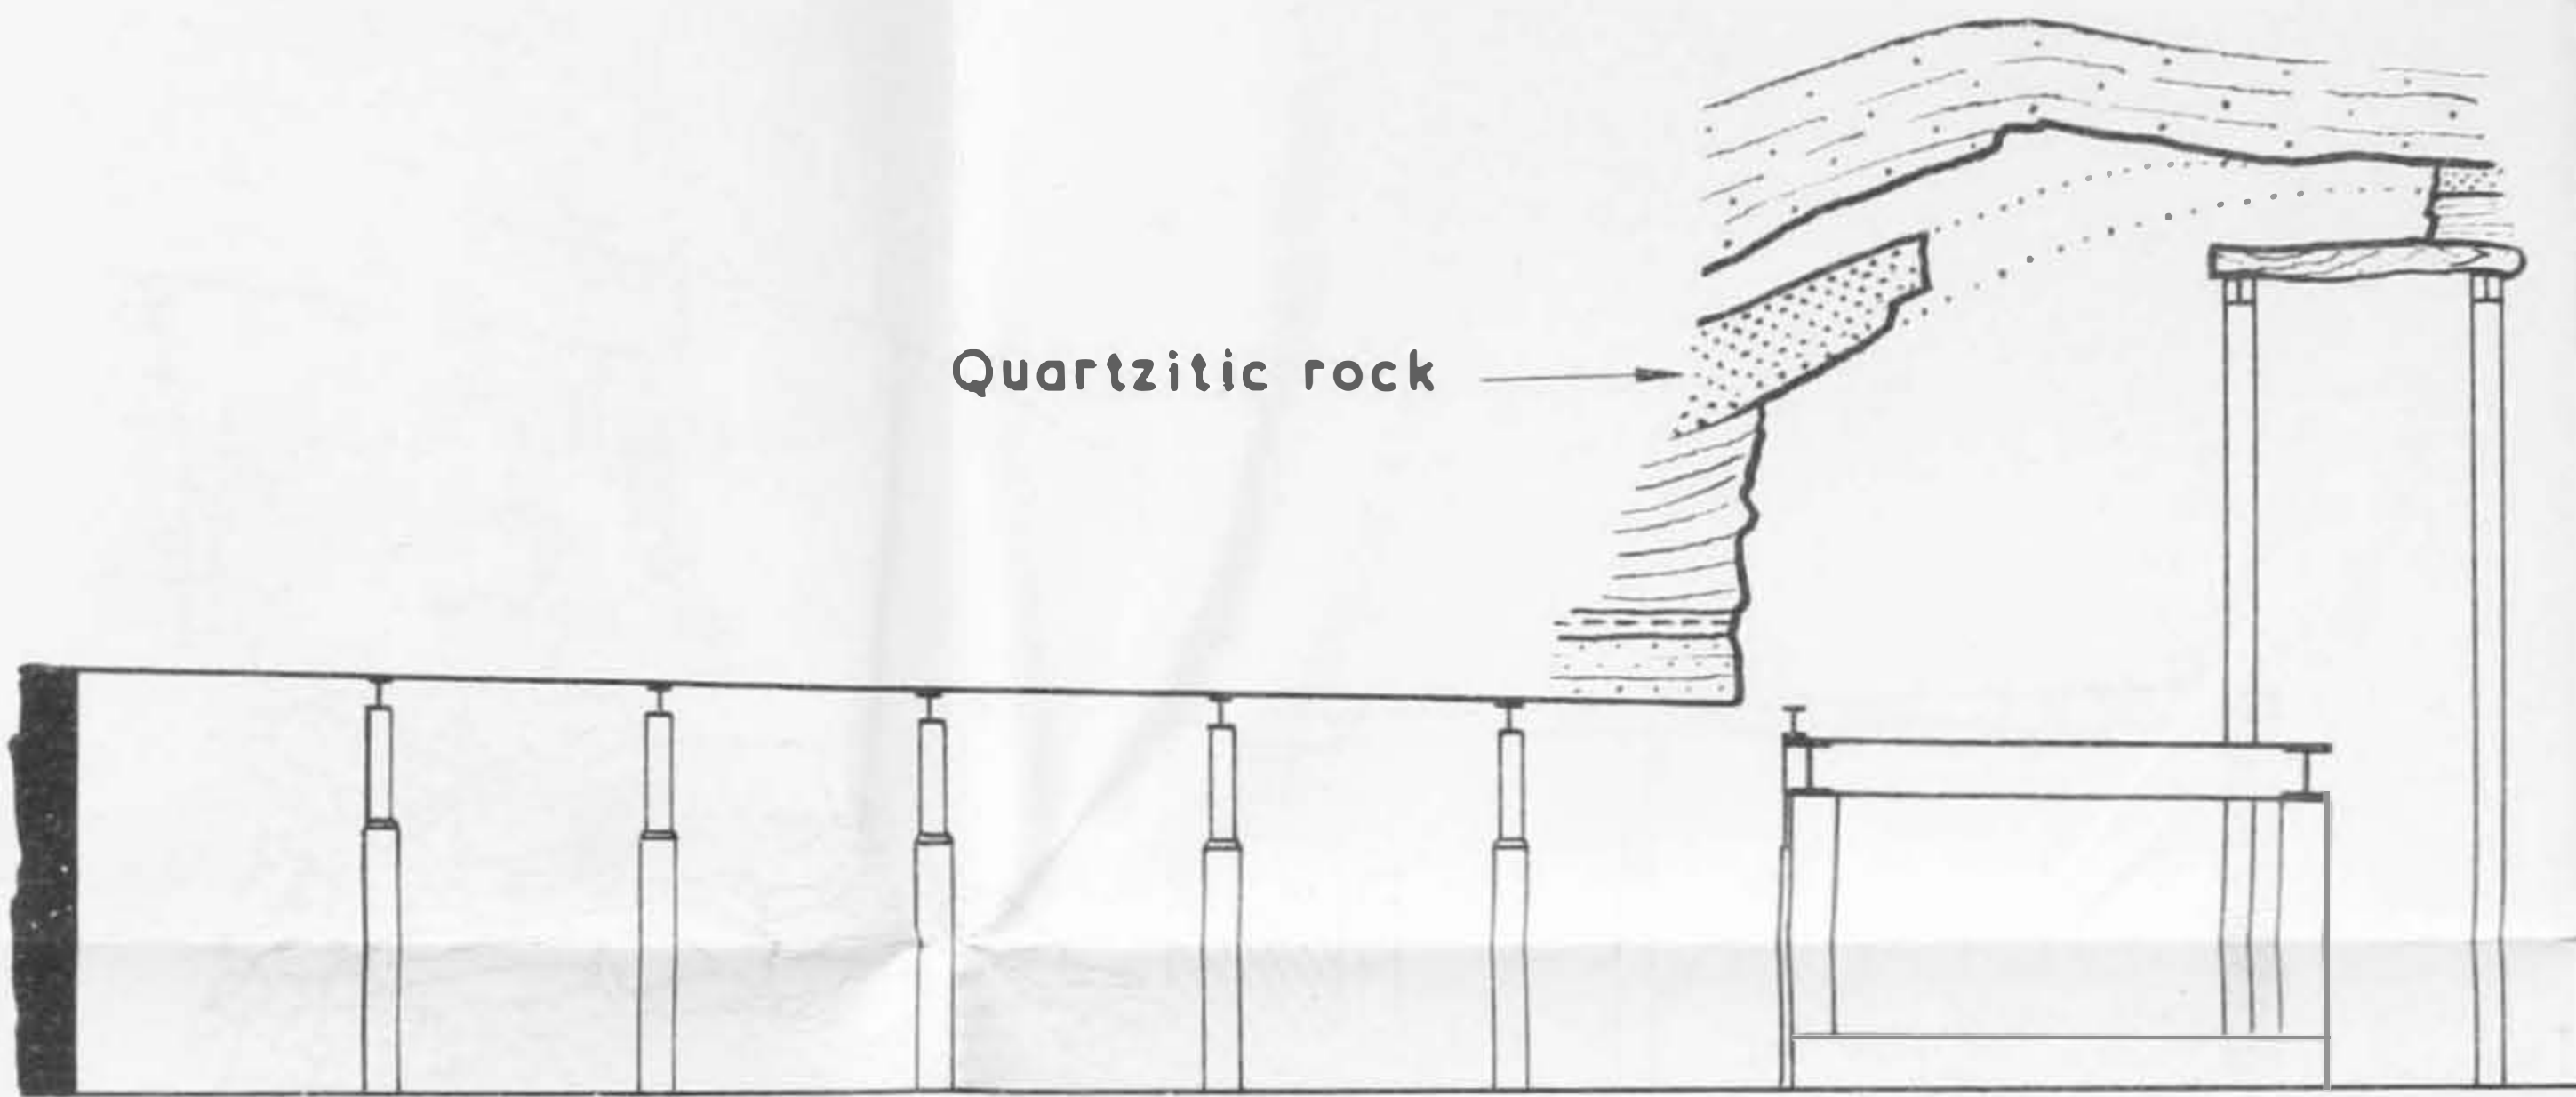
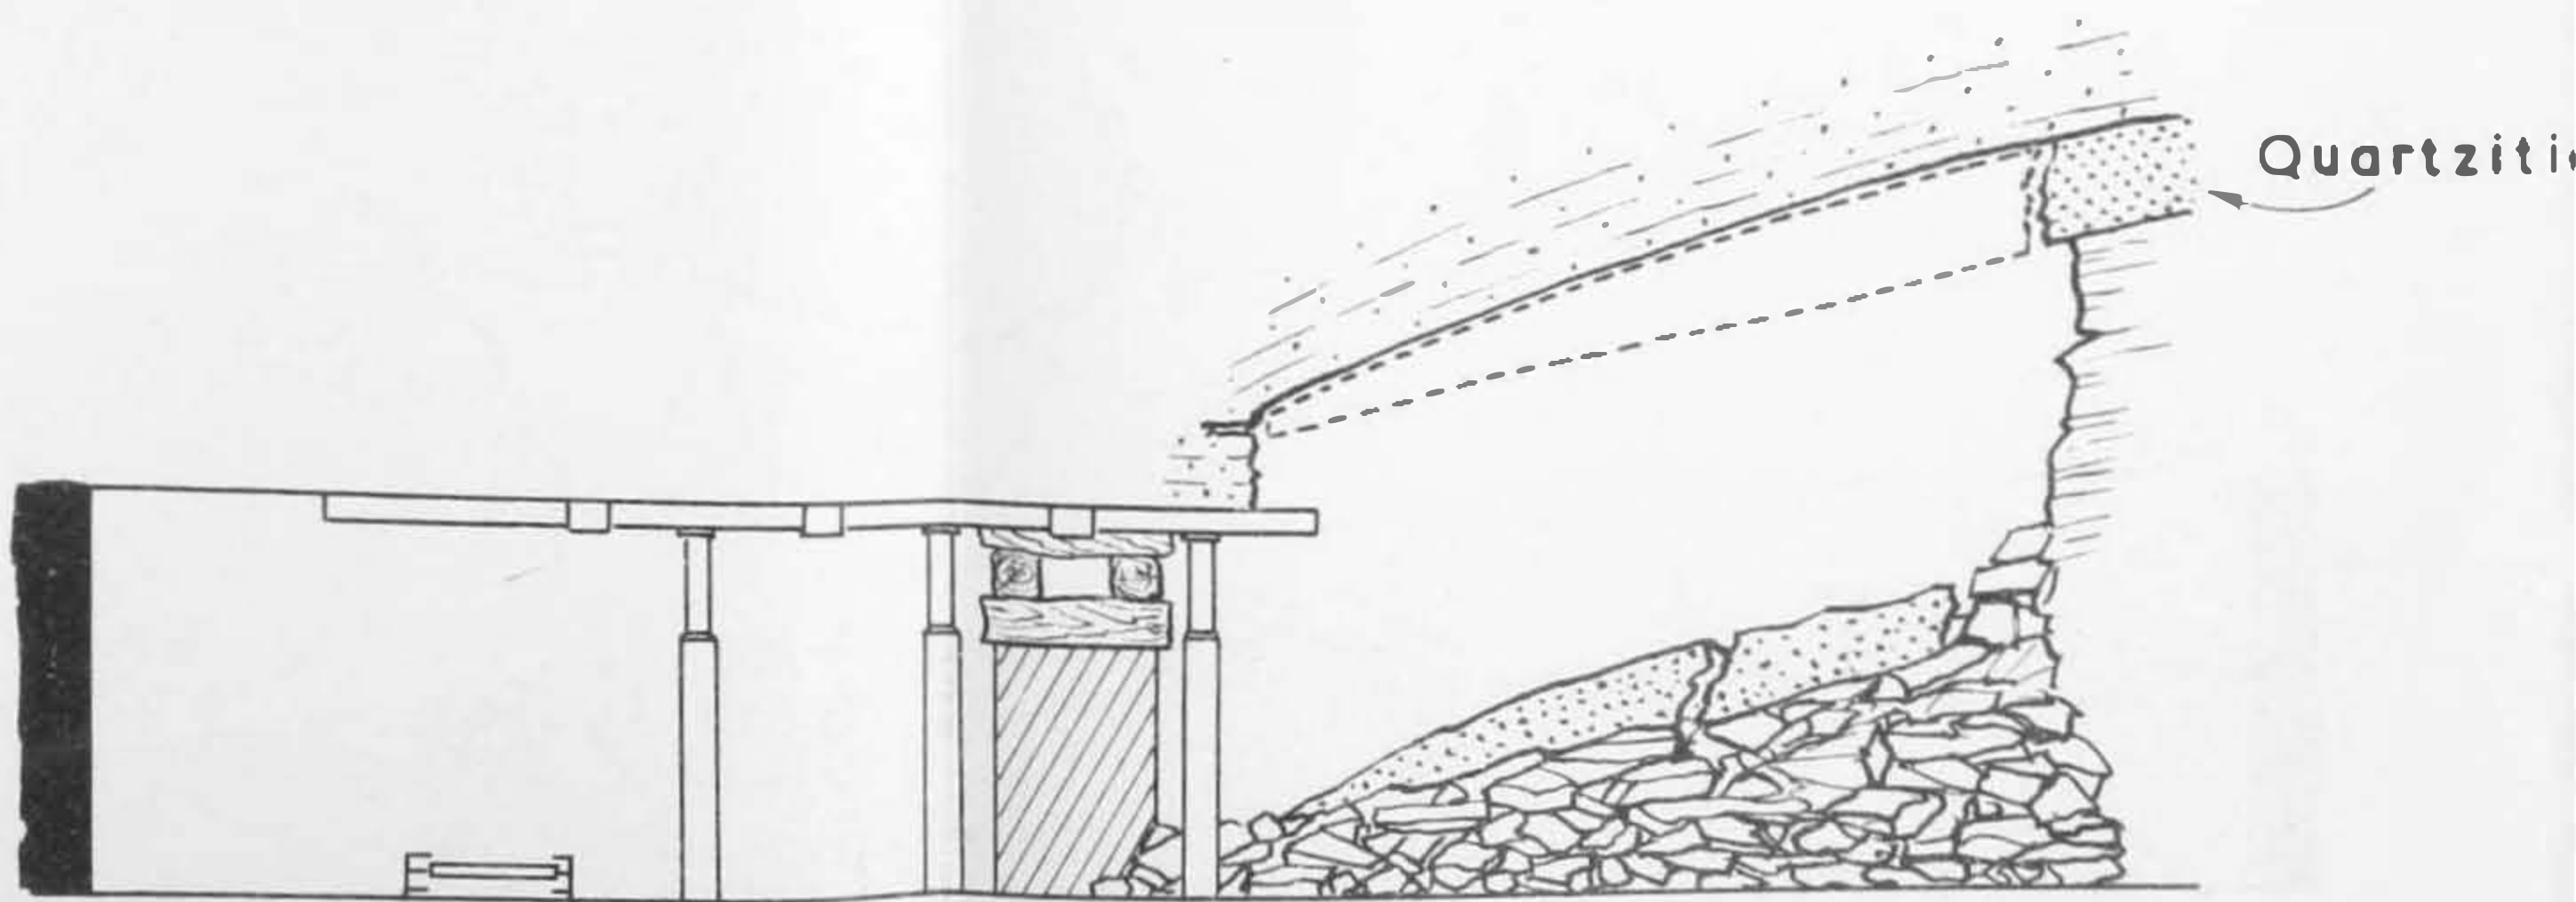
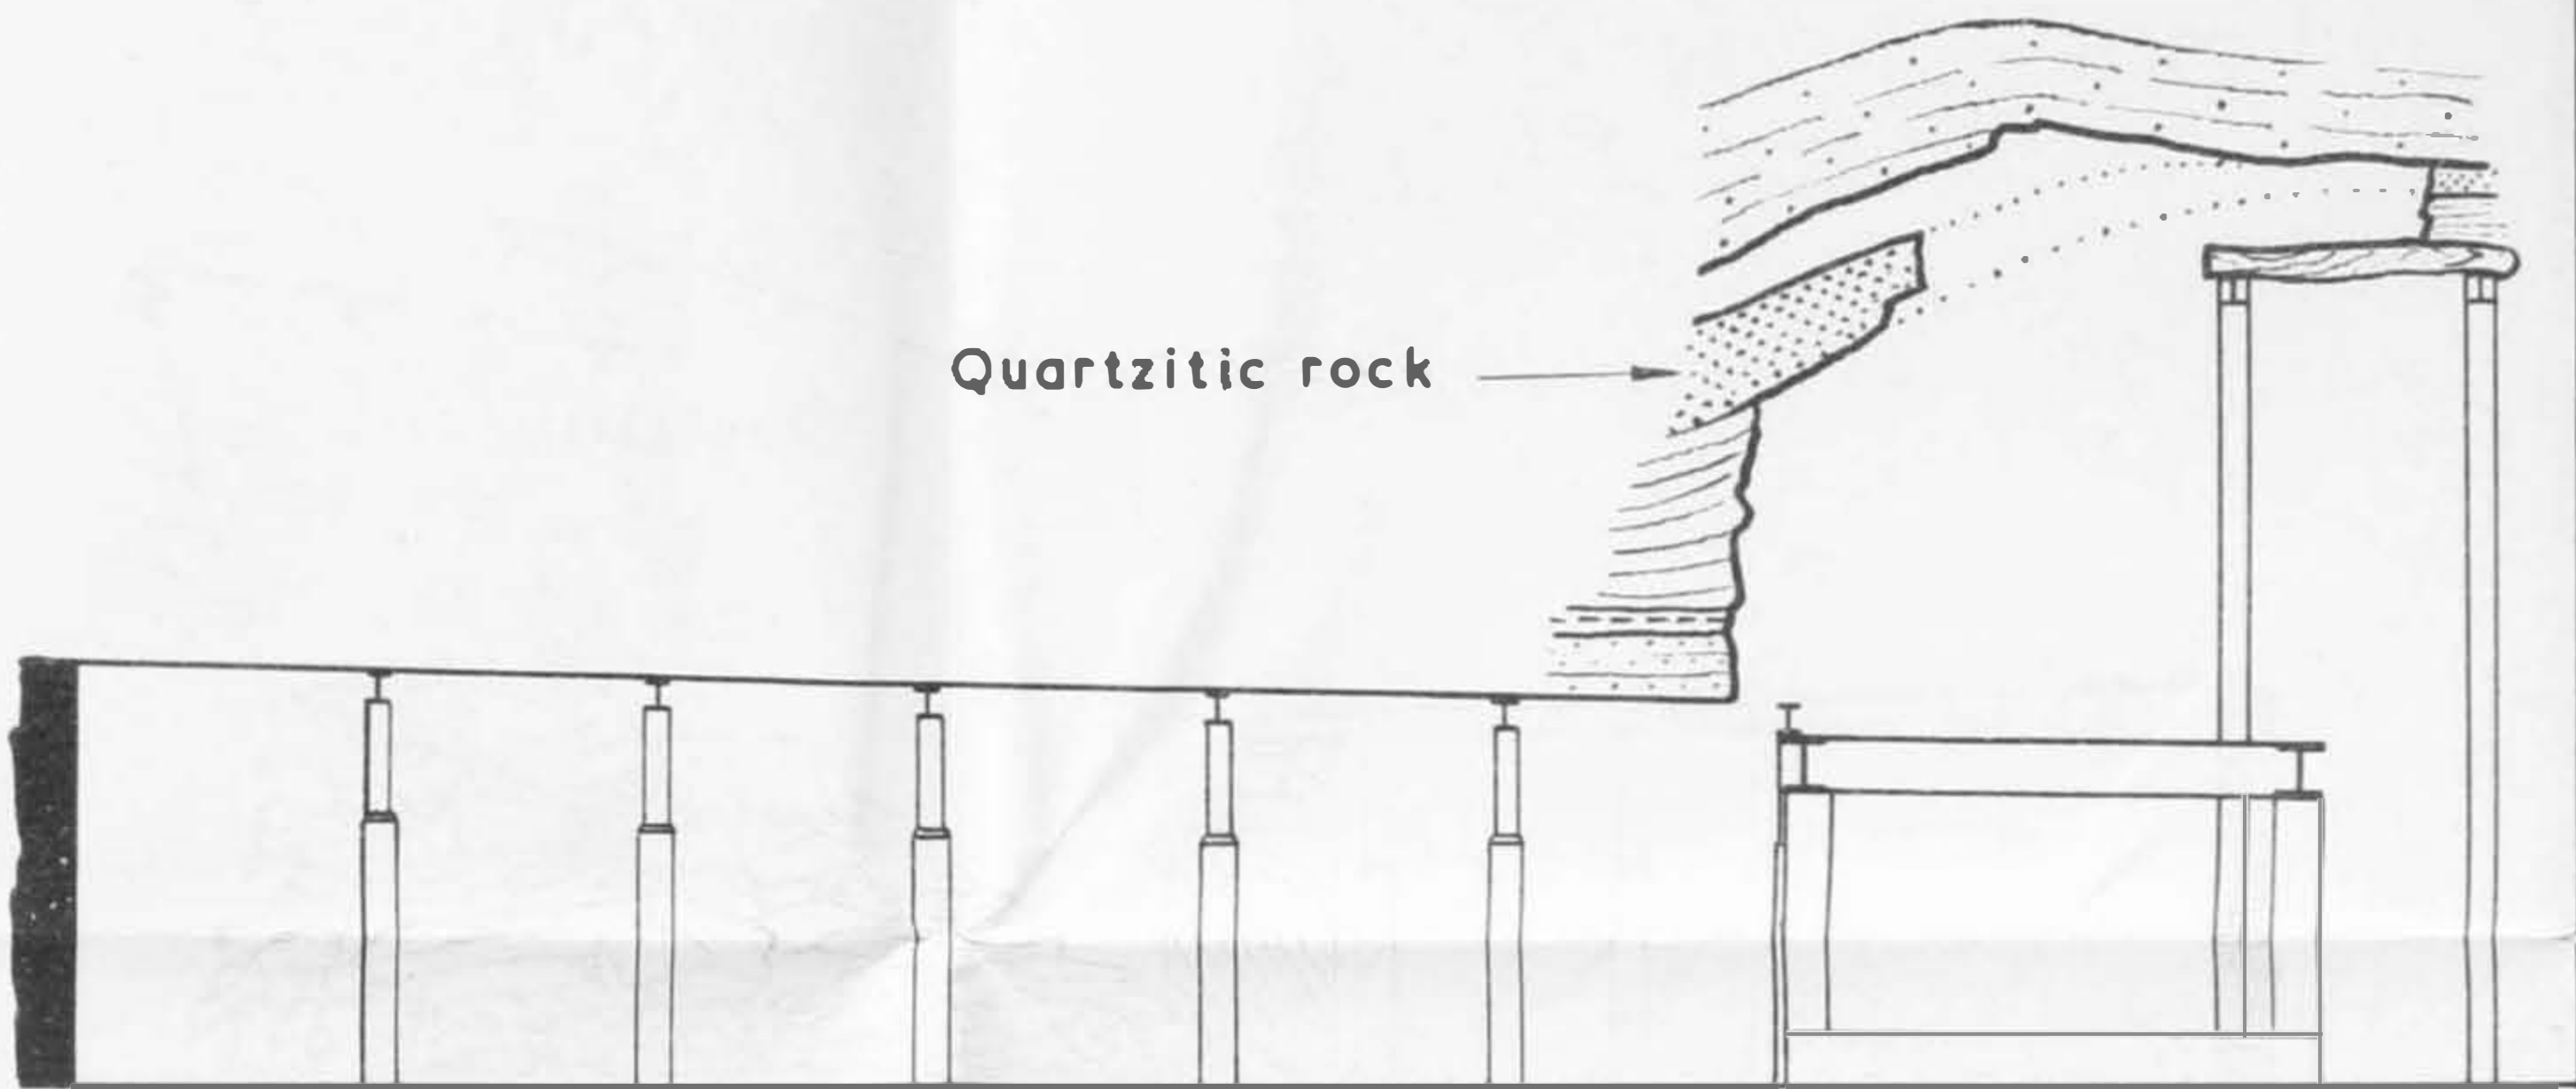
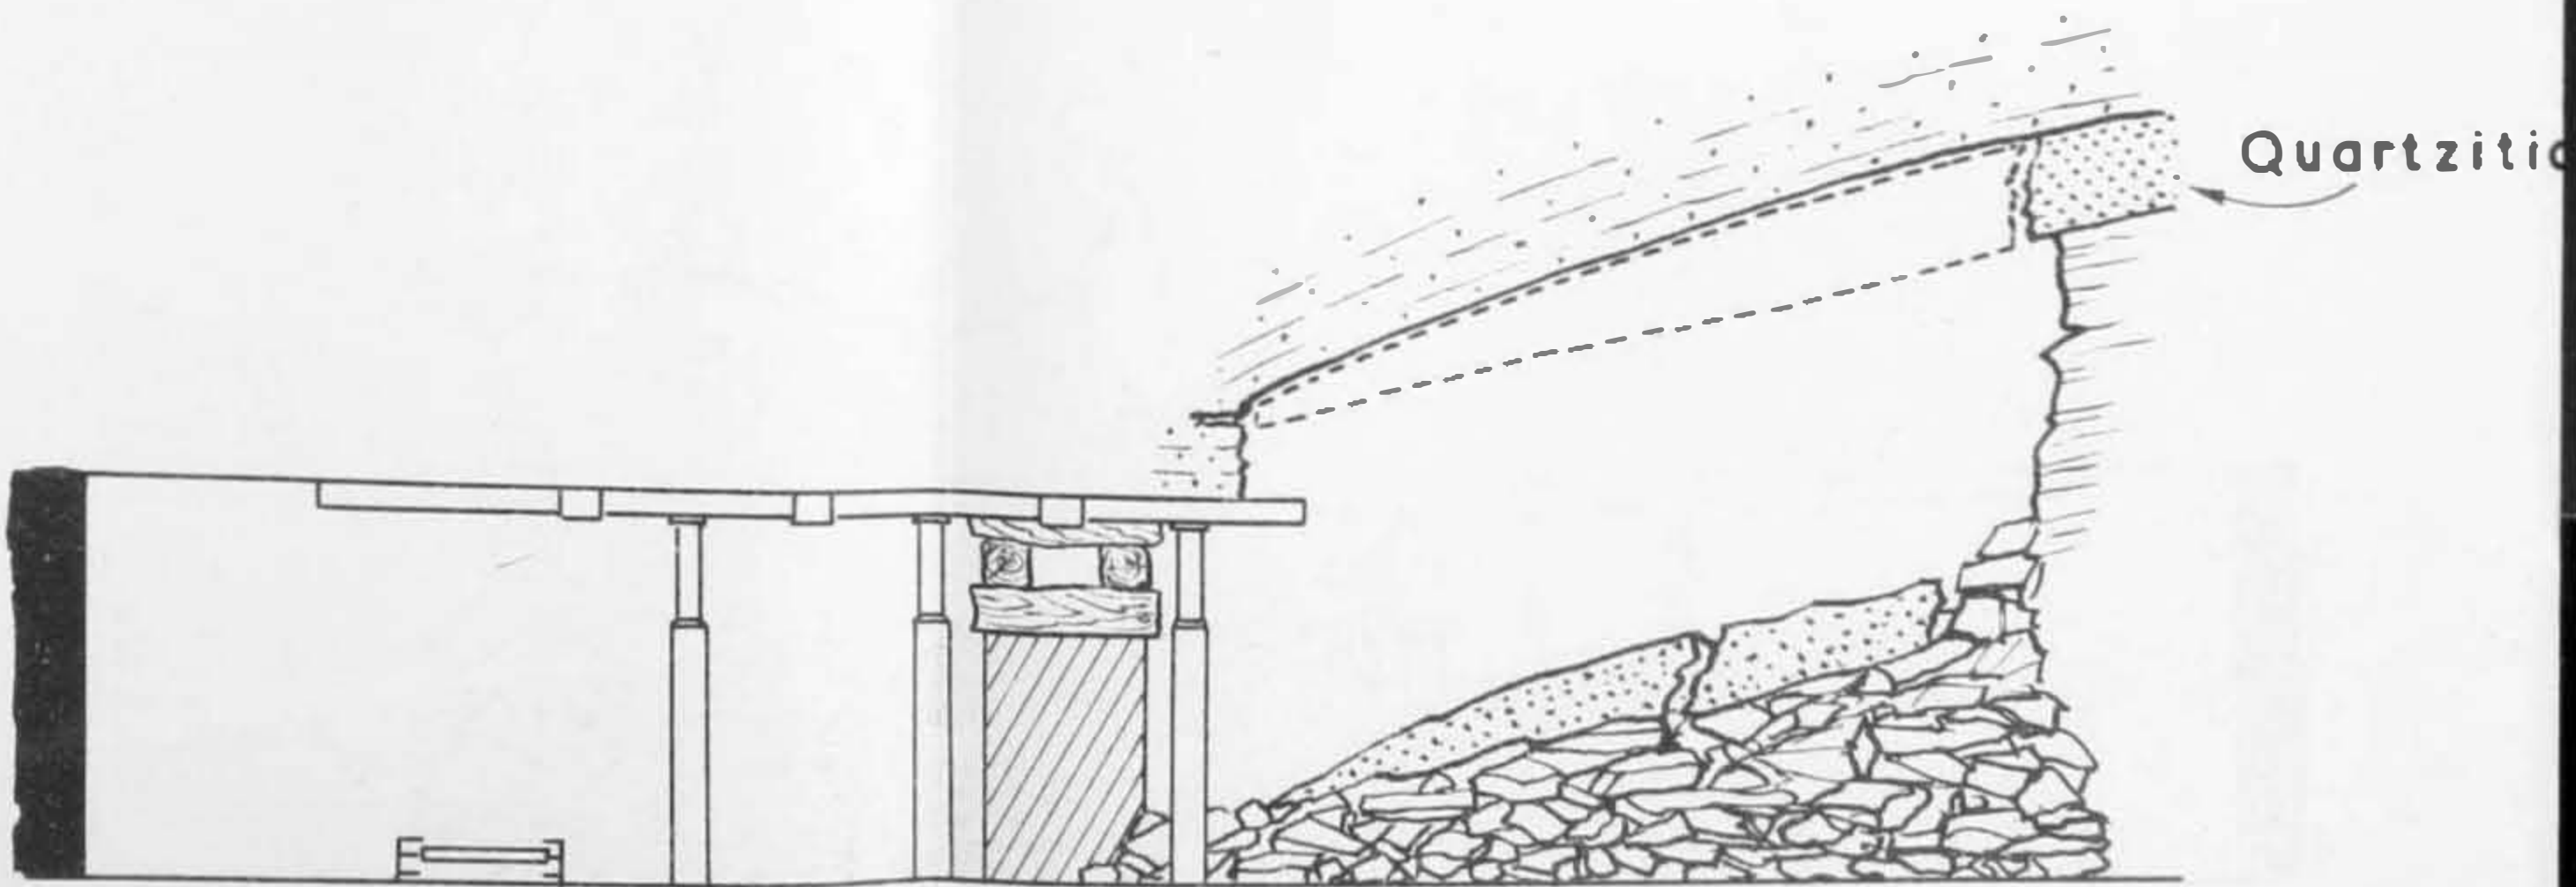
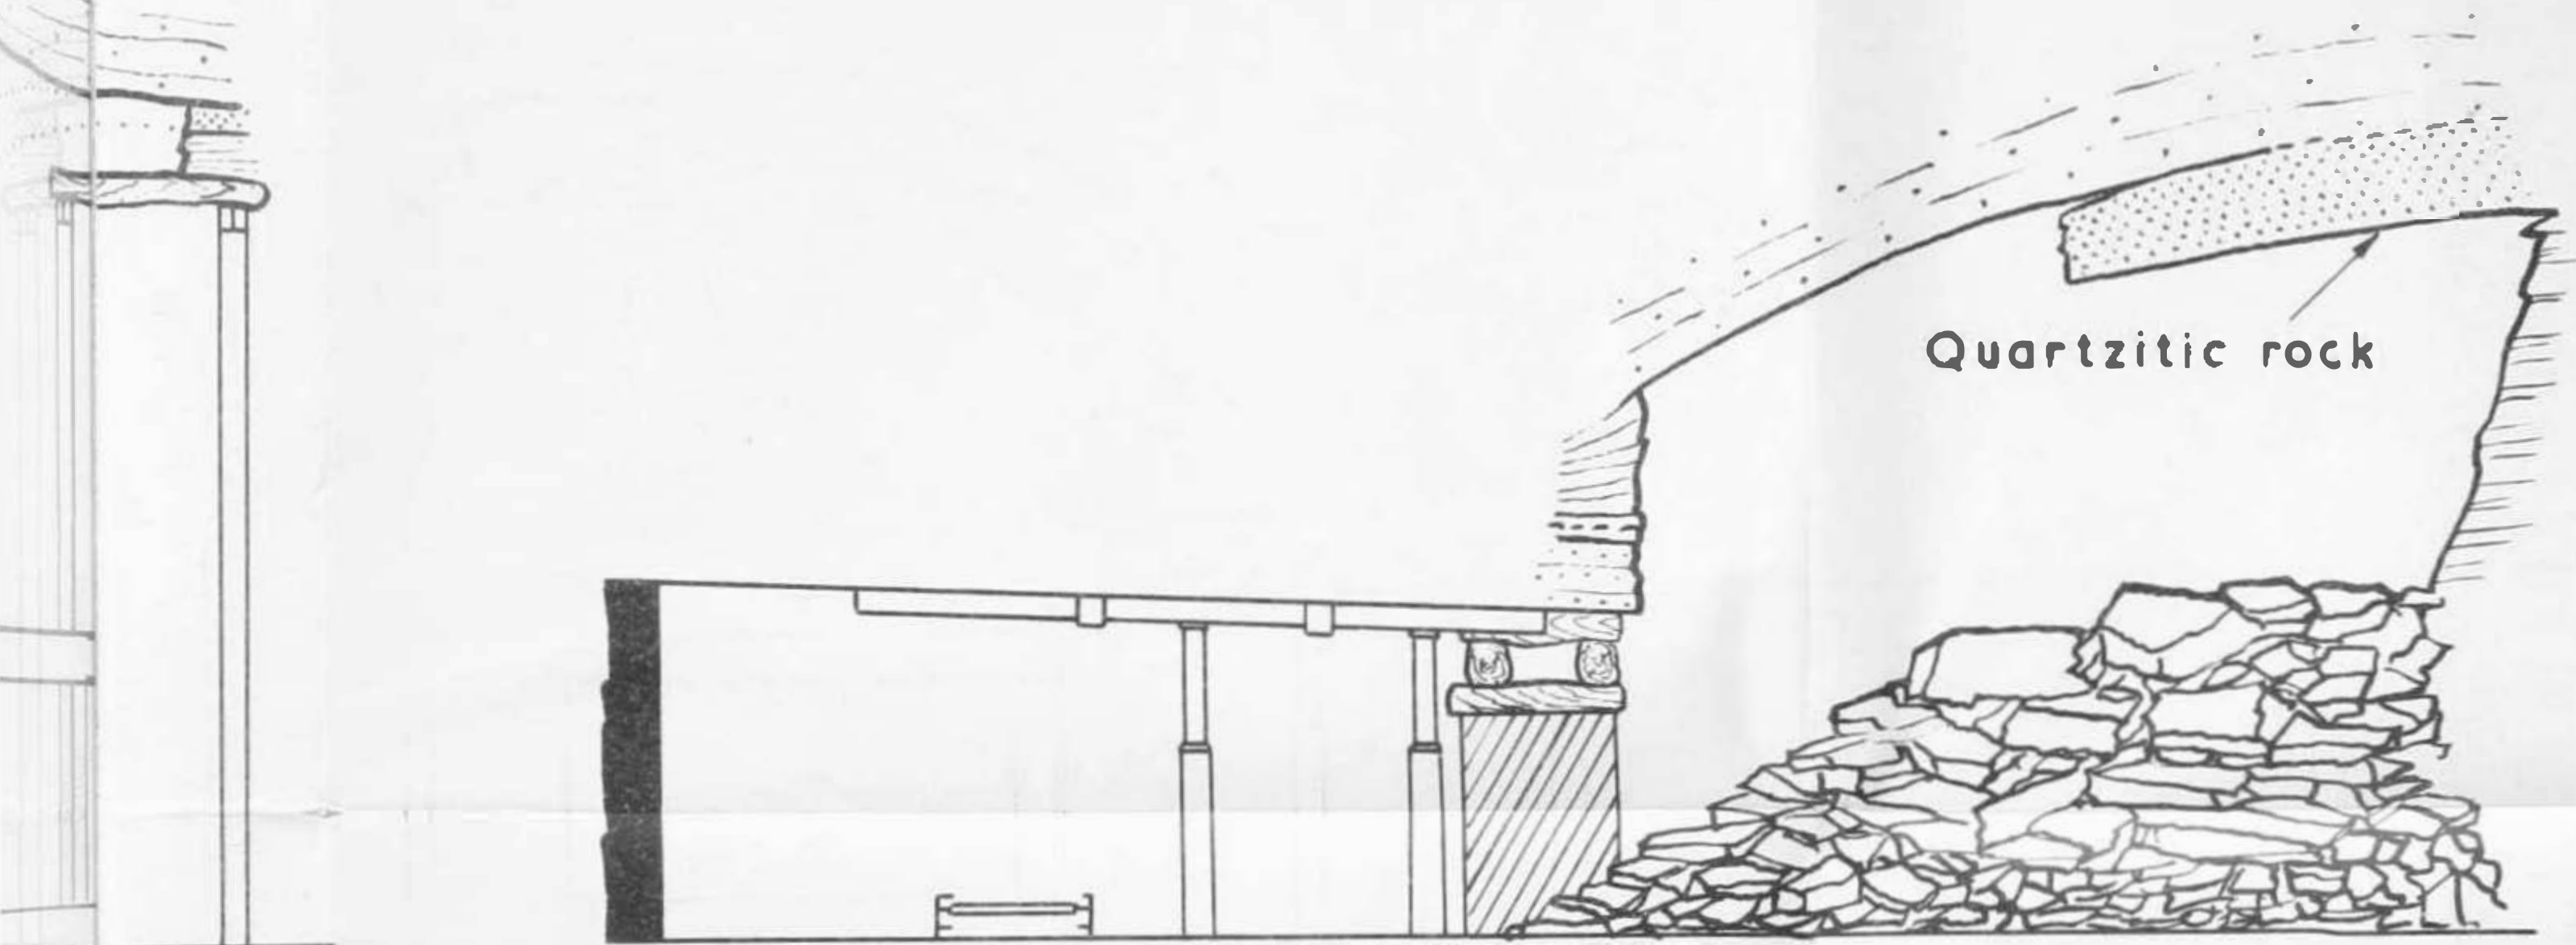
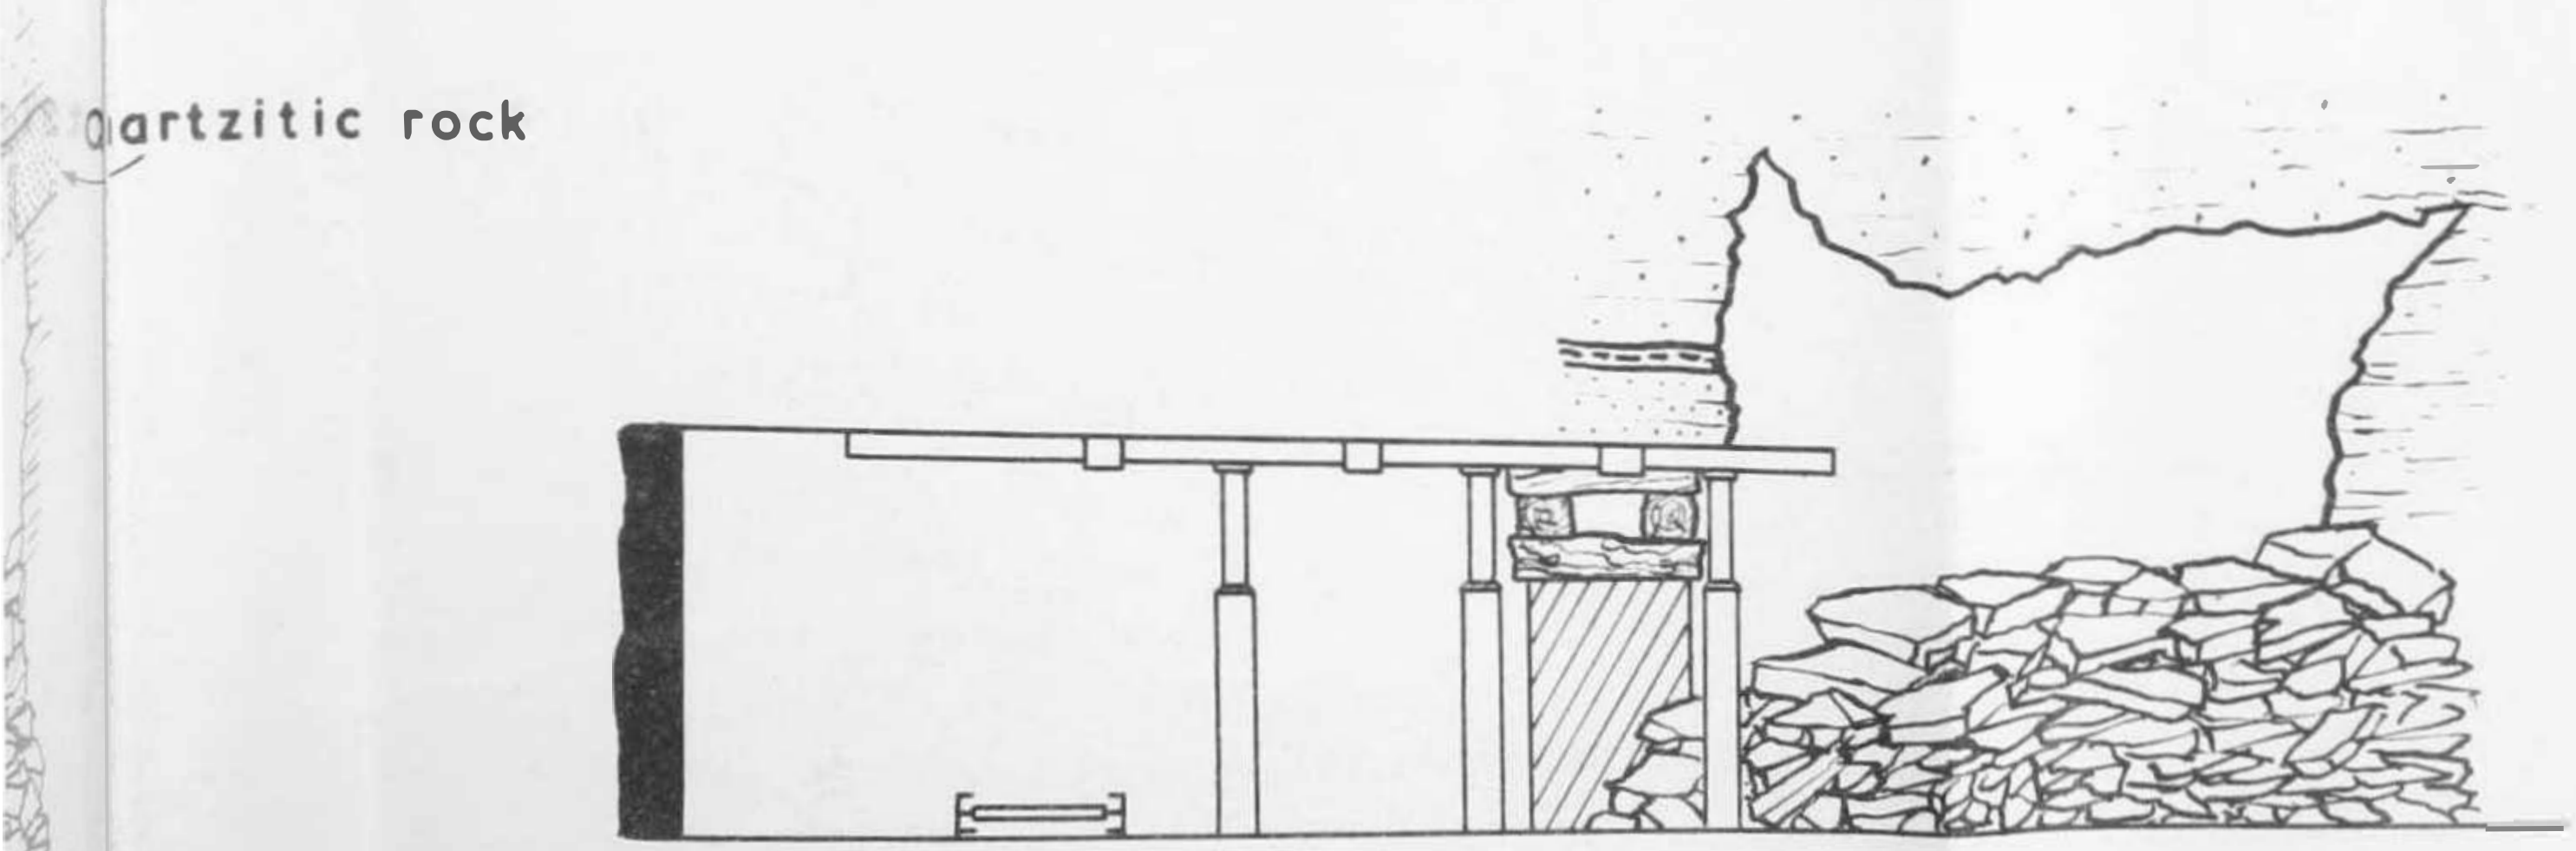
**PLAN No. 5**

EXTENT OF AN INTRUSION OF A HARD QUARTZITIC TYPE ROCK.
