## CIVIL AIRCRAFT ACCIDENT

Report on the Accident to  
Boeing 707-465 G-ARWE  
at Heathrow Airport, London  
on 8th April 1968

Civil Accident Report No. EW/C/0203

*Aircraft:* Boeing 707-465 G-ARWE

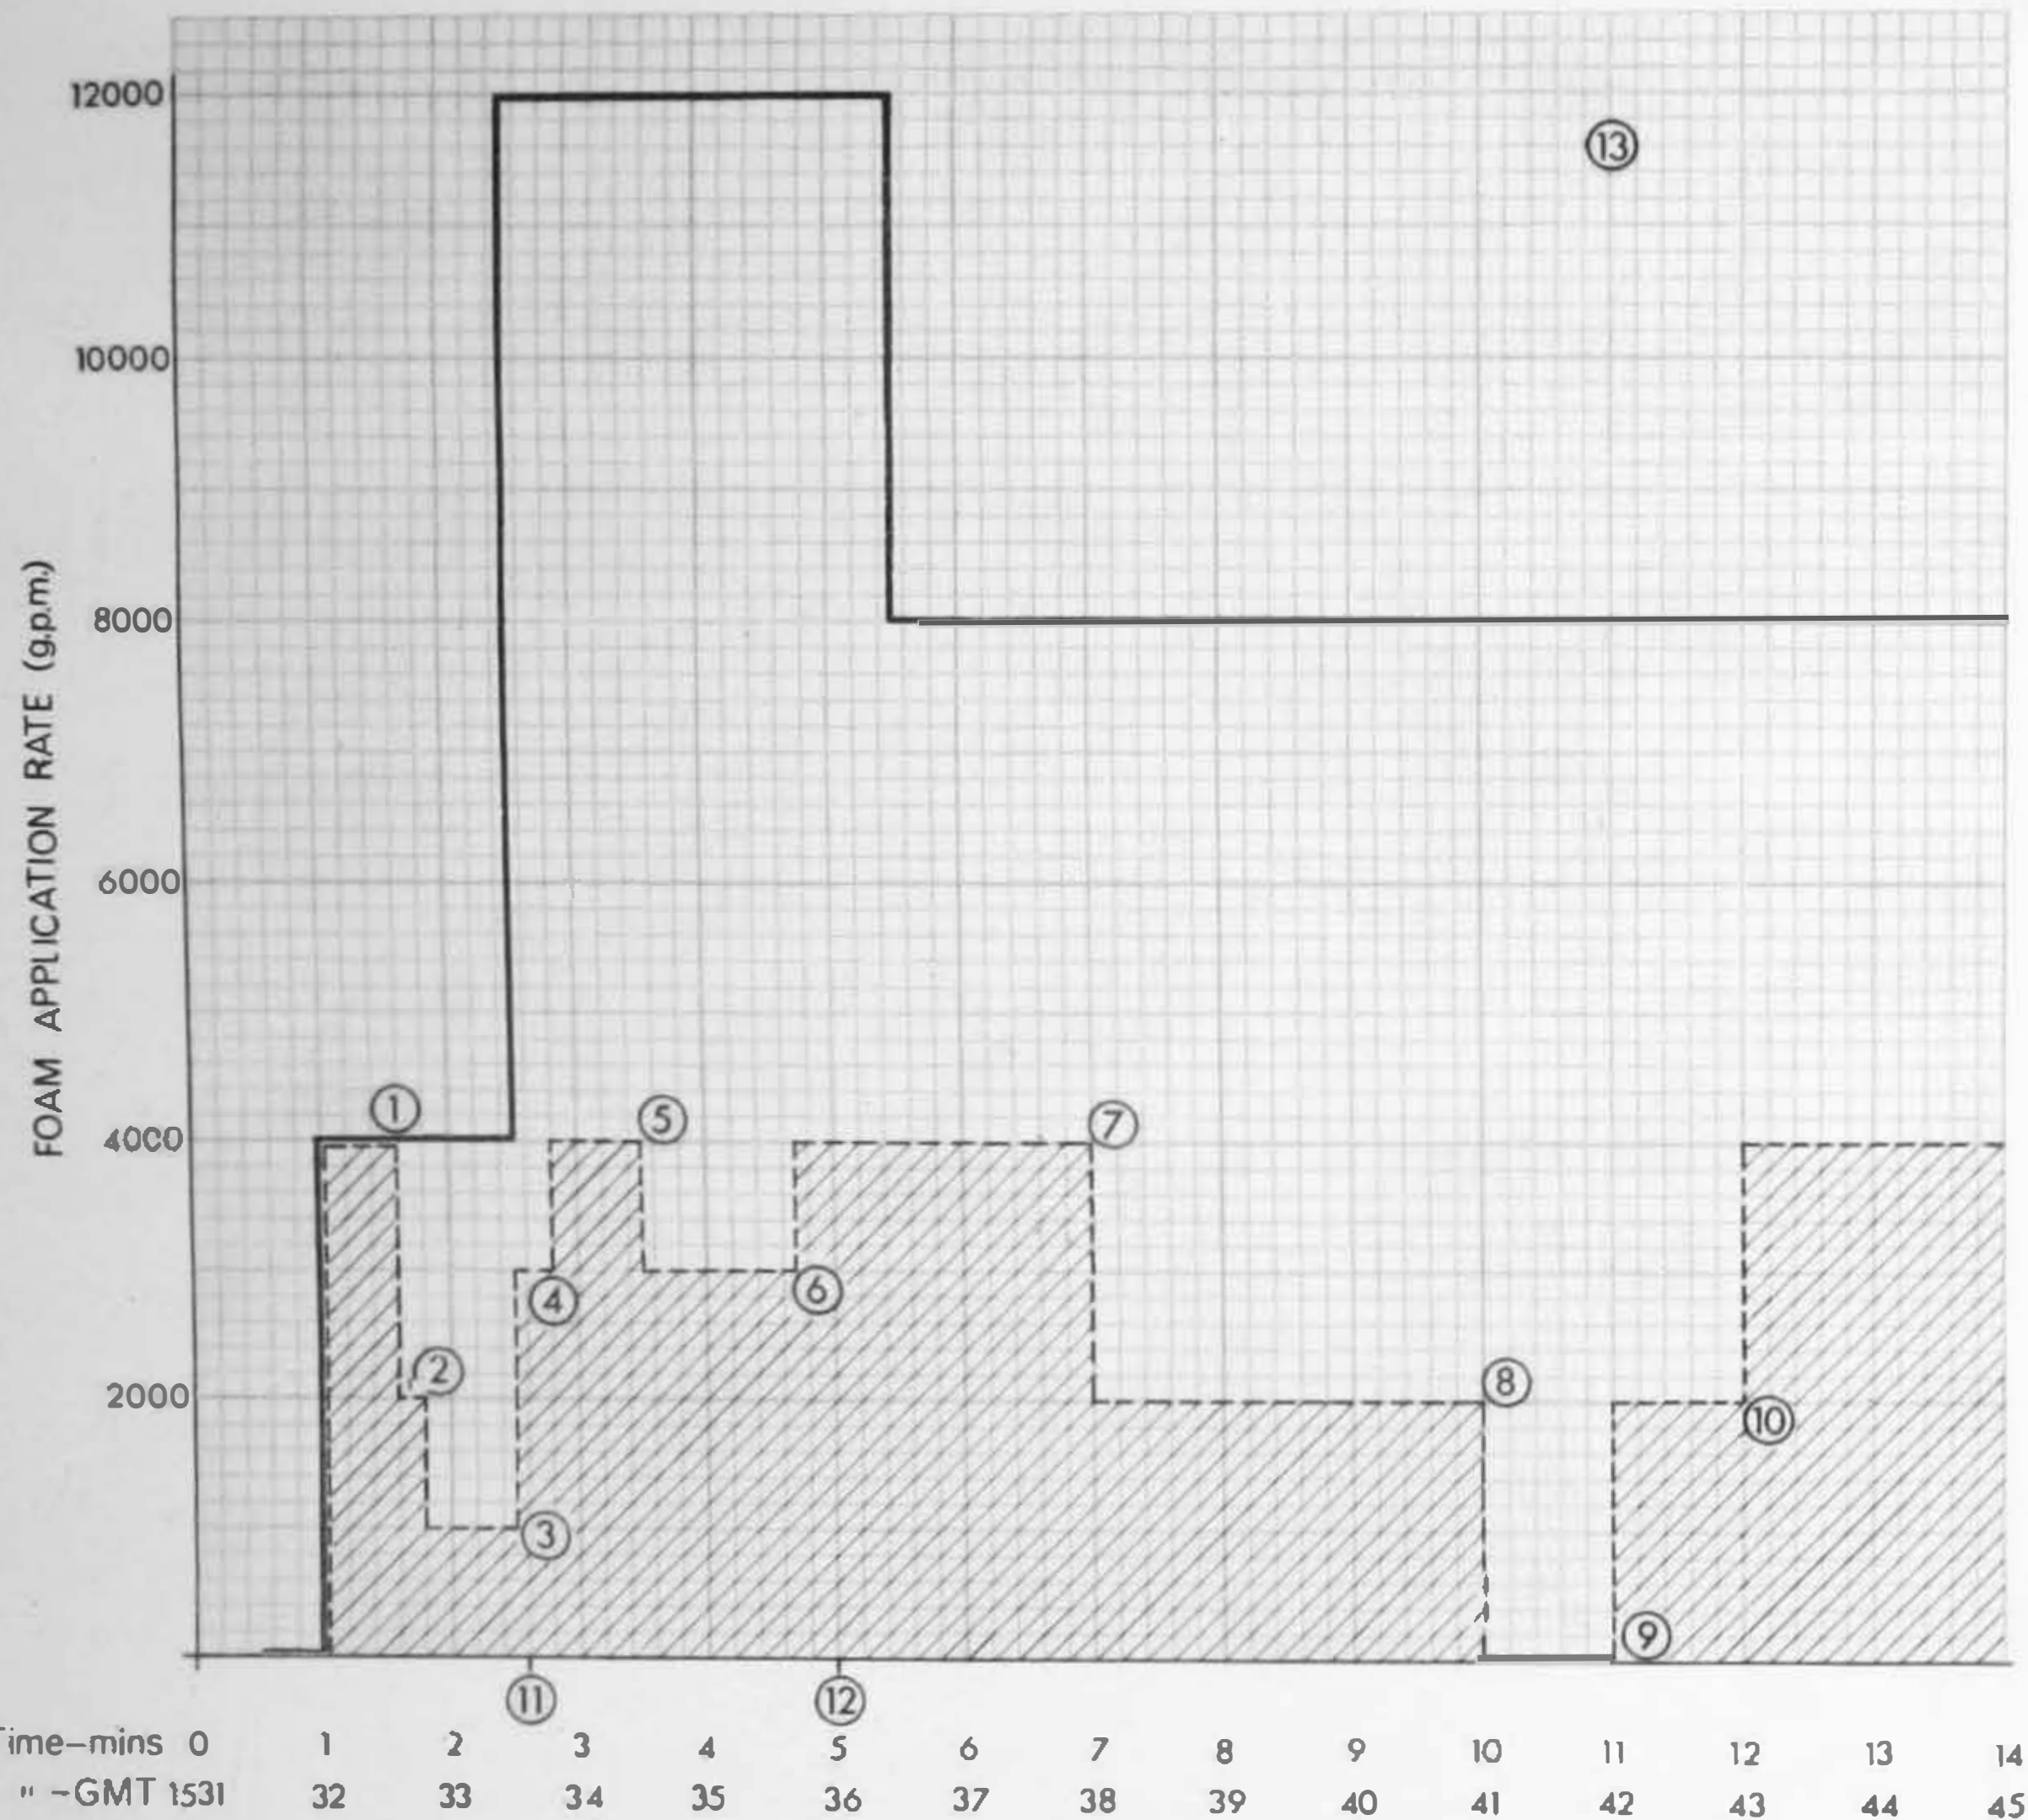
TIME HISTORY OF FOAM APPLICATION

The failure of a handline from the first foam appliance was serious as it reduced the already limited volume of foam being applied to a very low figure at a critical time. The reason for the burst hose has not been determined. Different hoses of a new design, which had been on order for some months before this accident, have now been fitted throughout as standard to all foam appliances and water tenders on the airport.

- ① Monitor VXN 863 shut down
- ② Offside hose VXN863 burst
- ③ SXT 118 producing foam
- ④ VXN 863 hose replaced
- ⑤ SXT118 offside hose burst
- ⑥ SXT 118 hose replaced
- ⑦ VXN 863/SXT 120 out of water
- ⑧ SXT 118/119 out of water
- ⑨ Hydrant water to VXN 863
- ⑩ " " to SXT 118
- ⑪ Cardox CO<sub>2</sub> into action
- ⑫ " empty
- ⑬ Hydrant supply connected

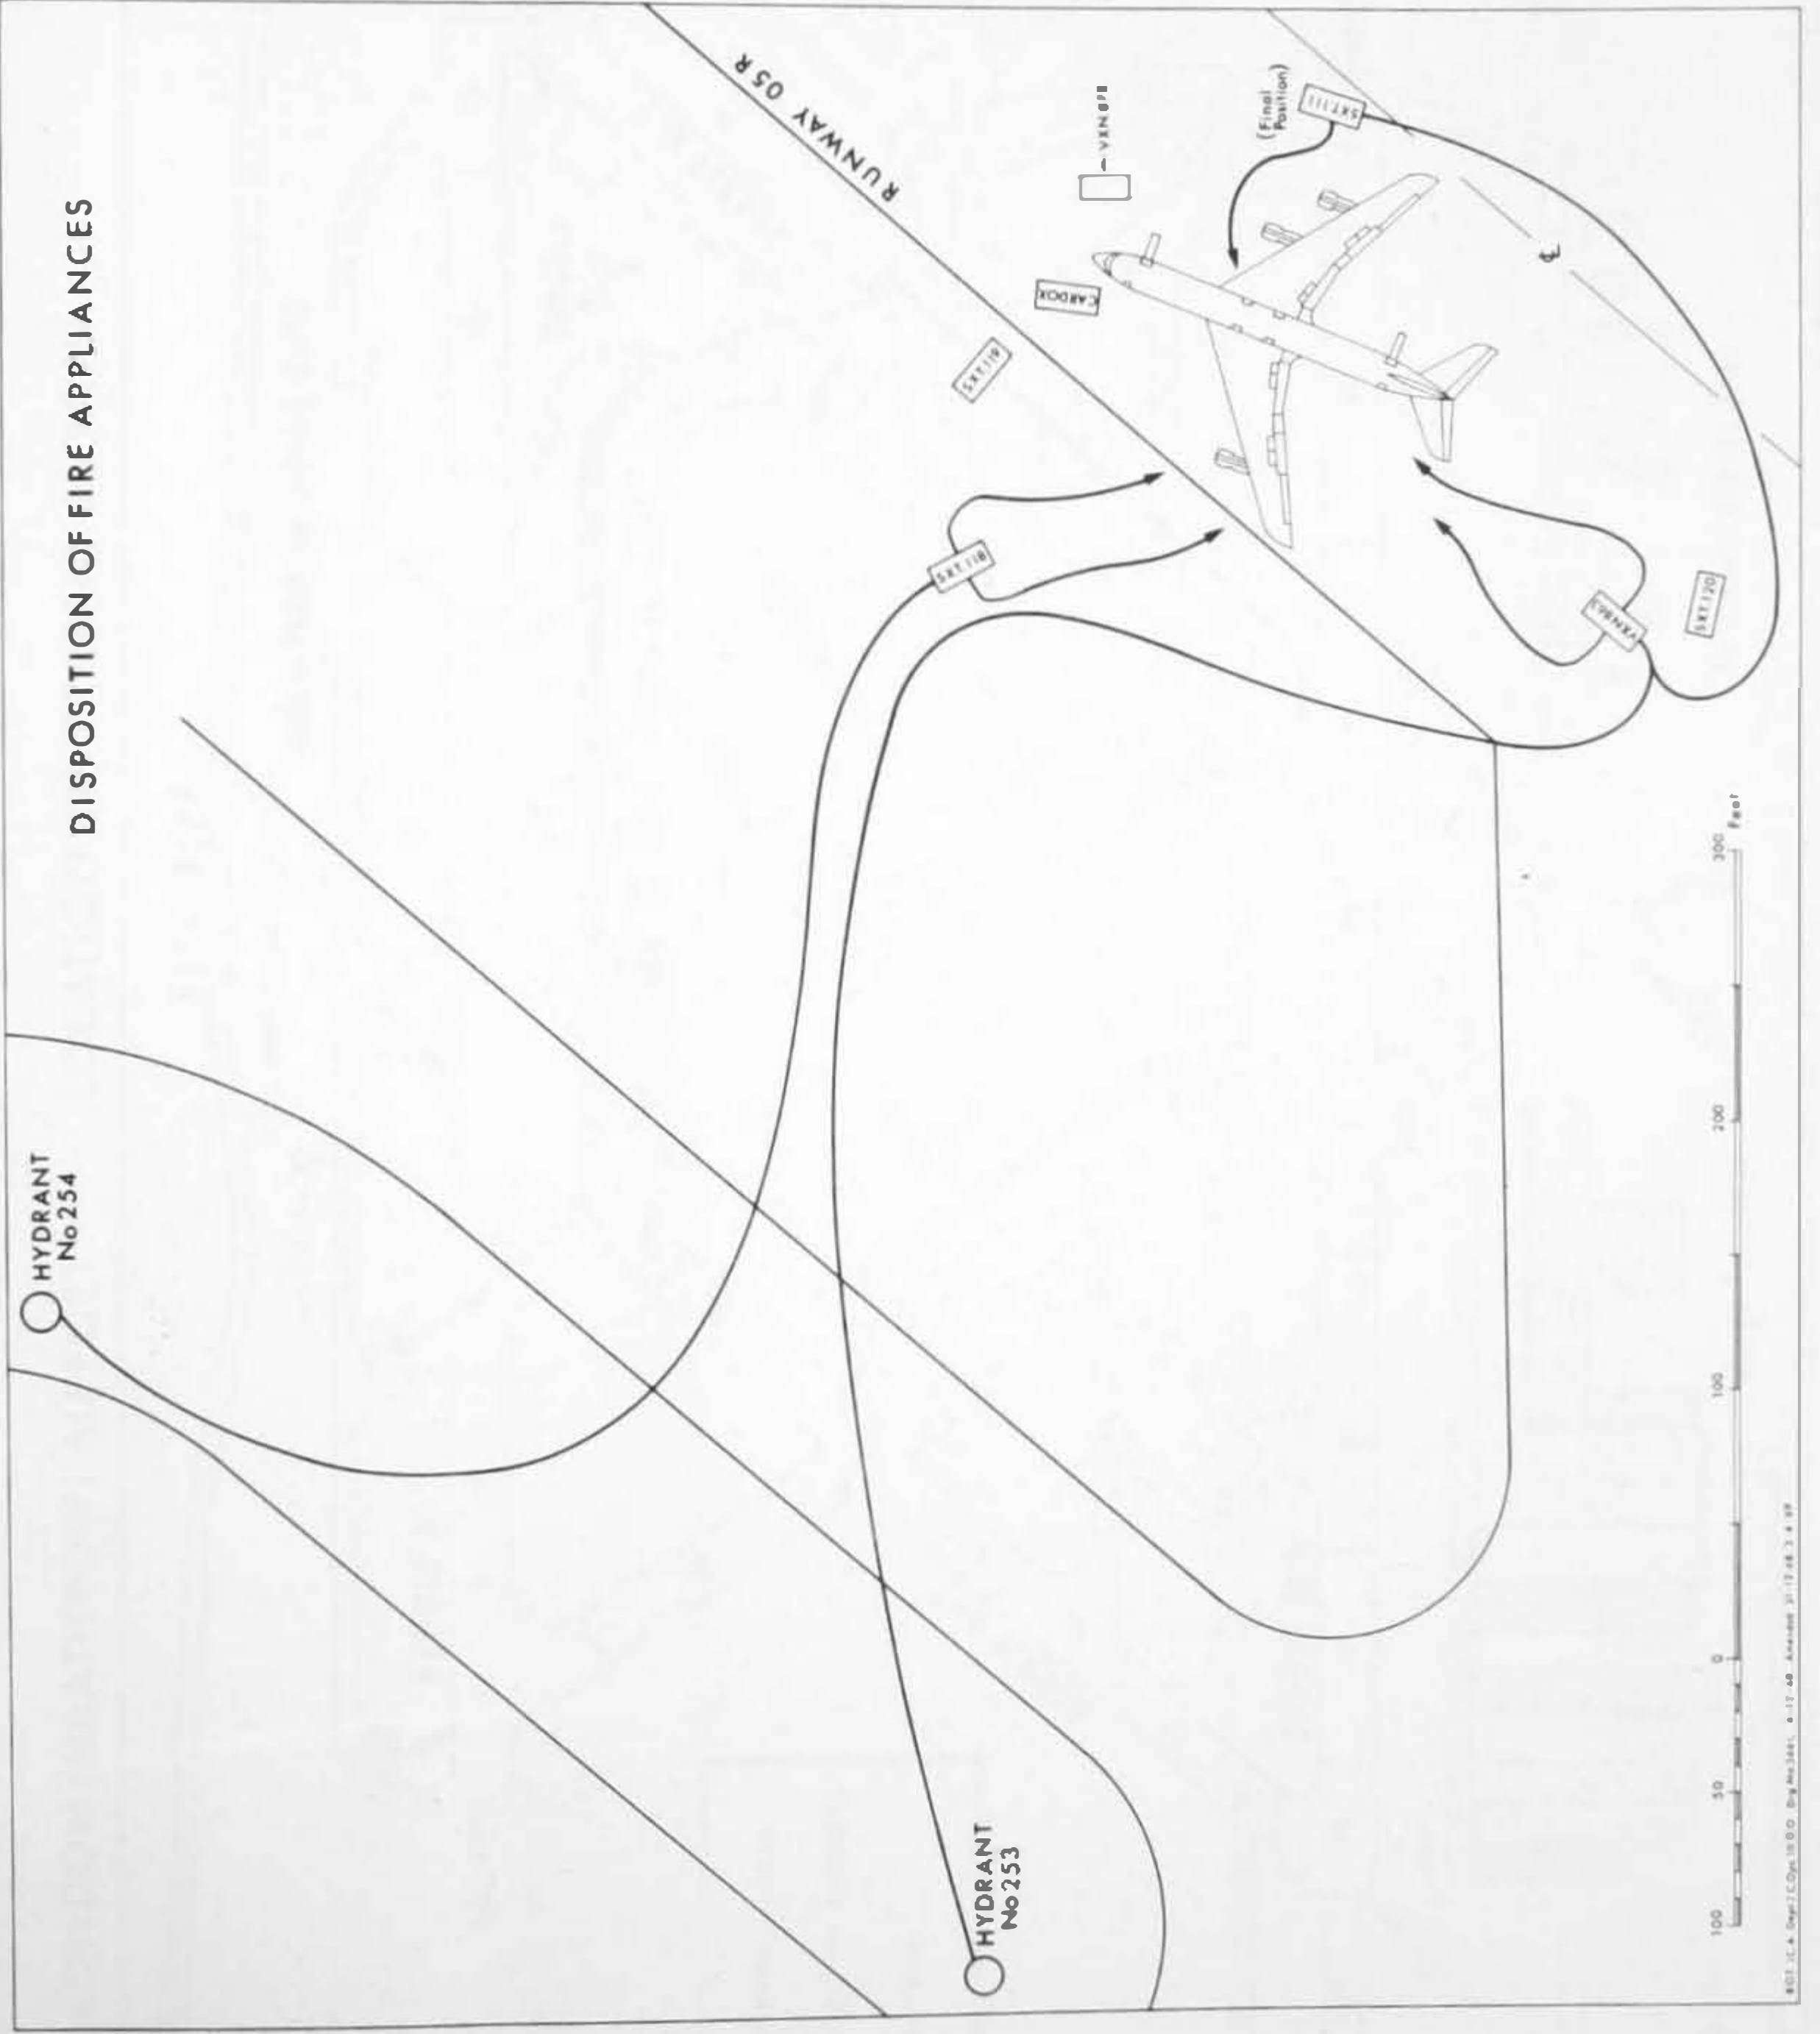
# DISPOSITION OF FIRE APPLIANCES

The tactical approach to this fire was not entirely in accordance with accepted training principles. Although it is accepted that the importance of not hazarding equipment is emphasised during training, on this occasion the positions taken up by the two foam tenders brought into use in the early part of the operation were not well judged. Consequently the main foam volume potentially available could neither be applied to help to isolate the fuselage from the fire, nor to the seat of the fire itself. The design of the appliances used is such that once the snap decision to stop and make foam has been taken, they become virtually immobile and no adjustment to rectify an initial error can be made since the appliances cannot make foam and move simultaneously. This is a recognised deficiency in the equipment which the British Airports Authority will shortly be replacing by new appliances which can make foam and move at the same time.

One foam tender (SXT 118) was positioned on the grass clear of the runway roughly in line with the aircraft nose on the port side and some 65 feet from the edge of the runway. The supporting water tender (SXT 119) stopped adjacent to it and started to transfer water to the foam tender. As the appliance was sited out of range, the monitor was not used. Two side lines were deployed, but shortly after the offside line had started to produce foam, the hose burst. The defective line was replaced in about a minute and the foam applied to the port wing area. At about 1541 hrs. (A+10m.), i.e. after some 8 minutes of operation, both SXT 118 and SXT 119 had used up their mobile supplies and ran out of water.
