Report on an  
**Explosion and Fire**  
involving the Motor Vessel  
*Atlantic Duchess* at Queen's  
Dock, Swansea, Glamorganshire  
on 2nd February, 1951

REPORT TO THE RIGHT HONOURABLE  
THE SECRETARY OF STATE FOR THE  
HOME DEPARTMENT ON THE CIRCUM-  
STANCES ATTENDING AN EXPLOSION  
AND FIRE WHICH OCCURRED ON 2ND  
FEBRUARY, 1951, AT QUEEN'S DOCK  
SWANSEA, IN THE COUNTY OF GLAM-  
ORGANSHIRE, INVOLVING THE MOTOR  
VESSEL *ATLANTIC DUCHESS*

BY H. E. WATTS

H. M. CHIEF INSPECTOR OF EXPLOSIVES

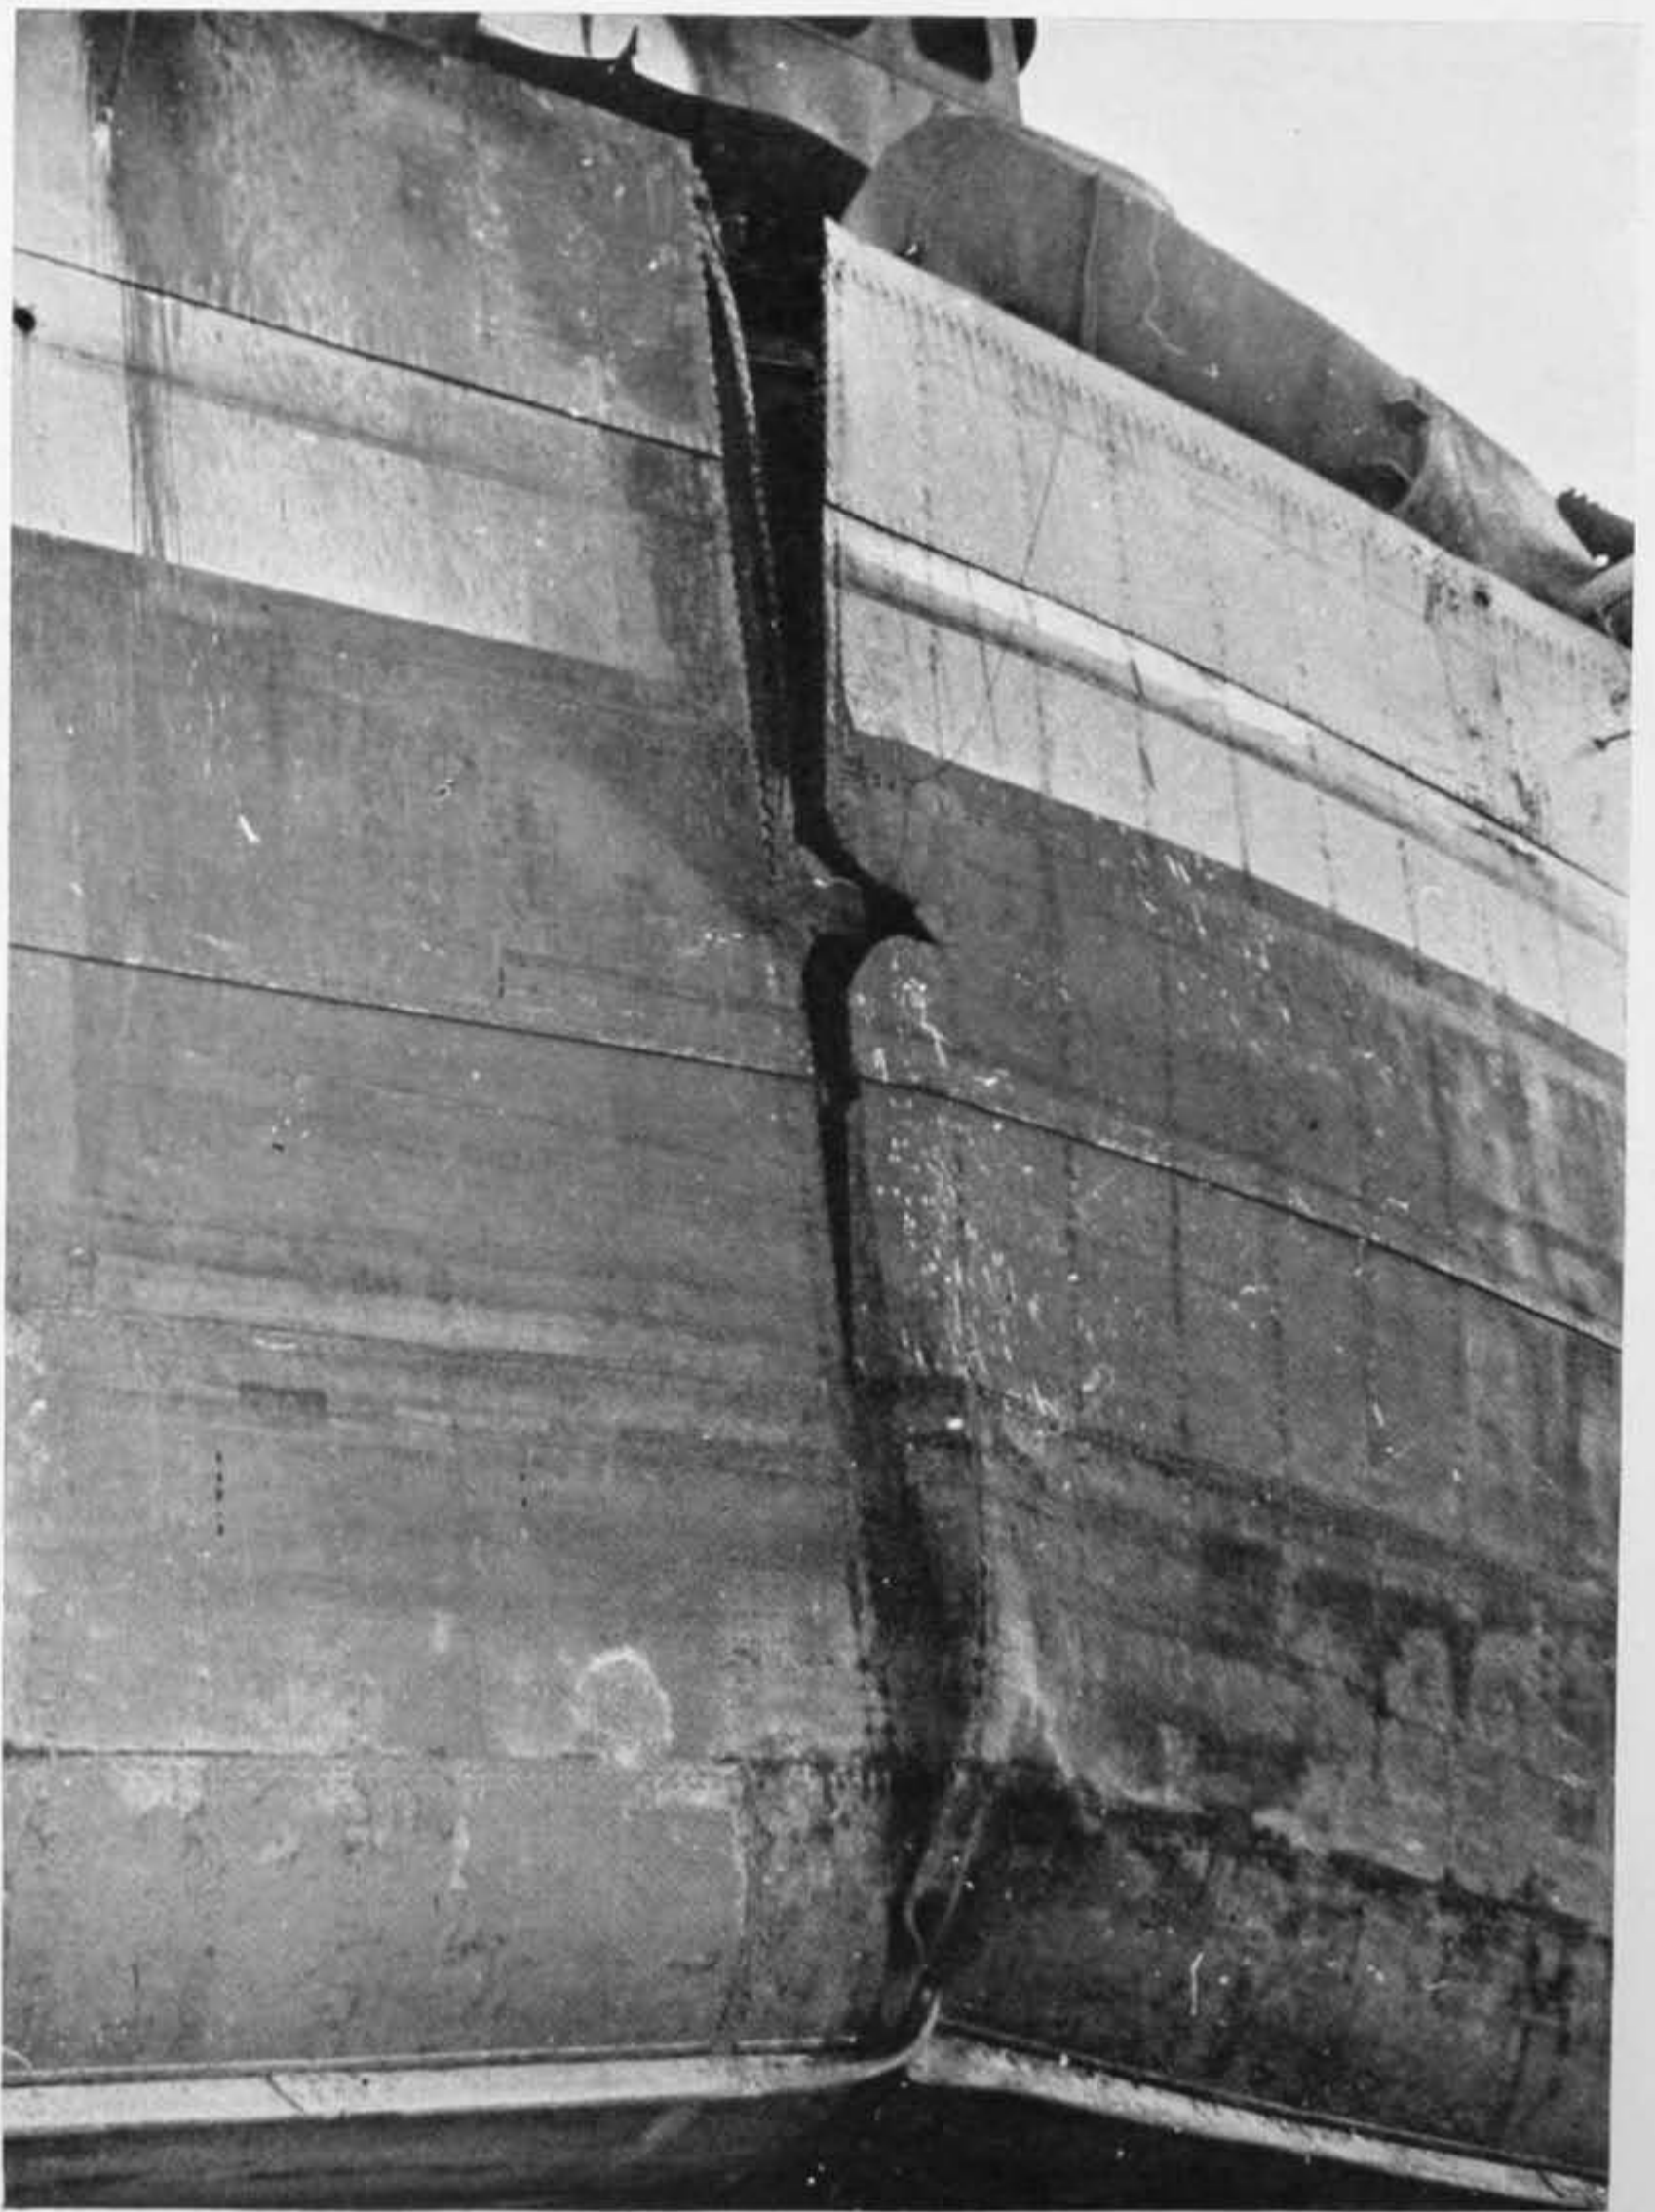
PLATE VII. *Break in hull, starboard side.*

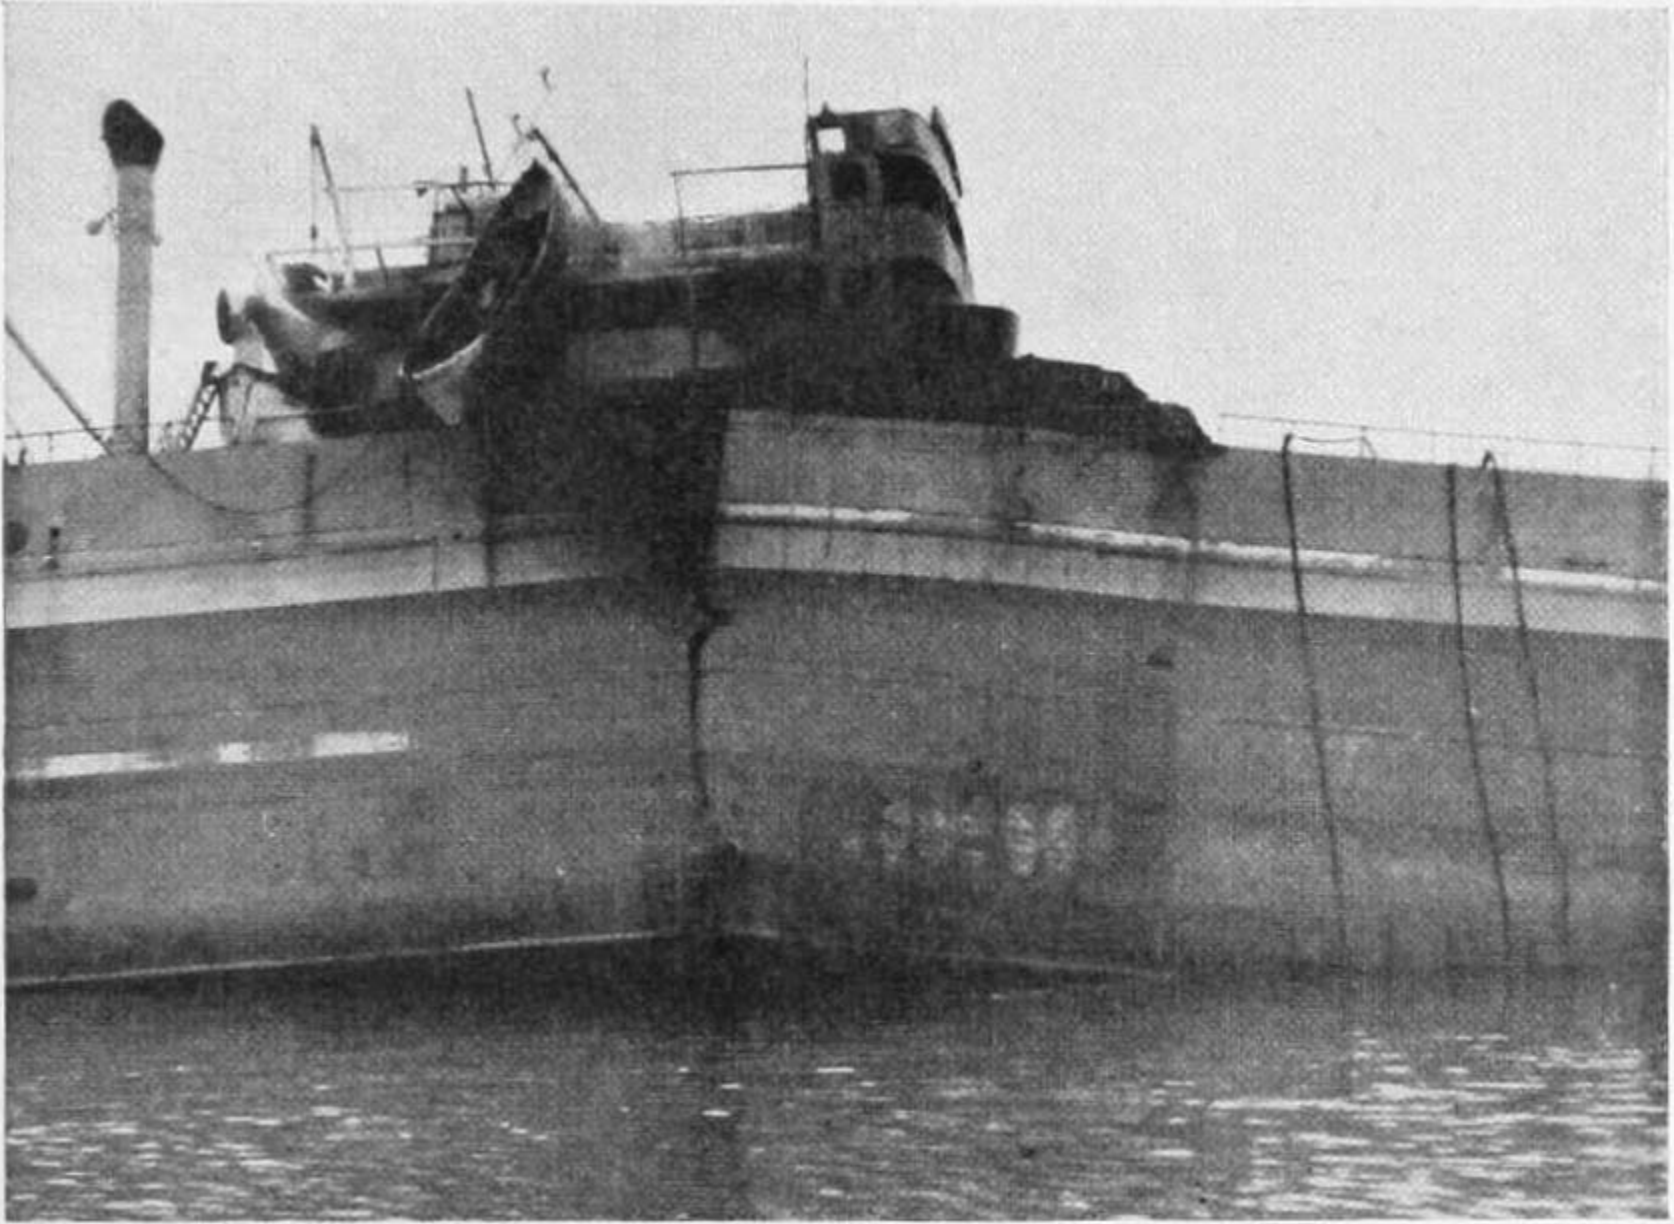
PLATE VIII. *Starboard side amidships, showing centre castle and break in hull.*

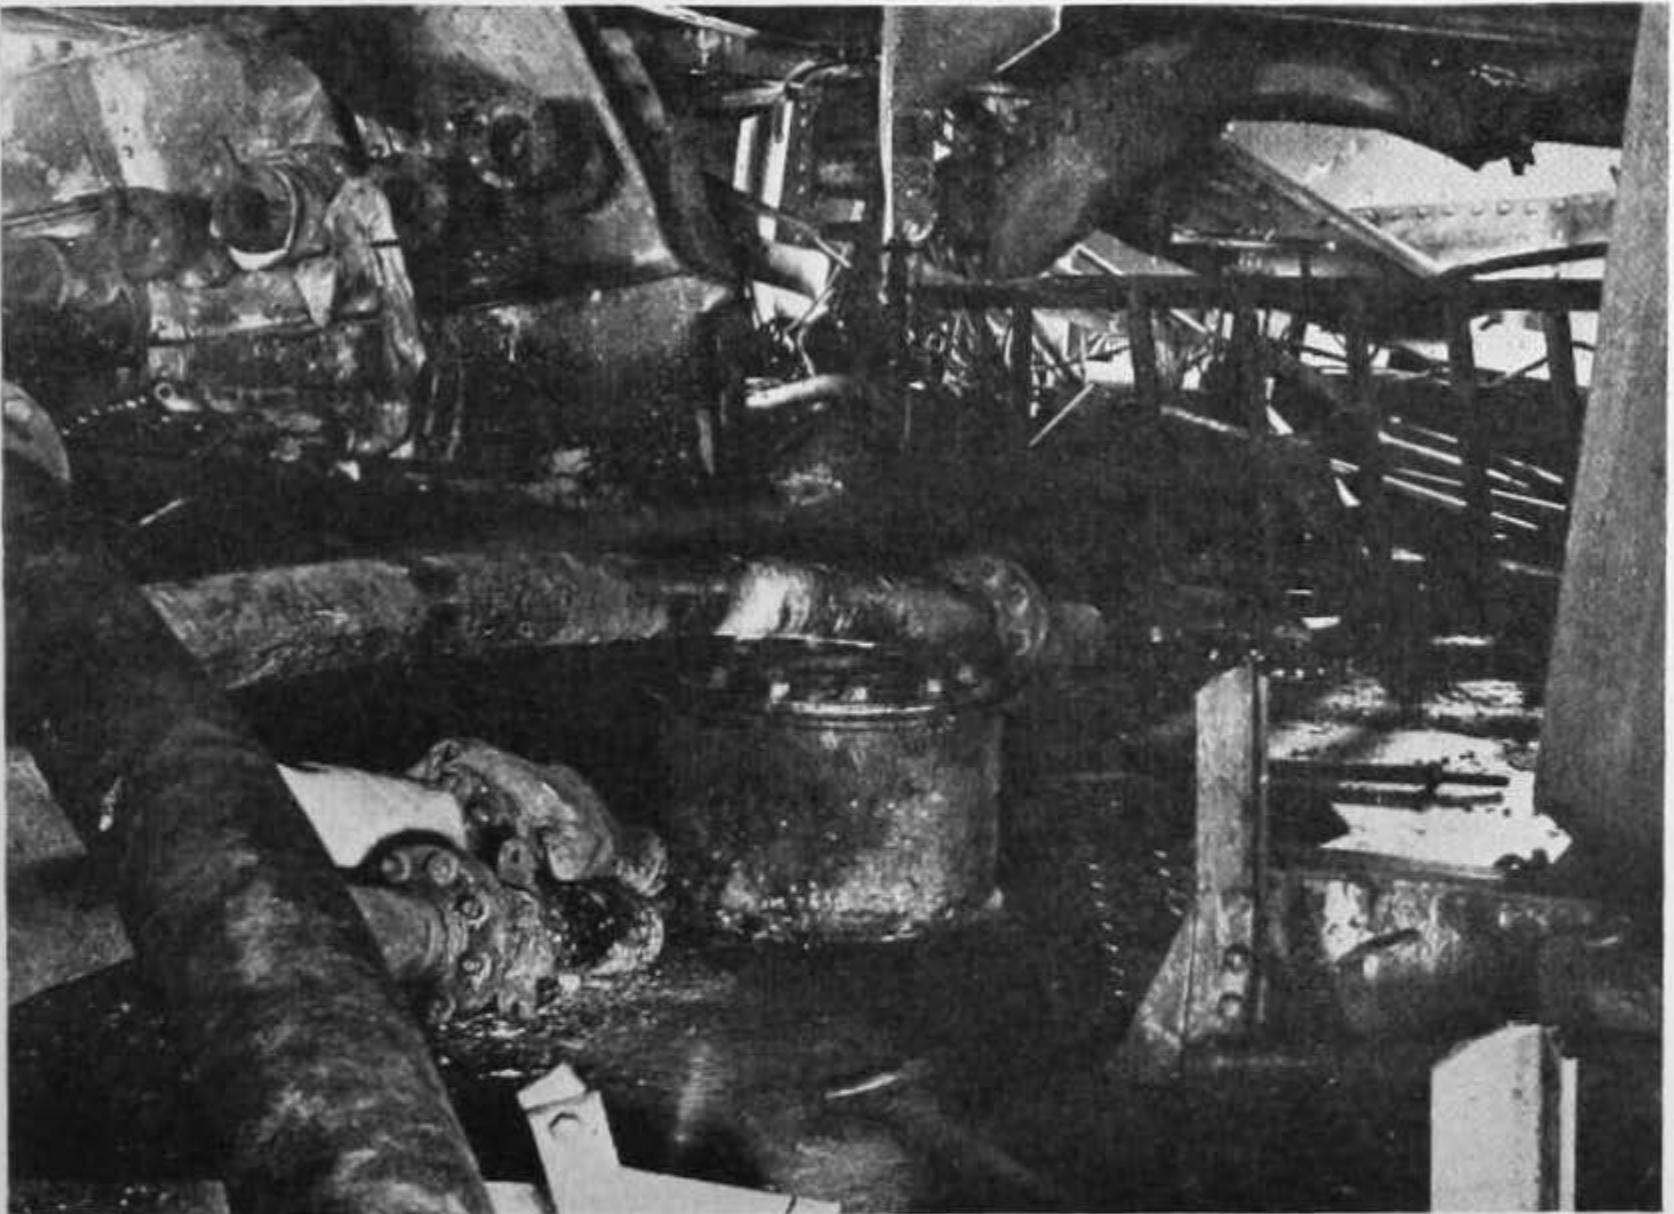
The vapour would not go through the vent pipe up the mast as it would have to overcome the pressure of 3 lbs. per square inch to pass through the "Tiros" valve. It is therefore clear that this space could soon be filled with an explosive mixture. In order to fire this mixture it is only necessary to produce some source of ignition, such as a spark or naked light of some kind. When the vessel was inspected after the explosion not only was there no ullage plug in the Butterworth hatch No. 5 centre tank, but there was also no ullage plug in the Butterworth hatches on No. 5 port tank or No. 4 port tank. We were informed that when preparations were being made to gas free the tanks, there was no ullage plug in the Butterworth hatch in No. 3 centre tank, and that the ullage plug in No. 8 port tank was also missing. These two plugs were replaced. It was thought that the ullage plug from No. 8 port tank was knocked out of its hole by projected debris from the explosion.

PLATE IX. *No. 5 centre ullage chamber with missing cap ; also view of centre castle after bulkhead with steam and water line flanges. View taken looking aft.*

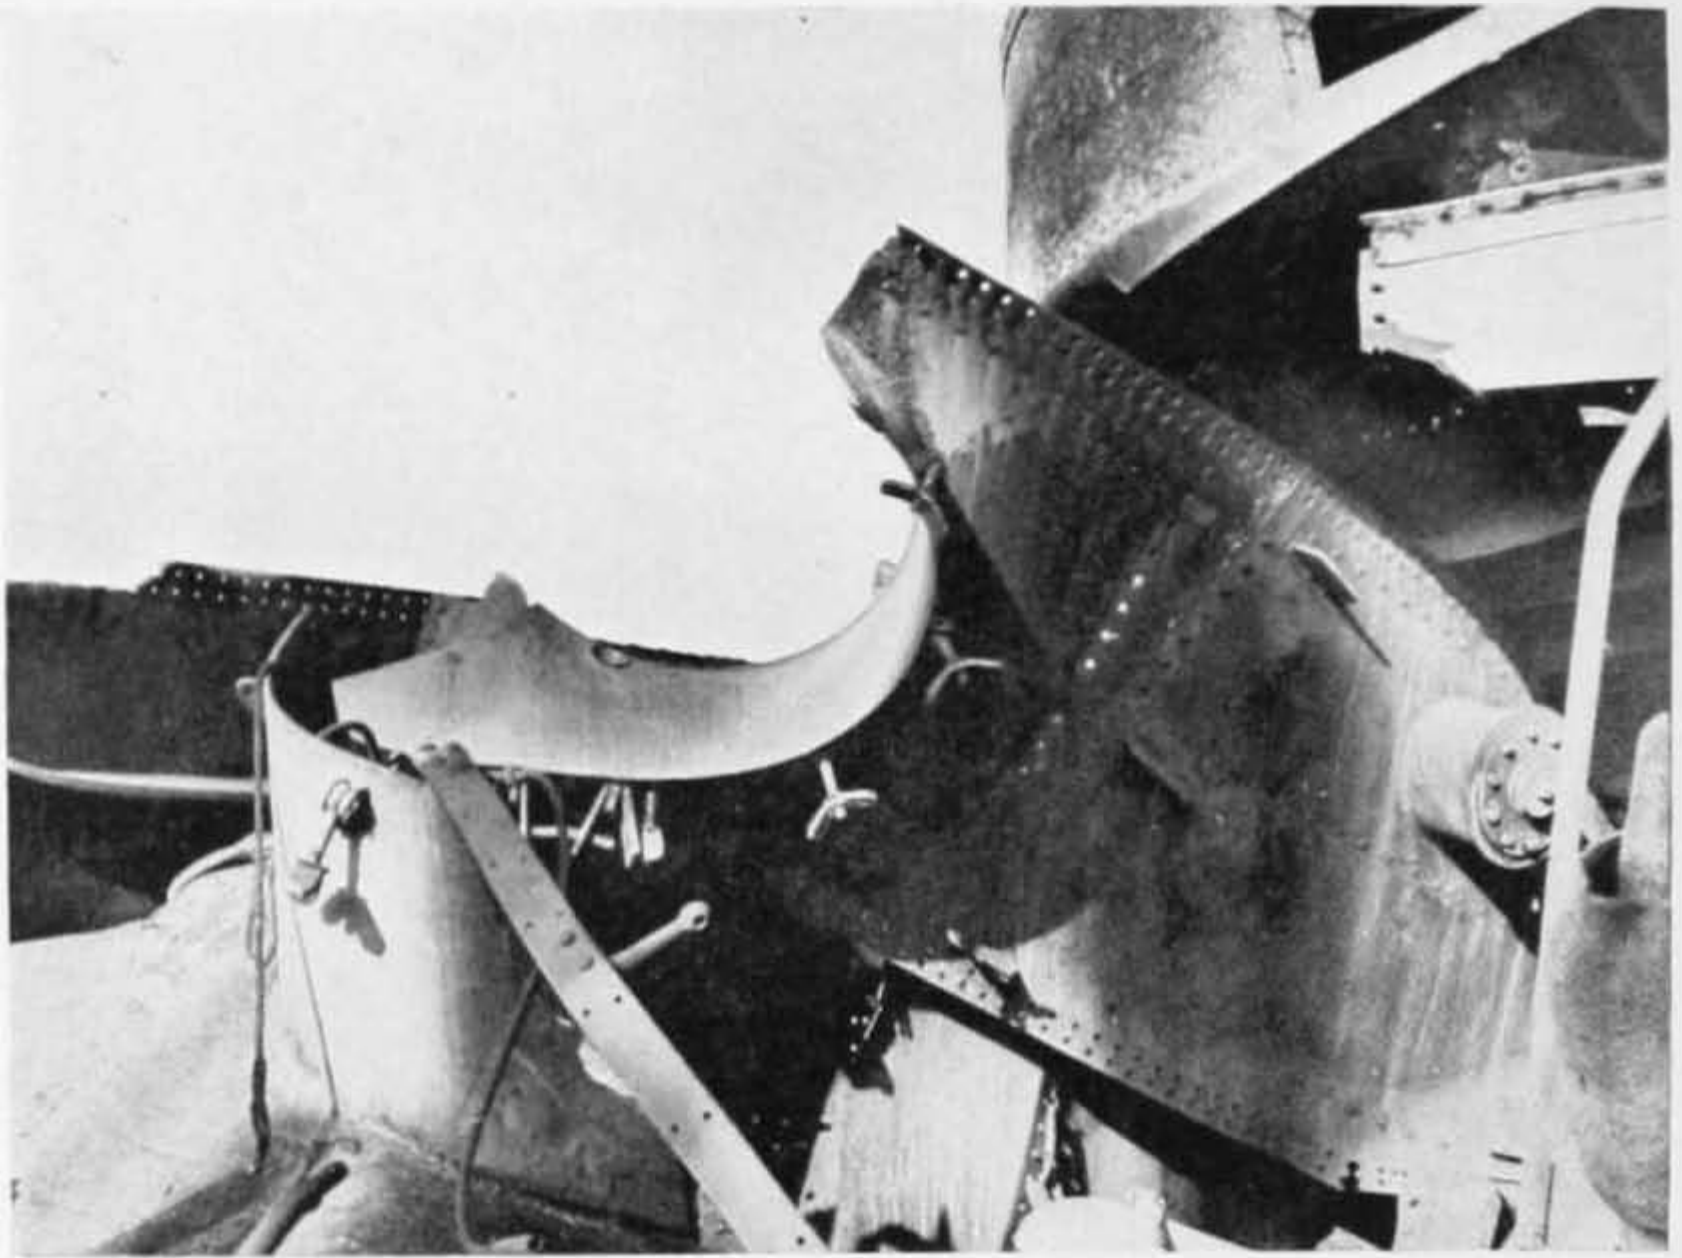
PLATE X. *No. 4 starboard wing tank—deck plates, hatch combing and ullage hatch and plug.*

2. In the enclosed space under the officers' accommodation, Butterworth hatches provided with ullage plugs were fitted to No. 4 port tank, No. 4 centre tank, No. 4 starboard tank and No. 5 centre tank. I consider that these Butterworth hatches fitted with ullage plugs should have been in the open so that the displaced oil vapour is dissipated in the open air during the process of pumping ballast into the tanks. Furthermore, I consider that it would be better to fit the ullage plugs in the main hatches, otherwise this may give rise to the spillage of oil at sea due to the motion of the vessel if the ullage openings are used when the tanks are loaded with oil. I recommend that consideration be given to this point by the owners of the vessel, and also by the firms who build petroleum tankers.

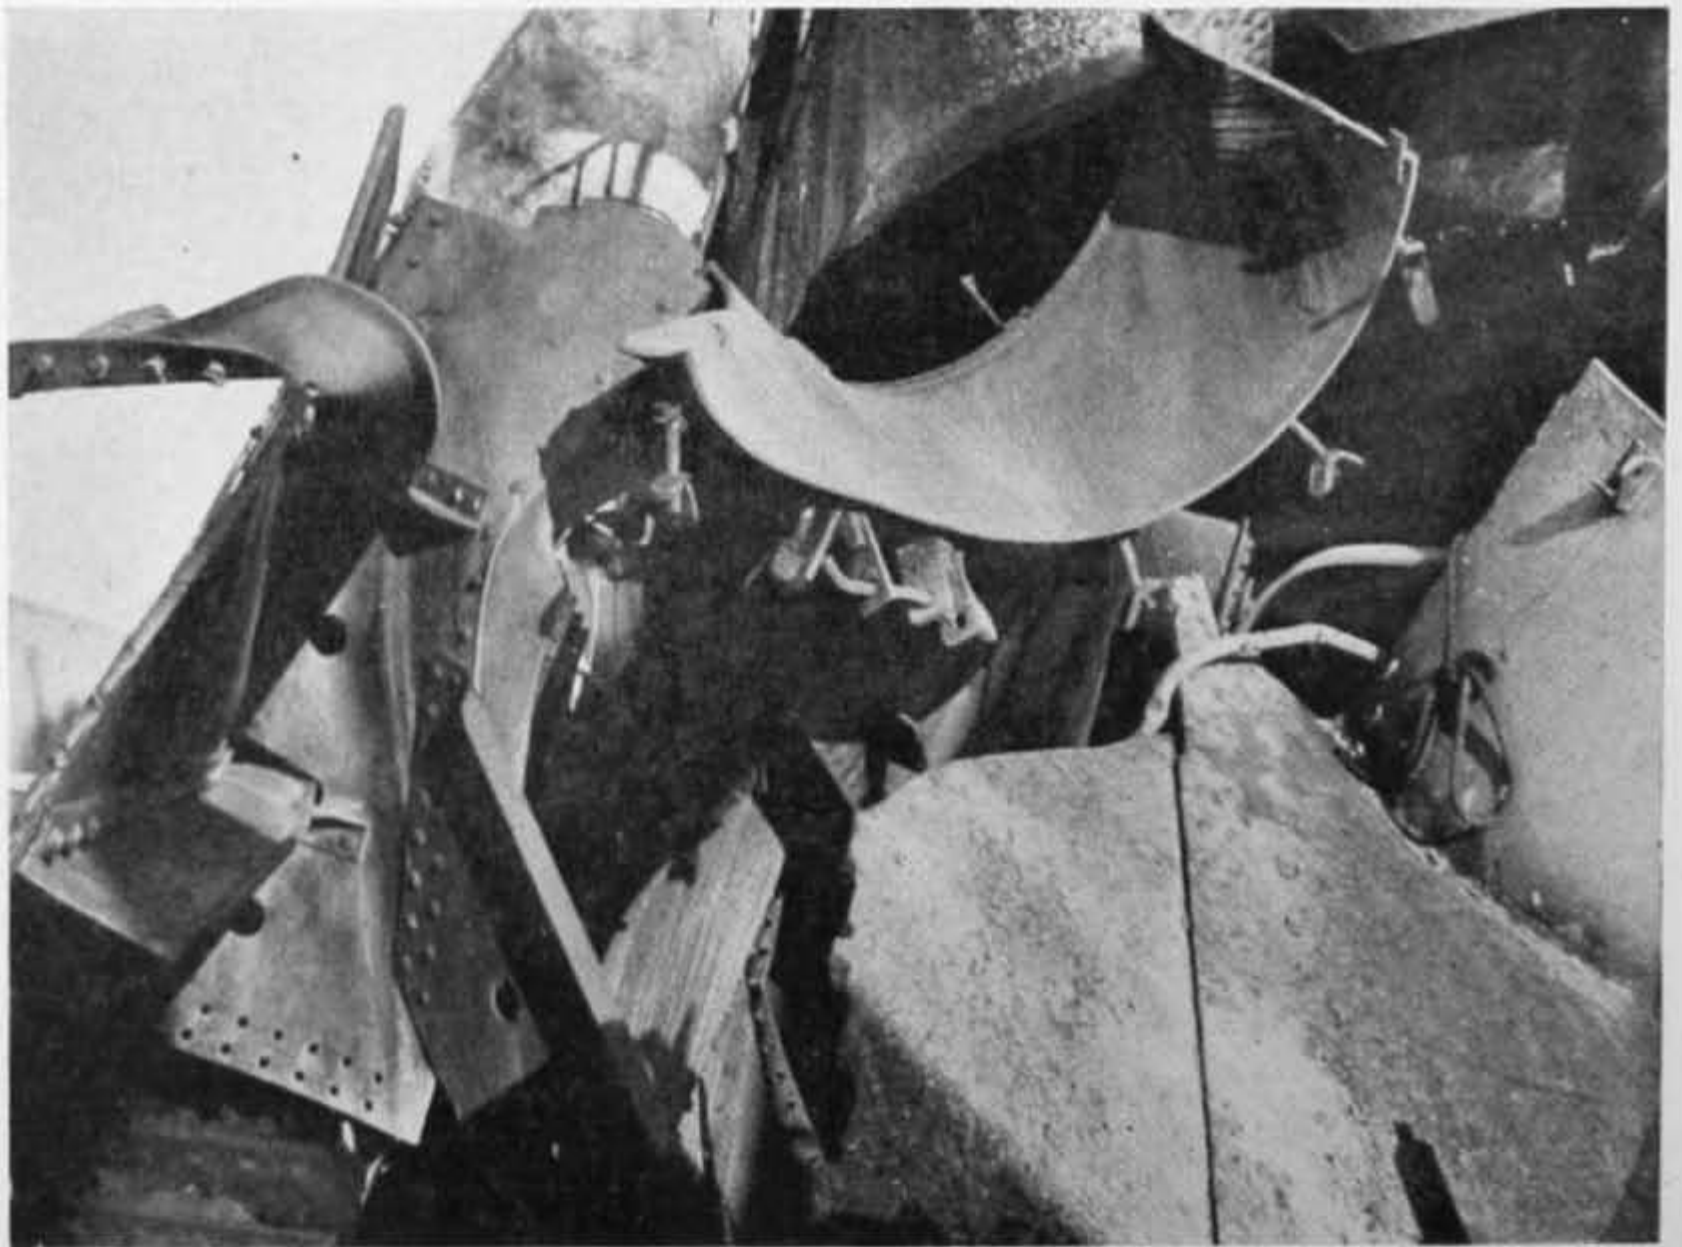
PLATE XI. *Second view No. 4 wing tank—deck plates, main hatch combing, ullage chamber and plug.*

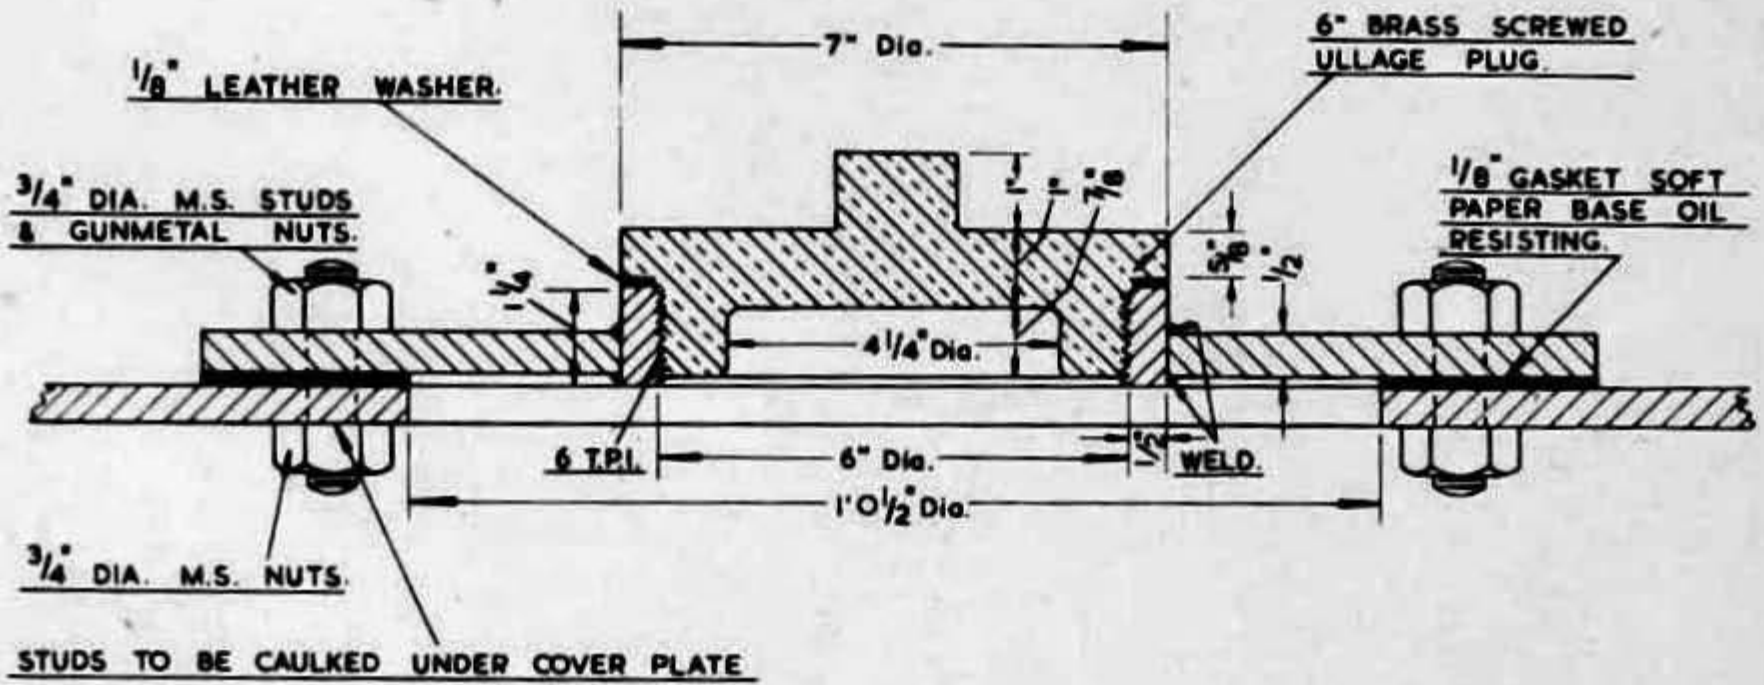
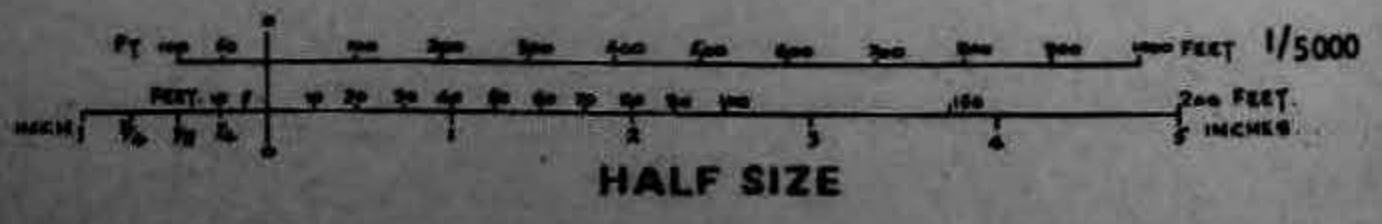
# PLAN A

Each tank was provided with a Butterworth hatch in the deck for the insertion of the Butterworth cleaning system. A blue-print of the hatch is contained in plan A attached\*. This opening consisted of a short metal cylinder about 18 inches in diameter, the top of which was about 12 inches above the deck.

The top of the cylinder was covered with a metal plate in which an ullage plug, about 6 inches in diameter, was screwed. These openings were not protected by wire gauze. Each tank was also provided with a steam ejection pipe which could be used for sounding the tanks. Tanks No. 4, port, centre and starboard had sounding pipes with screwed plugs flush with the deck. No arrangement was made for dipping the tanks from the main hatches.
