**Negotiating Repair and Authenticity in the Conservation of
Ornamental Architectural Stone: Managing Decay and Past
Interventions on the Façades of Rosslyn Chapel and Mission San
José**

A Dissertation submitted for

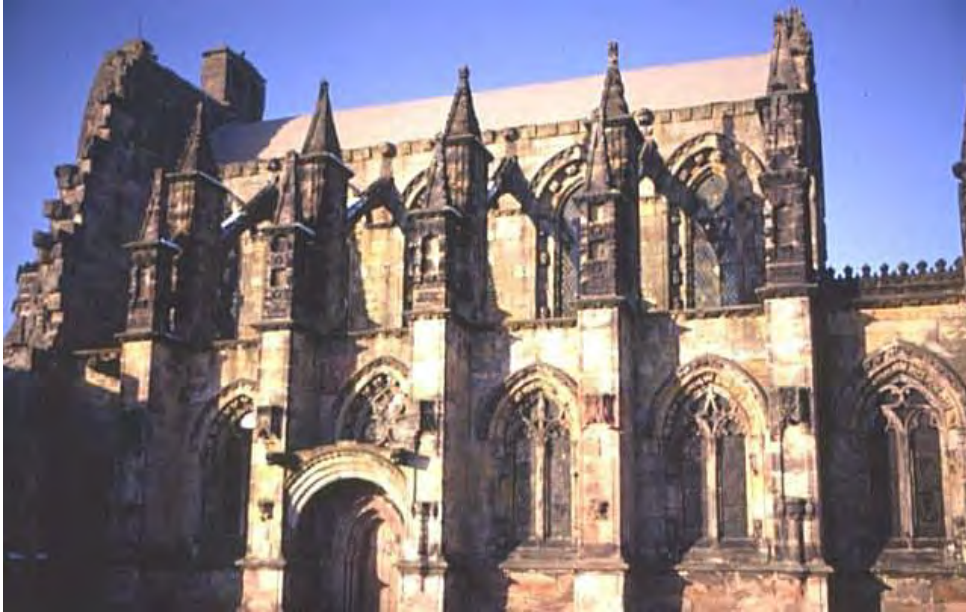
Figure 0.1 Rosslyn Chapel, Roslin, Scotland

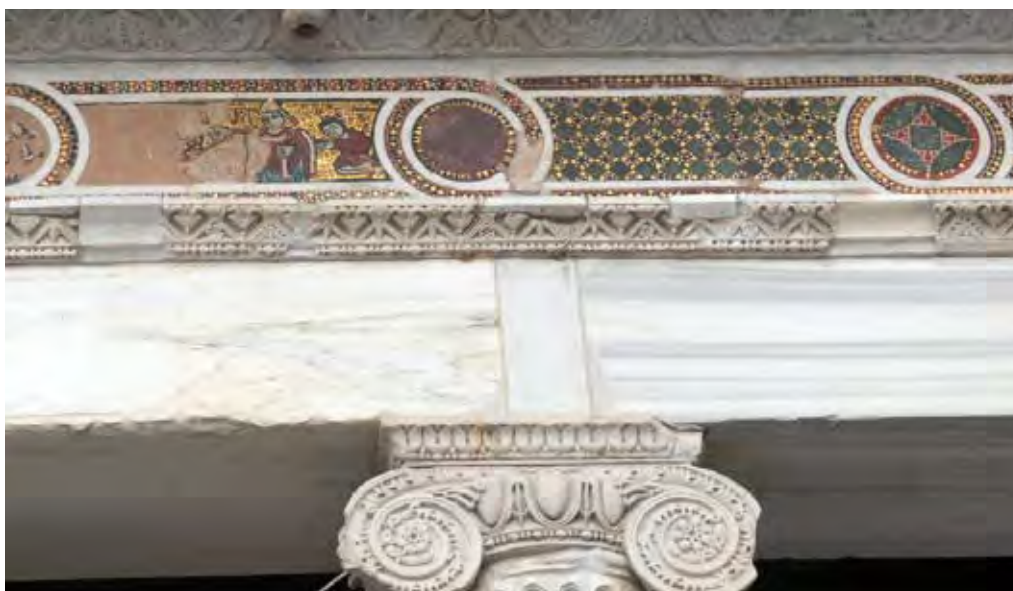
Figure 1.5 Detail of exterior portico of San Lorenzo fuori le mura, Rome, showing simple, undecorated stone indents into cornice where original sections were lost from damaged sustained in WWII.

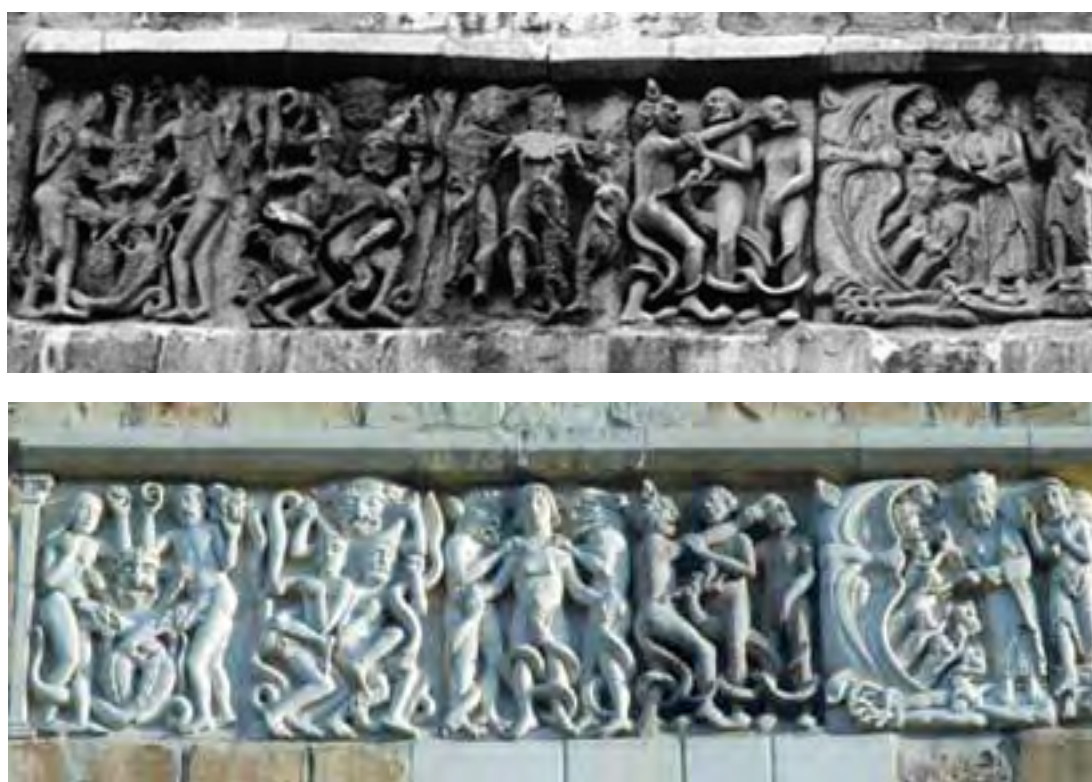
Figure 1.6 Detail of Romanesque frieze at Lincoln Cathedral before restoration (top), showing decayed original stonework, and after restoration (bottom), showing replacement stonework inserted on facade. The original stone frieze was removed for conservation and installed in a permanent exhibit inside the cathedral to protect the stonework from further decay. Where documentation did not exist for lost original details, the stonemasons created original designs that were in-keeping with the extant original carvings.

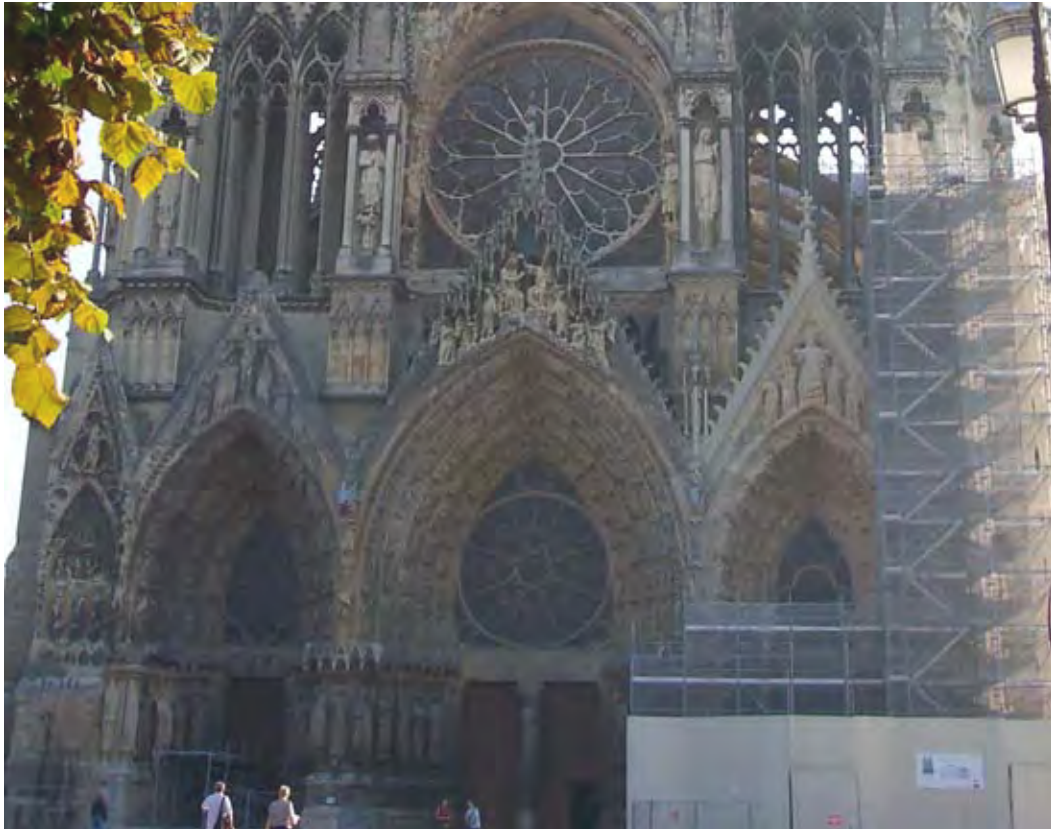
Figure 1.7 Reims Cathedral, France in 2004 during restoration and conservation work on the south portal.

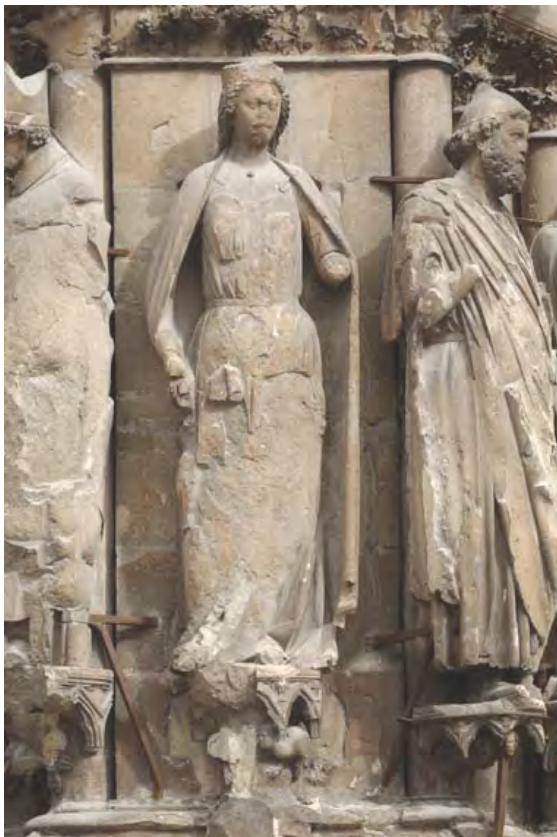
Figure 1.8 Reims Cathedral. Detail of the damaged original Queen of Sheba figure at the central portal of the facade before removal and replacement with a replica.

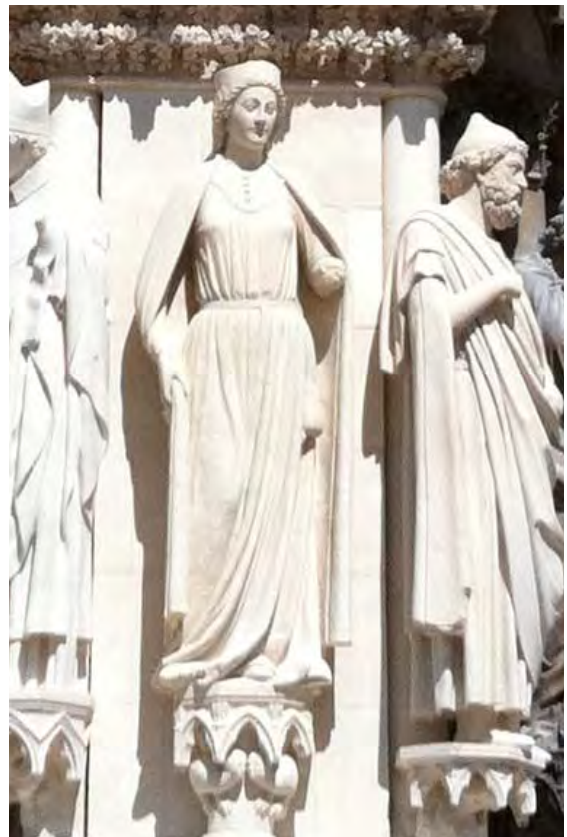
Figure 1.9 Reims Cathedral. Detail of the replica Queen of Sheba figure installed in 2007 at the central portal.

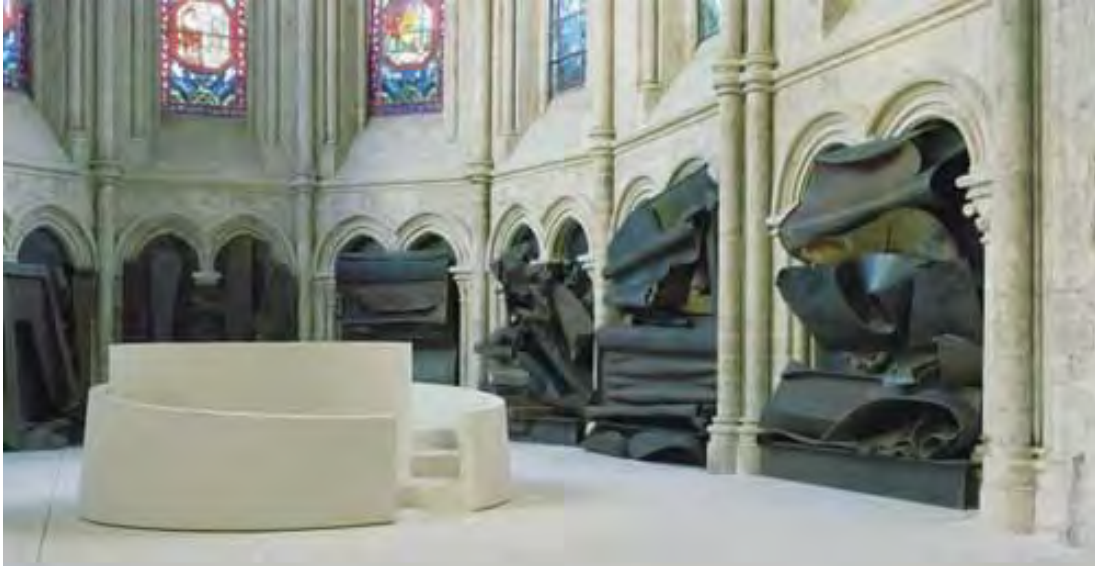
Figure 1.10 Restored 12th century choir of the church of St. Jean-Baptiste in Bourbourg, France. The choir was heavily damaged during WWII and was restored in 1999. The church commissioned modern sculptures for the niches along the interior of the choir that would have originally held carved stonework. In 2008, artist Anthony Caro installed modern steel and terracotta sculptures in the niches.

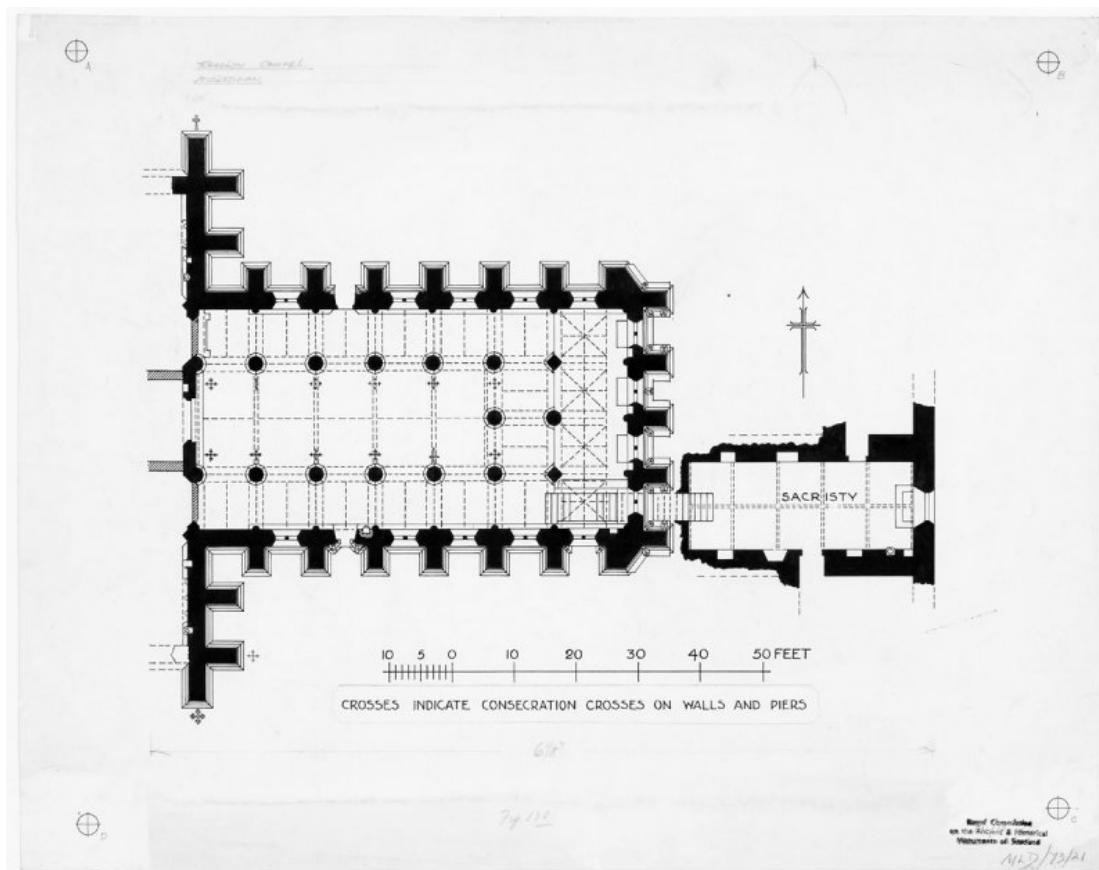
Figure 2.1 Plan of Rosslyn Chapel, c.1920

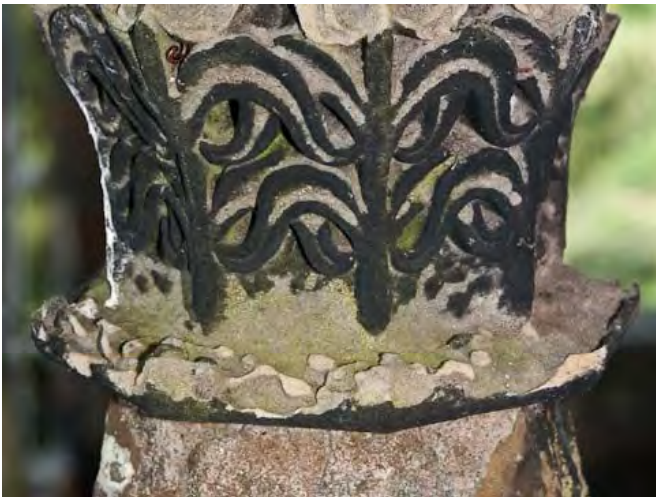
Figure 2.18 Examples of preferential erosion on carved elements caused by adjacent dark pollution crusts.

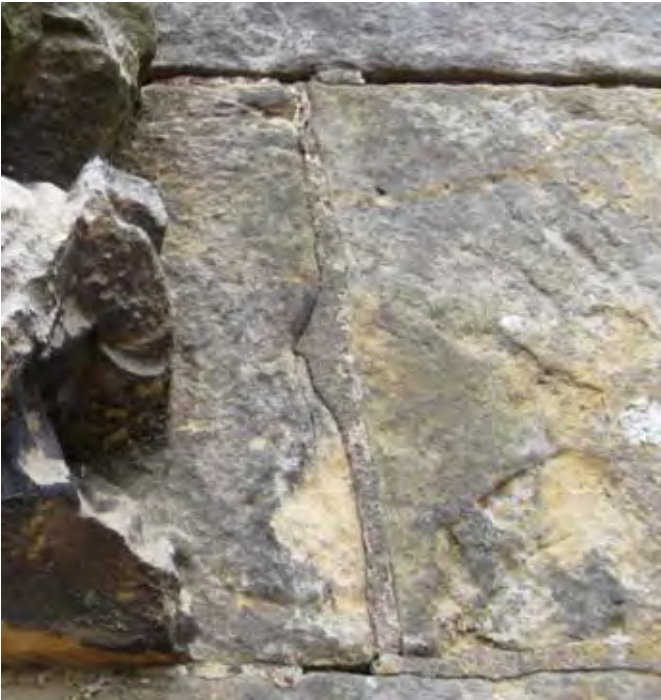
Figure 2.19 Examples of cement mortar that is causing preferential erosion of the adjacent stone surfaces.

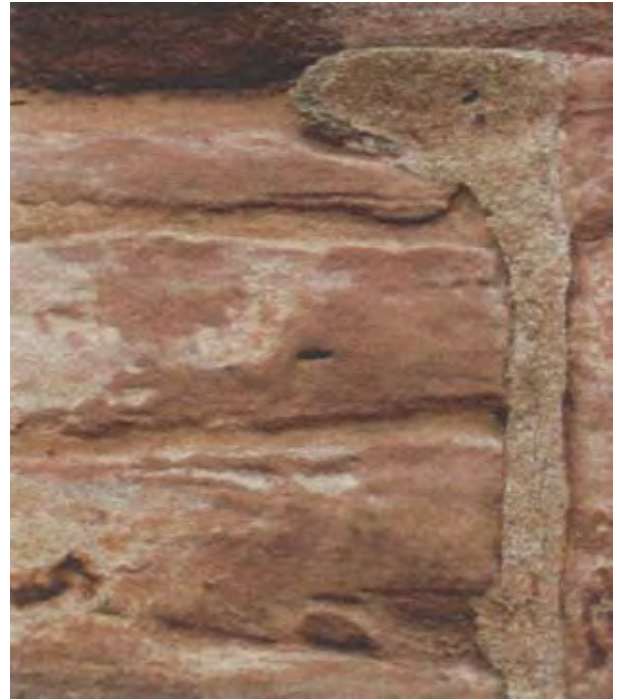
Figure 2.20 Detail of cement mortar on red sandstone surface that has caused significant preferential erosion of the stone.

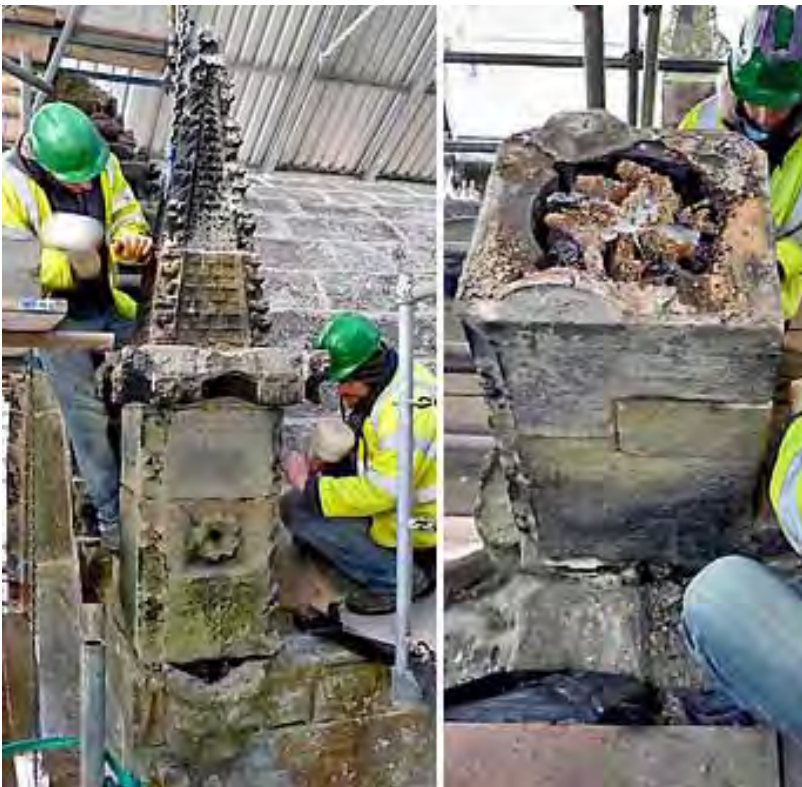
Figure 2.21 Deconstruction of N5 left side pinnacle during stabilization work in 2010 in order to properly re-bed and secure pinnacle.

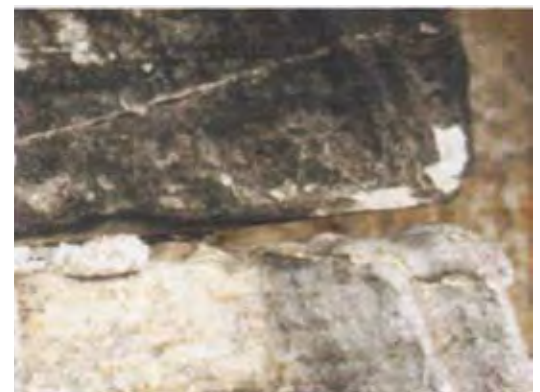
Figure 2.22 Detail of construction joint at buttress pinnacle showing loss of bedding mortar that has caused the stonework to become structurally unstable.

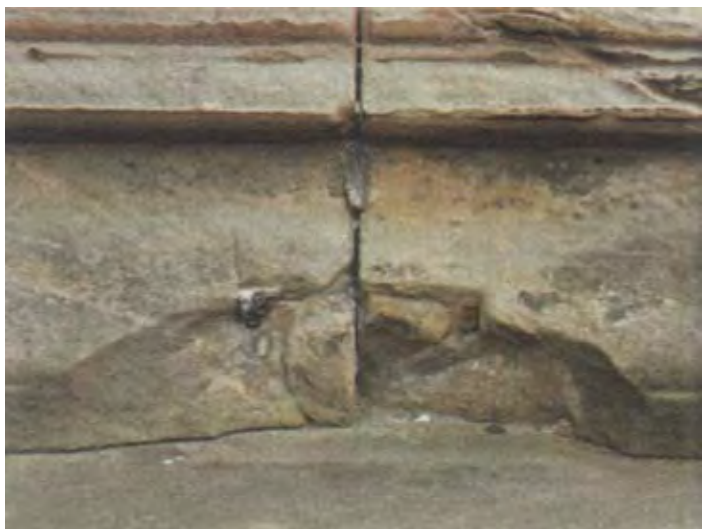
Figure 2.23 Damage to stonework at carved base course caused by oxide jacking of ferrous dog cramp.

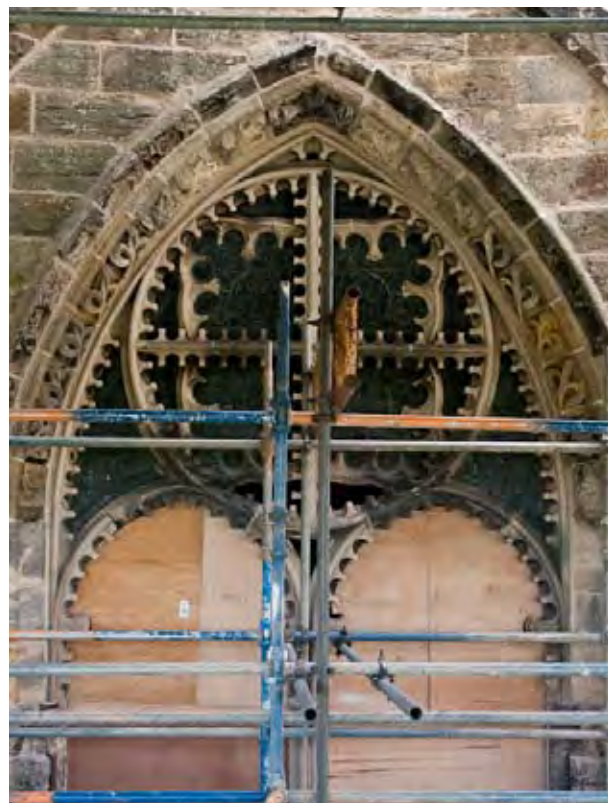
Figure 2.24 Great east window at Rosslyn Chapel in 2010 prior to replacement of section of tracery.

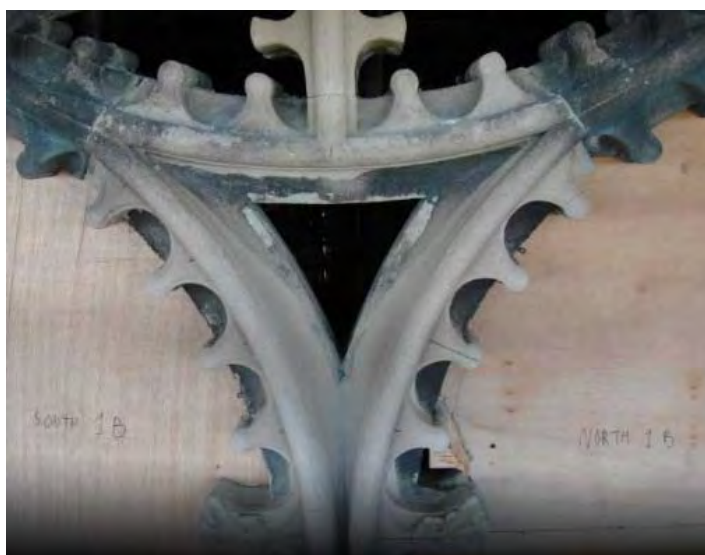
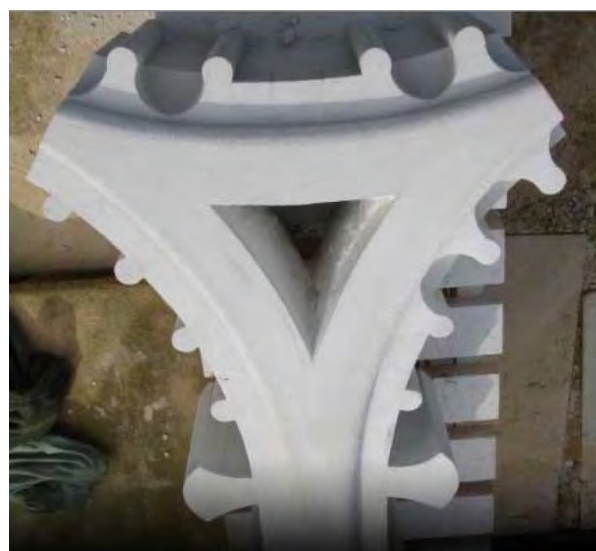
Figure 2.25 Detail of failed 19th century section of tracery from great east window (left) and detail of replacement stone during carving (right).

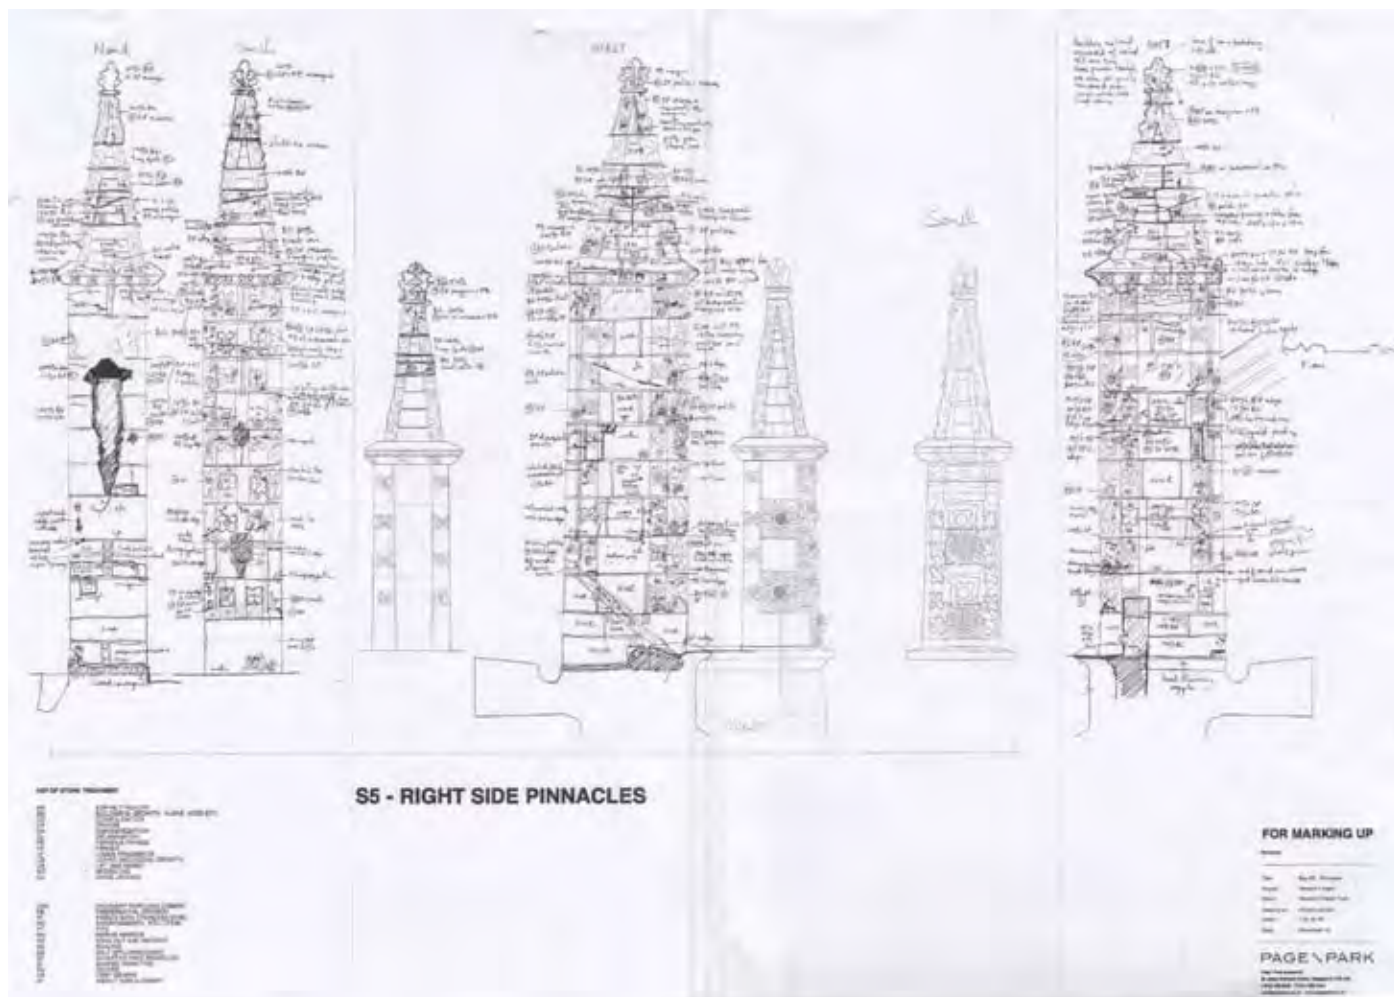
Figure 2.26 Bay S5 pinnacles decay mechanism and treatment mark-up drawing, 2010. Each stone and carved element has been carefully inspected and scheduled for treatment.

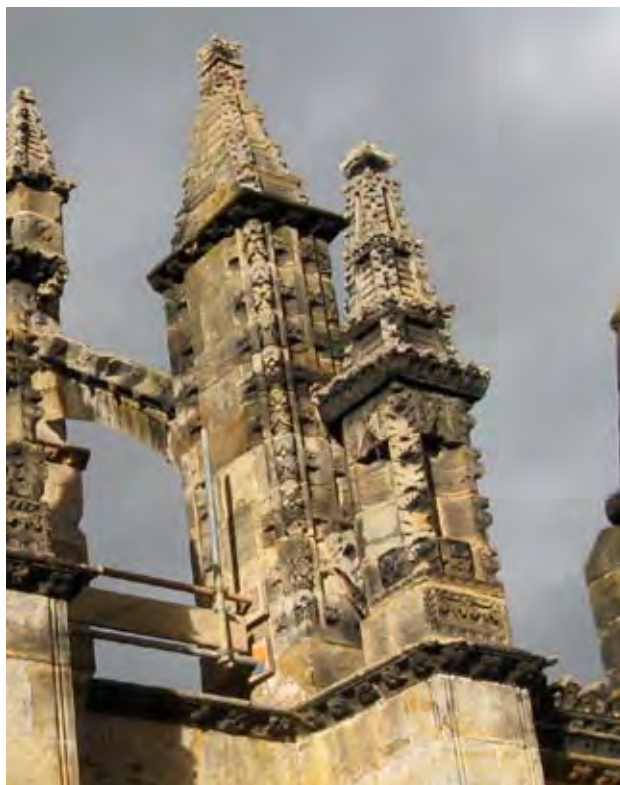
Figure 2.27 Pinnacles between bays S5-S6 before conservation treatment in 2010.

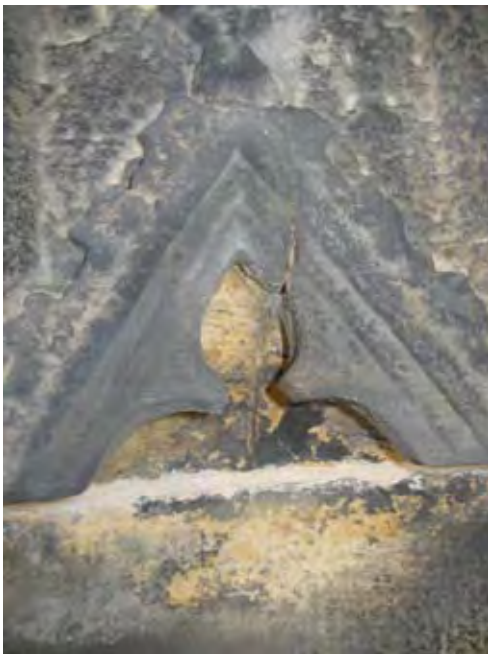
Figure 2.34 Crack along carved element on S5 pinnacle after being consolidated with acrylic resin. June 2011.

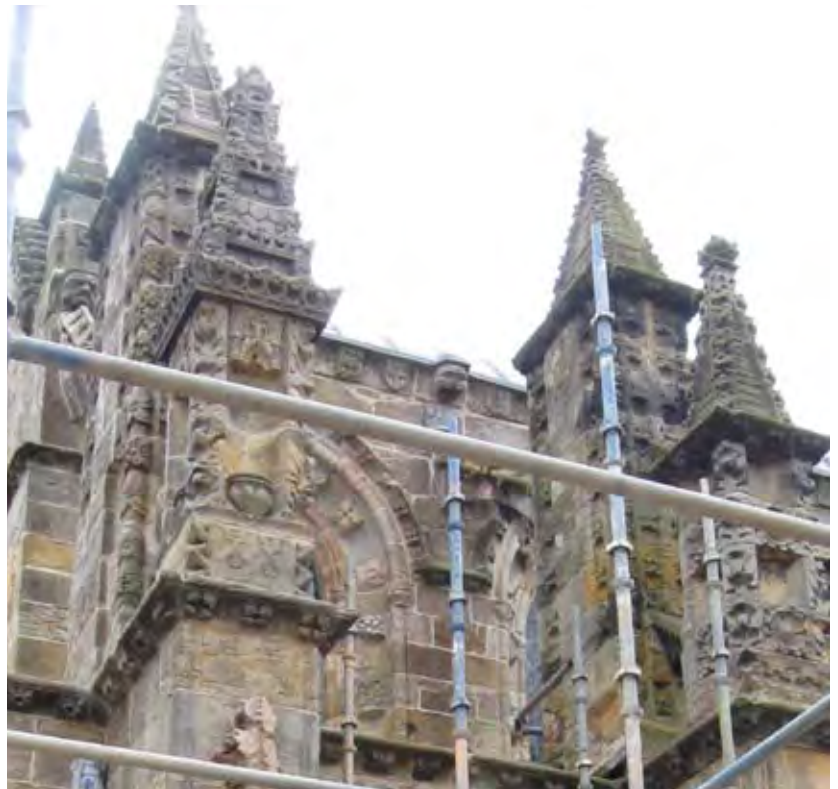
Figure 2.35 North facade with de-soiled and laser treated pinnacles at left and untreated pinnacles at right. July 2011.

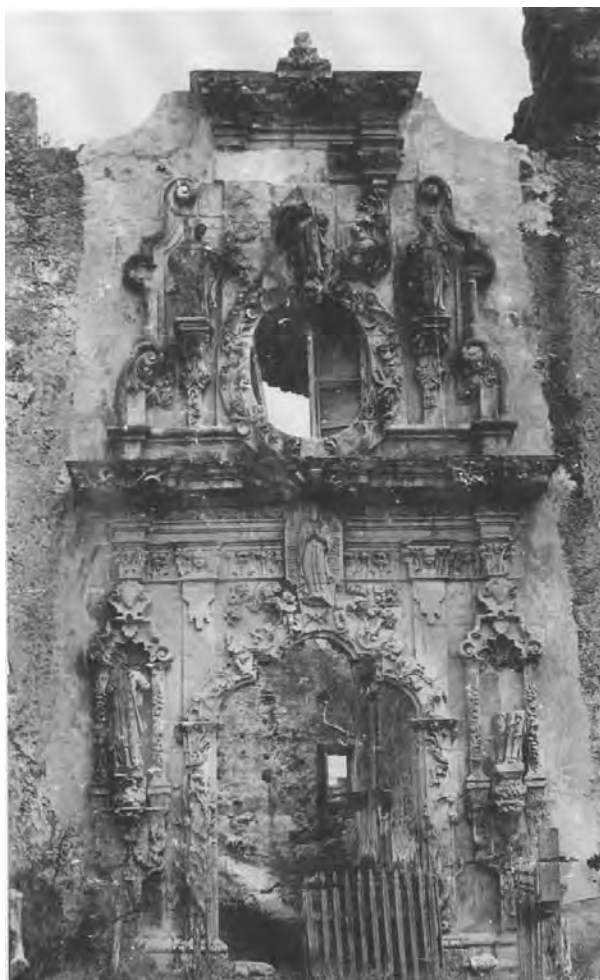
Figure 3.9 San Jose facade c.1890, showing loss of several sculptural elements and carved relief, as well as heavy dark staining on the stonework.

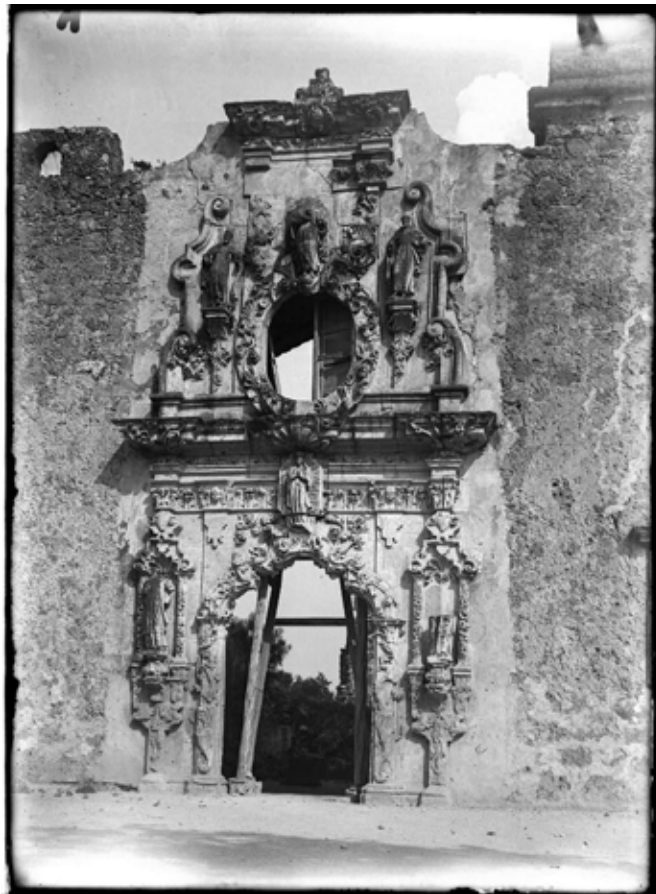
Figure 3.10 San Jose facade in 1917, showing bracing timbers supporting the facade wall.

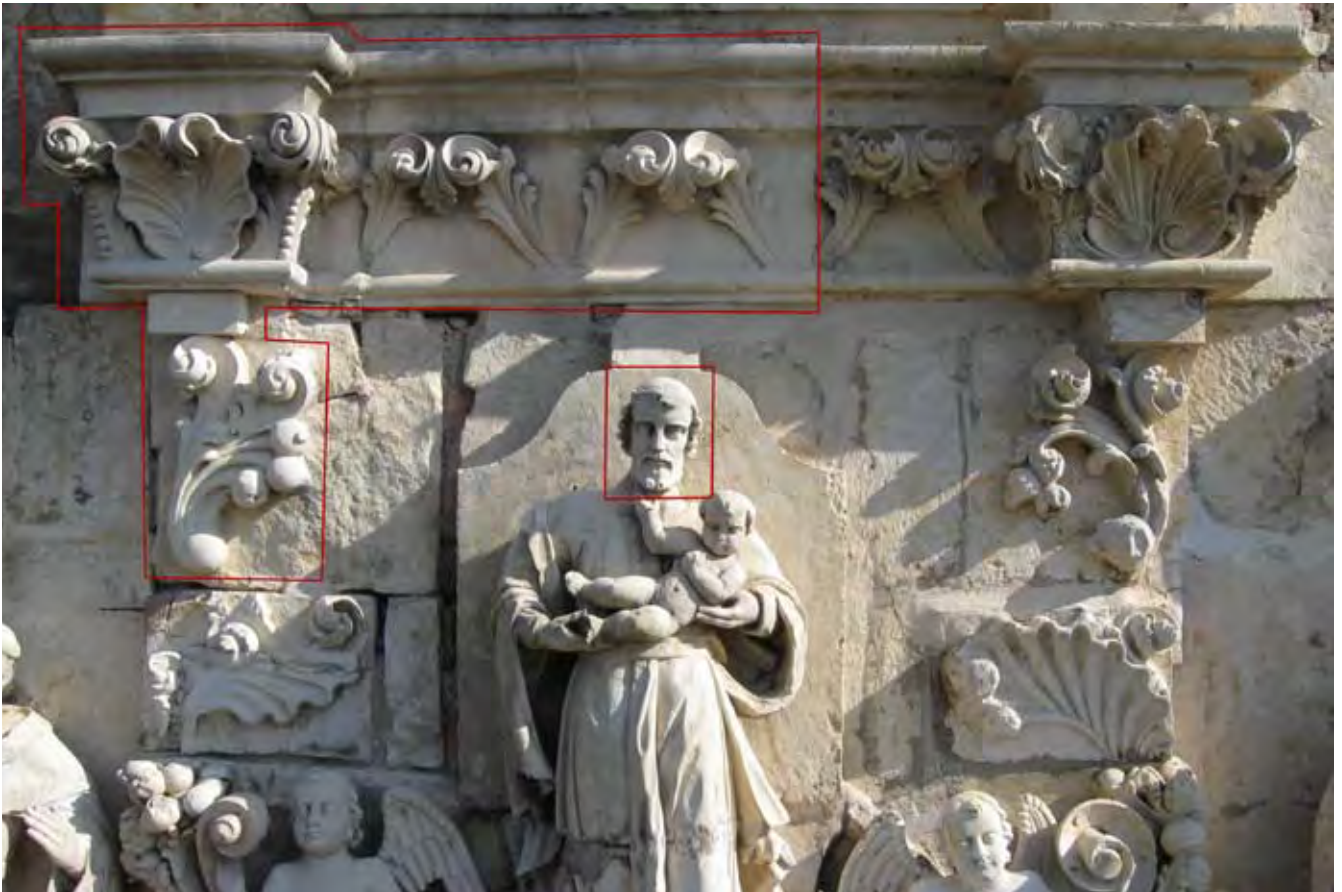
Figure 3.16 Detail of facade above window, showing inappropriate 1949 replacement carvings at left and central sections of cornice with original sections at right, as well as the 1949 replacement head of the central figure of St. Joseph. Note construction joints cleared of OPC mortar and awaiting new lime mortar. November 2010.

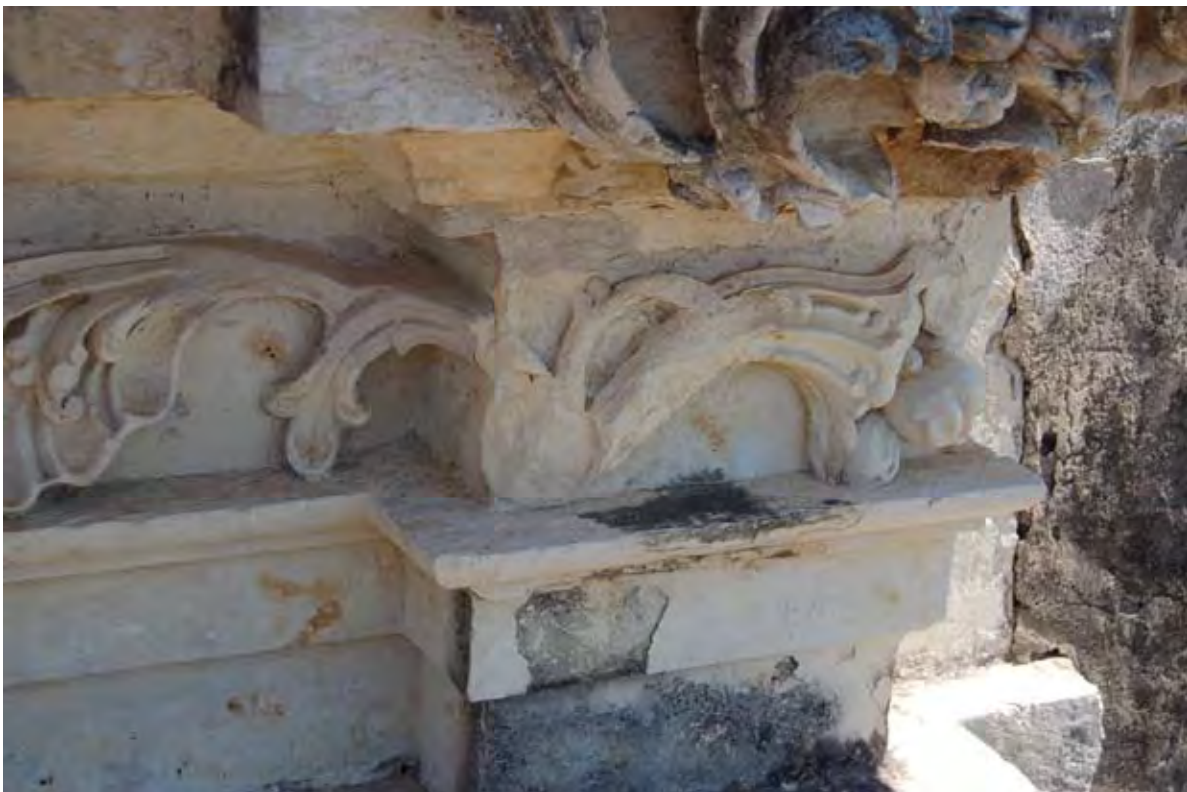
Figure 3.17 Detail of Zone C showing areas of cement mortar repairs and areas of heavy scaling, delamination and biological growth below the cornice, where stone tends to remain damp after periods of heavy rain. February 2009.

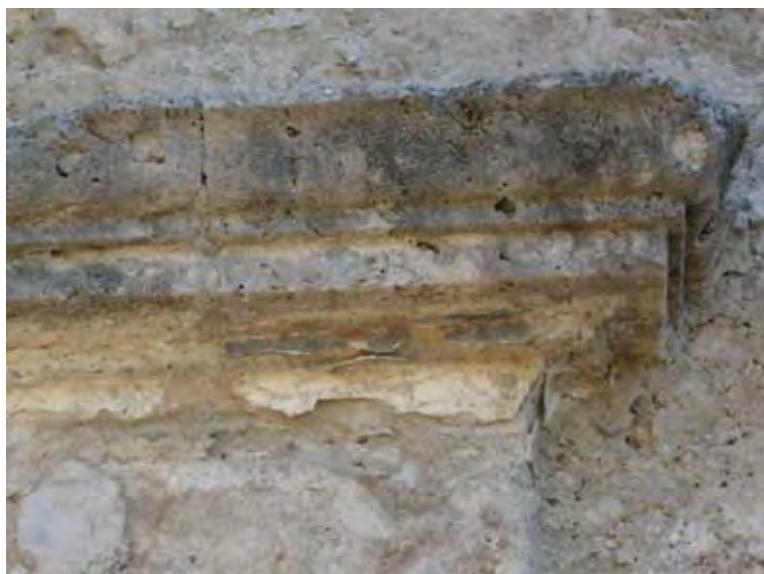
Figure 3.18 Detail of window to north of carved central facade showing traces of lime render below cornice that originally covered the entire west elevation on either side of the central carved facade.

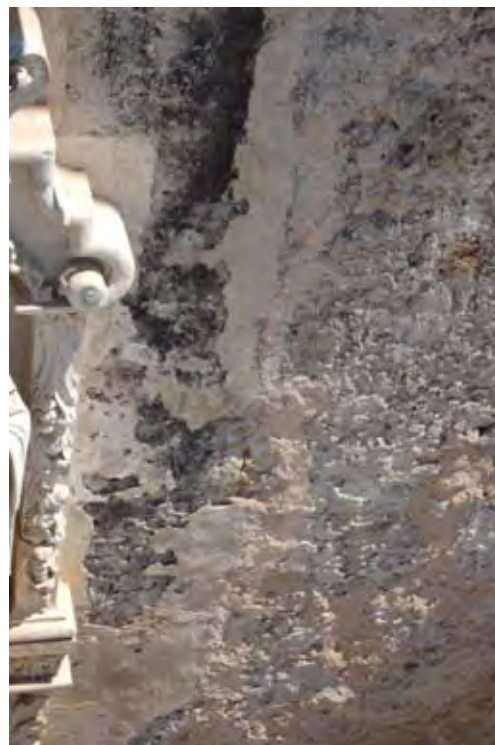
Figure 3.19 Exposed rubble limestone wall adjacent to central carved facade that originally would have been covered in a protective lime render but is now vulnerable to water infiltration.

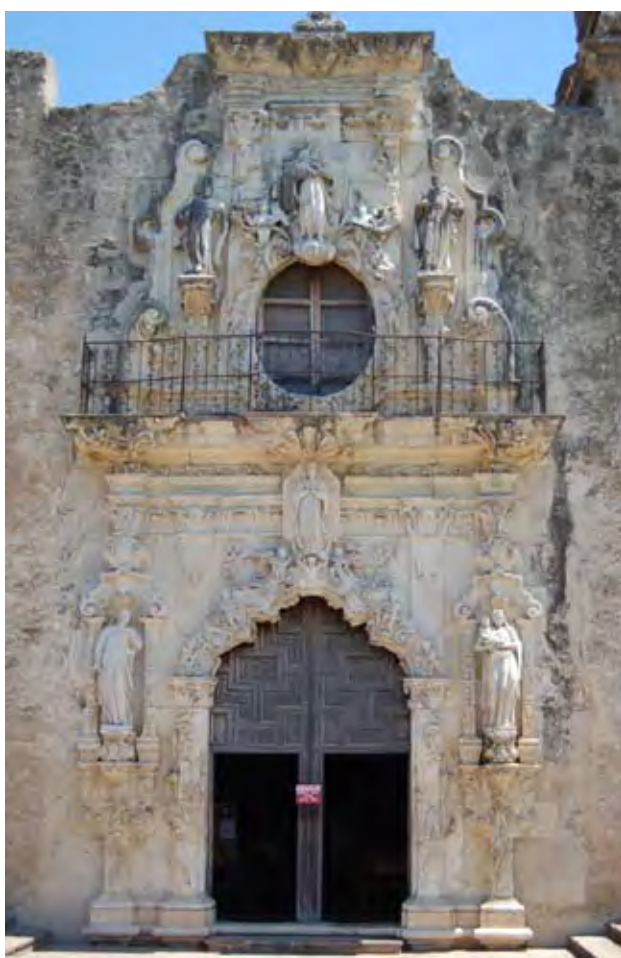
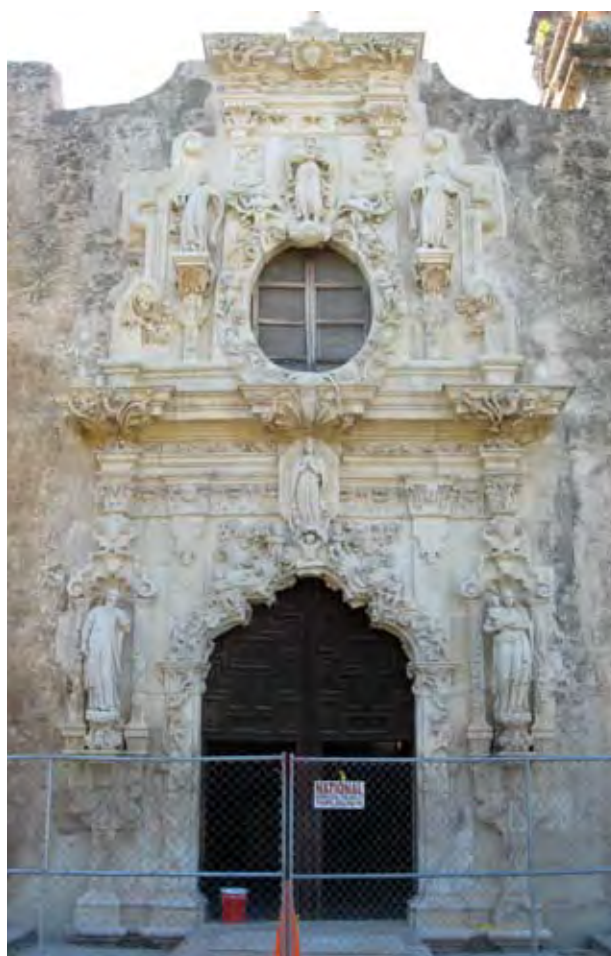
Figure 3.20 San Jose facade before (left) cleaning and conservation in 2009 and after (right) Phase II completion in July 2011.

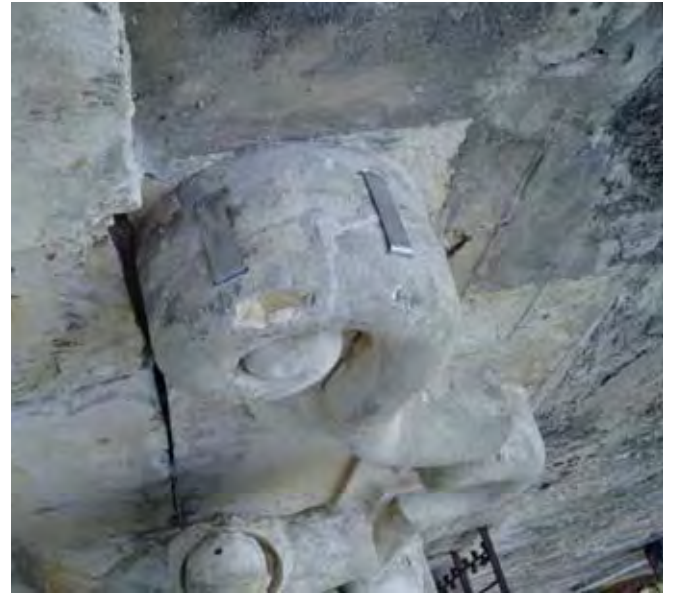
Figure 3.22 Cracked volute in zone H stabilized in Phase I with stainless steel cramps.

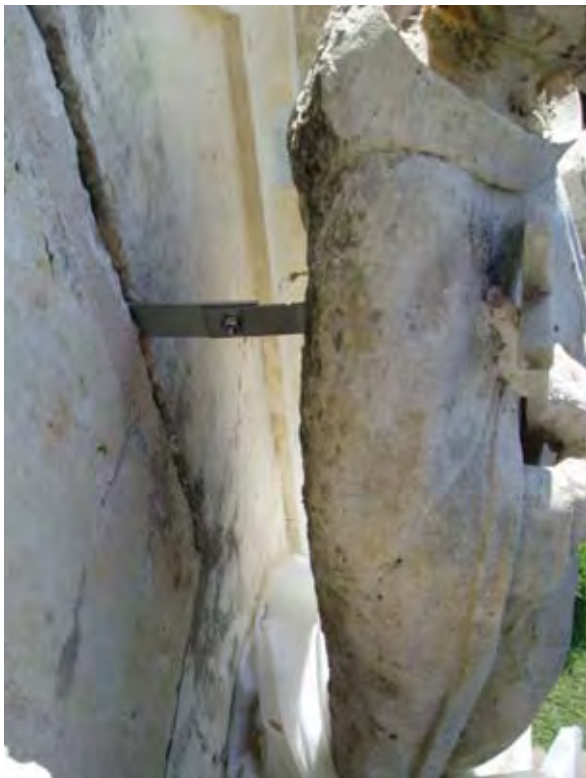
Figure 3.23 Stainless steel lateral tie-back installed to secure St Francis figure during Phase I in 2009.

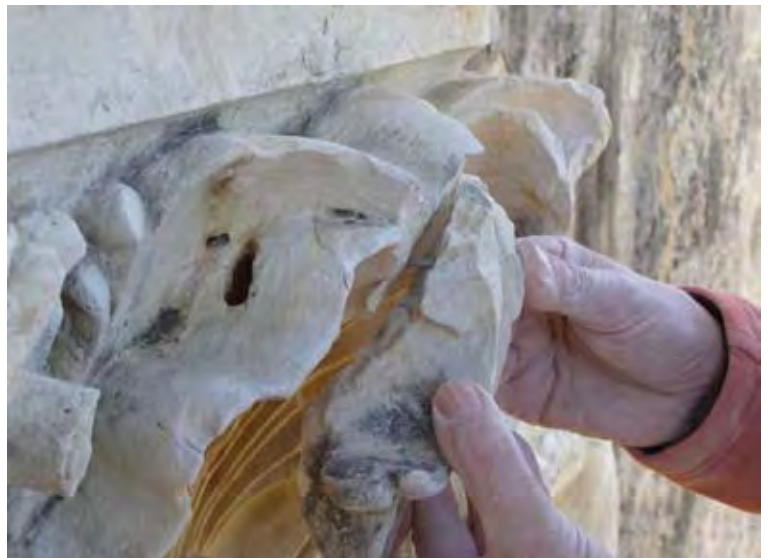
Figure 3.24 Pinning of detached drop pendant in zone C during Phase I in 2009.

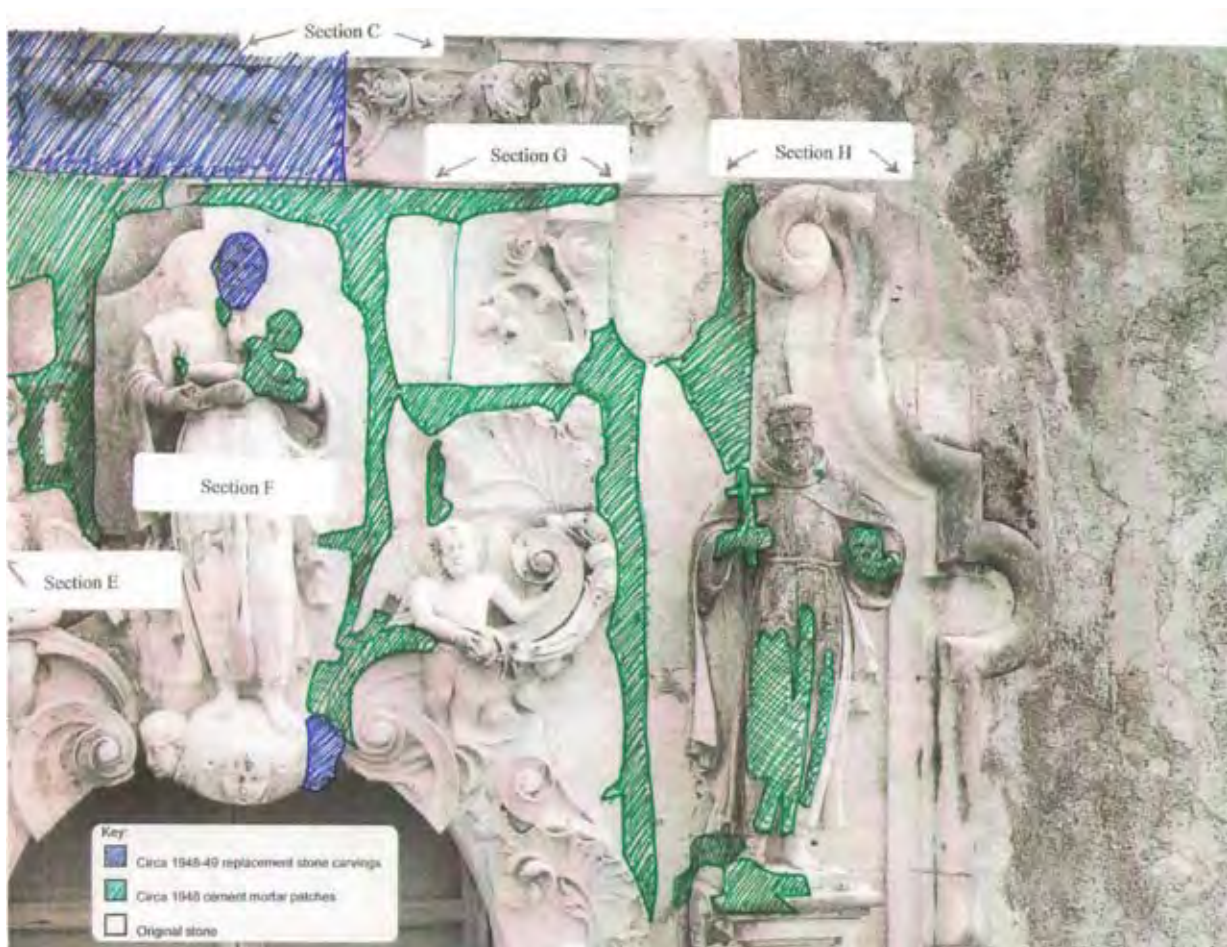
Figure 3.26 Detail of St. Joseph and St. Francis figures, showing areas of original stone, 1949 replacement stone and cement patches and mortars.

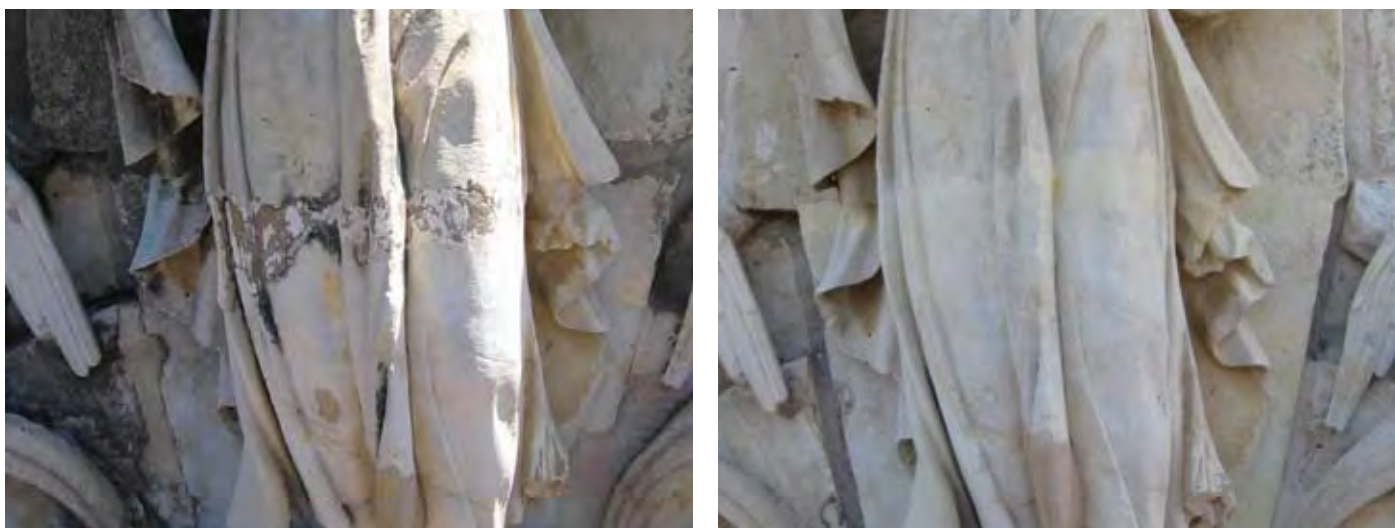
Figure 3.27 20th century cement patch across robe of St. Joseph (left) in 2009 and removal and replacement with compatible tinted lime mortar patch during Phase II in 2011 (right).

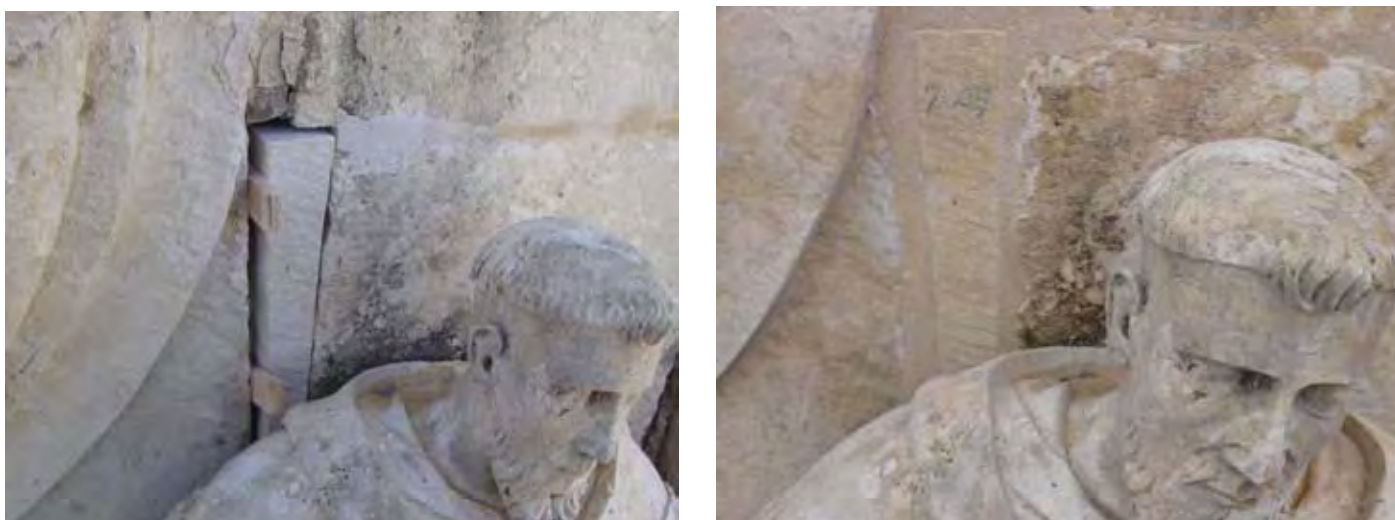
Figure 3.28 Stone indent being installed in 2009 into large void in construction joint that had been patched in the early 20th century with cement (left) and the completed indent repair showing year of installation on stone surface to differentiation it from the original adjacent stone (right).
