**Negotiating Repair and Authenticity in the Conservation of
Ornamental Architectural Stone: Managing Decay and Past
Interventions on the Façades of Rosslyn Chapel and Mission San
José**

A Dissertation submitted for

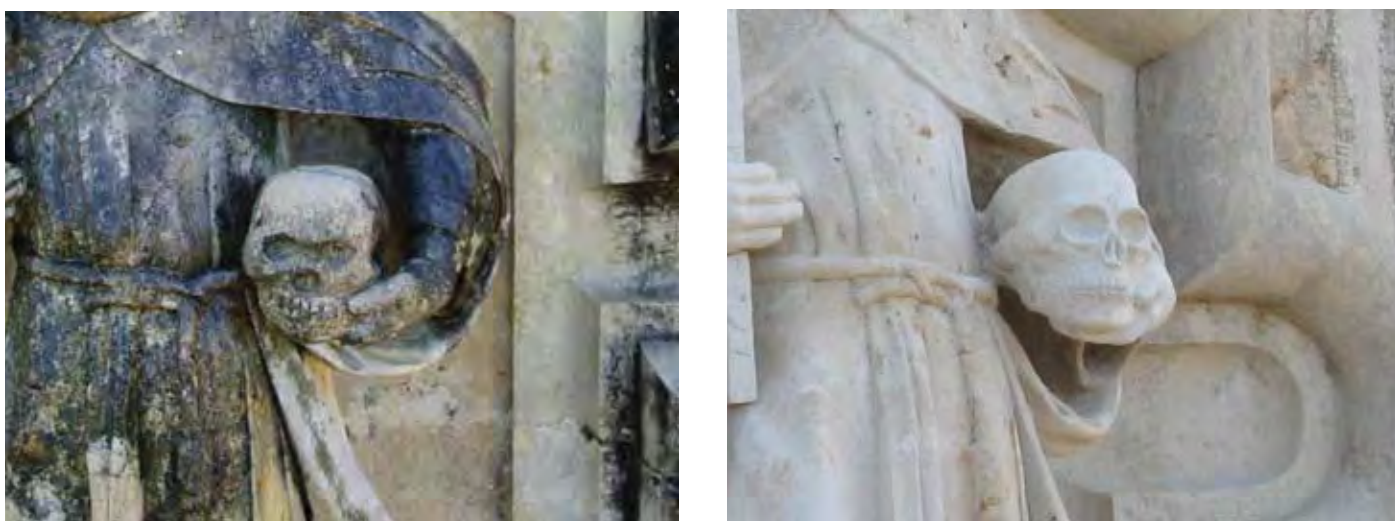
Figure 3.29 Replacement skull at St. Francis figure executed in cement in 1949 (left) before restoration in 2009 and after restoration (right) in 2011 with new carved stone indent secured to original stone behind with pins and grout.

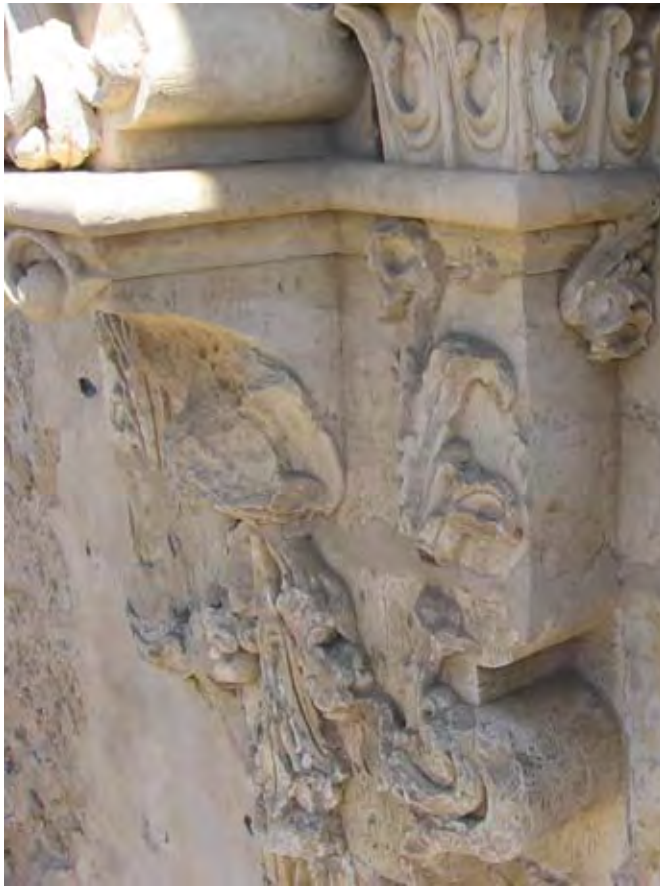
Figure 3.30 Detail of area below St. Joachim figure in Zone W, showing area of missing original carved stonework beneath pedestal. February 2009.

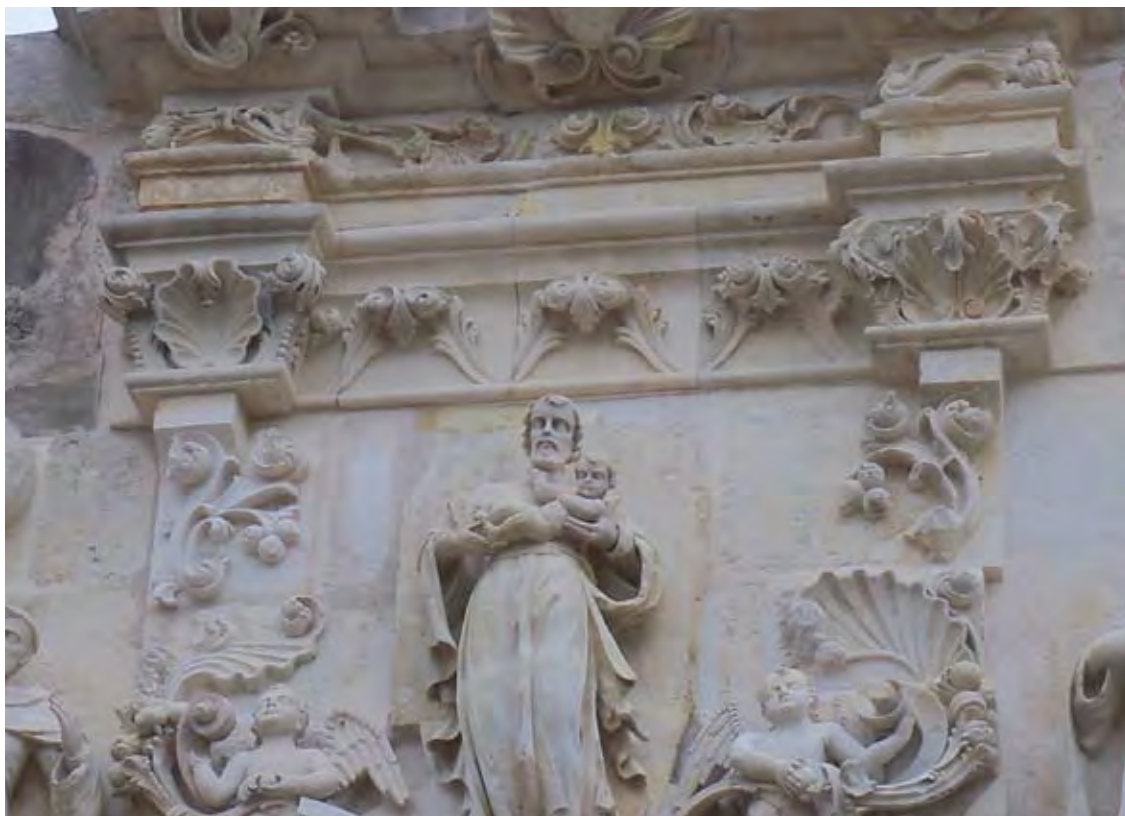
Figure 3.31 Upper portion of facade showing recarved 1949 cornice blocks and new limestone floral element to left of St. Joseph that replaced the inappropriate 1949 carving. Note how this new floral element is more consistent with the style and proportion of the existing original floral element to the right of St. Joseph. March 2011.

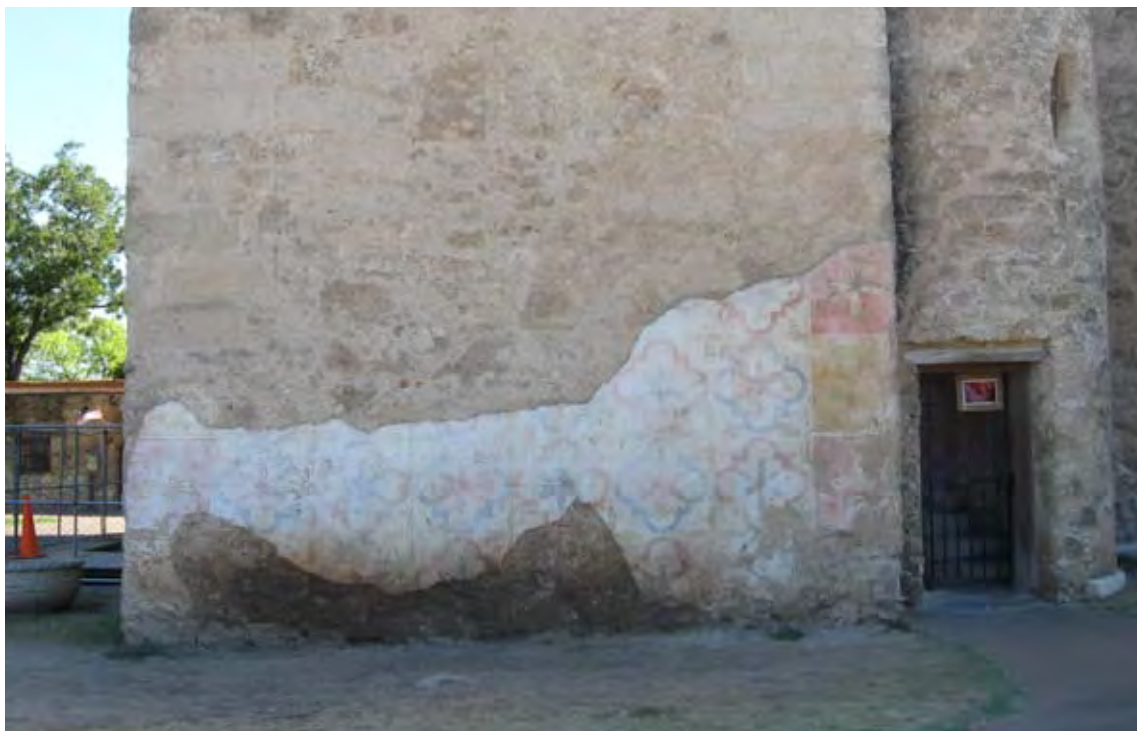
Figure 4.1 Recreated render and polychrome design at the south elevation of the bell tower instated during the 1949 restoration.

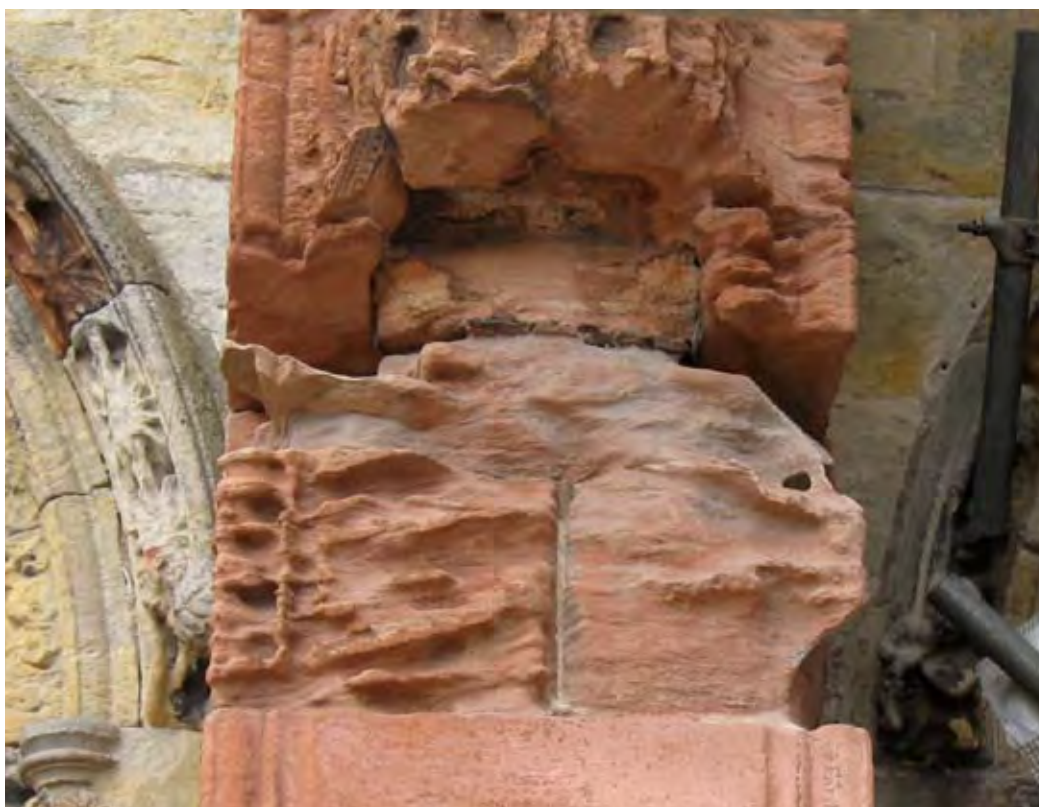
Figure 4.2 Severly weathered carved stonework on the south facade of Rosslyn Chapel. According to Boyes [Interview, 16 June 2011], the stonework will be stabilized with lime mortar at the open joints in order to prevent water ingress, however, no replacement of the carved stonework will be carried out as the stone is currently considered structurally stable.
