# **Monumental Misjudgements?**

## **Early Conservative Interventions and their Impact on Orcadian Neolithic Sites**

**A Dissertation submitted for  
MSc in Architectural Conservation  
University of Edinburgh**

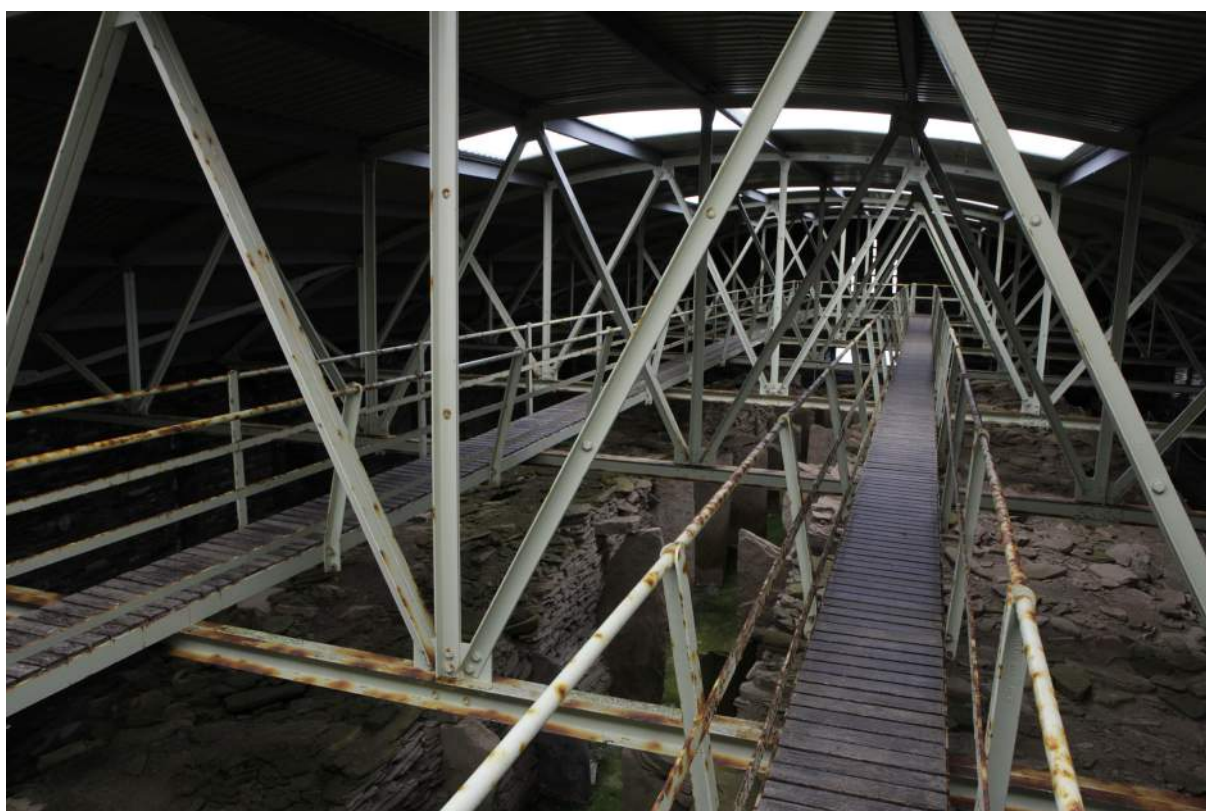
Figure A1: Free-standing protective steel enclosure over Midhowe, with elevated gangways from which to view the interior of the tomb.

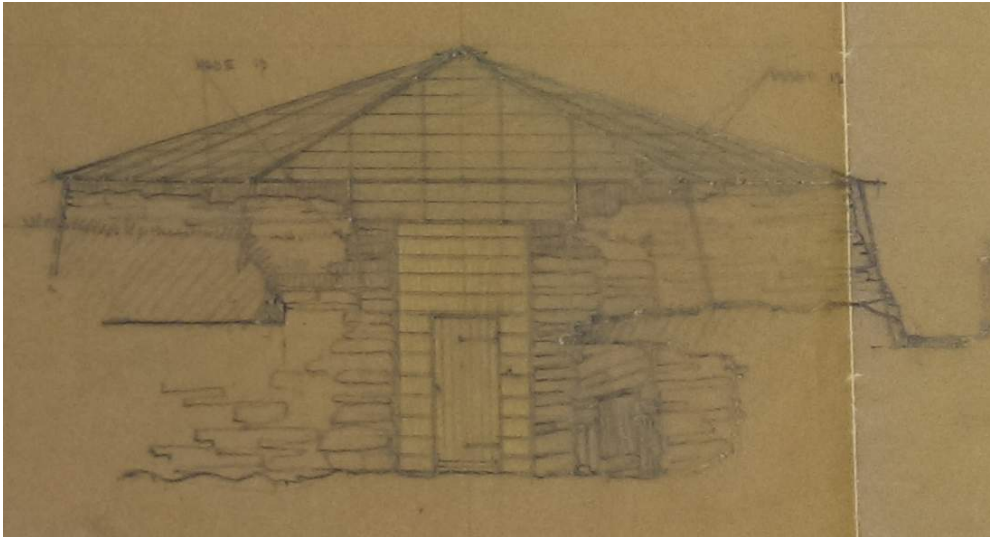
Figure 2.3: Left:  
HMMOW Design proposal for pitched reinforced glass roof over House 7 of Skara Brae, No Date, but referred to in SB35, AX20 of 17/5/1930,  
Image courtesy of National Archives

The reinforced glass covering in place by 1932 over House 7 of Skara Brae<sup>28</sup> was an exceptional design amongst the interventions, and had previously undergone a series of revisions to reach the form finally adopted; from a pitched roof of reinforced glass (Figure 2.3)<sup>29</sup>, to a flat roof with central drainage (Figure 2.4), or drainage provided around the circumference (Figure 2.5), to the design of 28/7/1931 (Figure 2.6) that was ultimately implemented, which had movable hatches to be opened daily for ventilation. Here glass was utilised in order to withdraw from the elements what was considered to be not only the finest structure in the whole village<sup>30</sup>, but “the most perfect prehistoric structure of a purely domestic character in Europe”<sup>31</sup>, whilst still allowing the interior within to be viewed. Indeed as early as 1929 it had been planned to make the whole settlement “readily visible without the necessity of crawling through passages”<sup>32</sup>, i.e. offering visual access down into the structures from above, rather than bodily access. It should be noted that a roof encompassing the whole settlement was considered on a number of occasions<sup>33</sup>, but ultimately rejected due to the difficulty of achieving a solid foundation<sup>34</sup>.

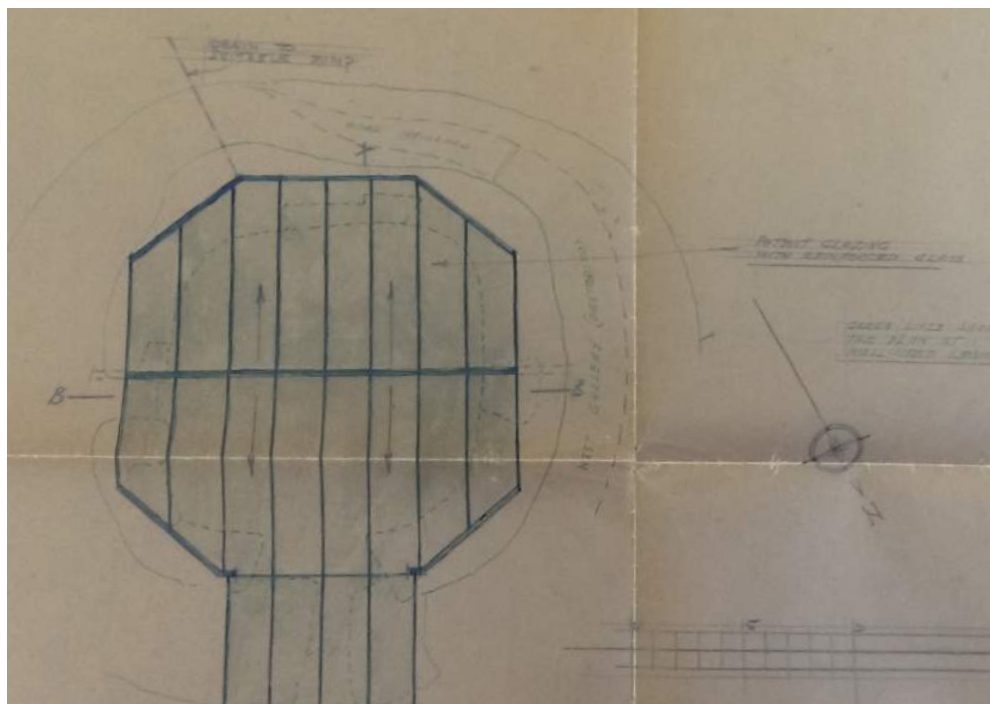
Figure 2.5: Left:  
HMMOW Design proposal for flat glass roof over House 7 of Skara Brae, with drainage around the circumference, Dated 07/1930,  
Image courtesy of National Archives

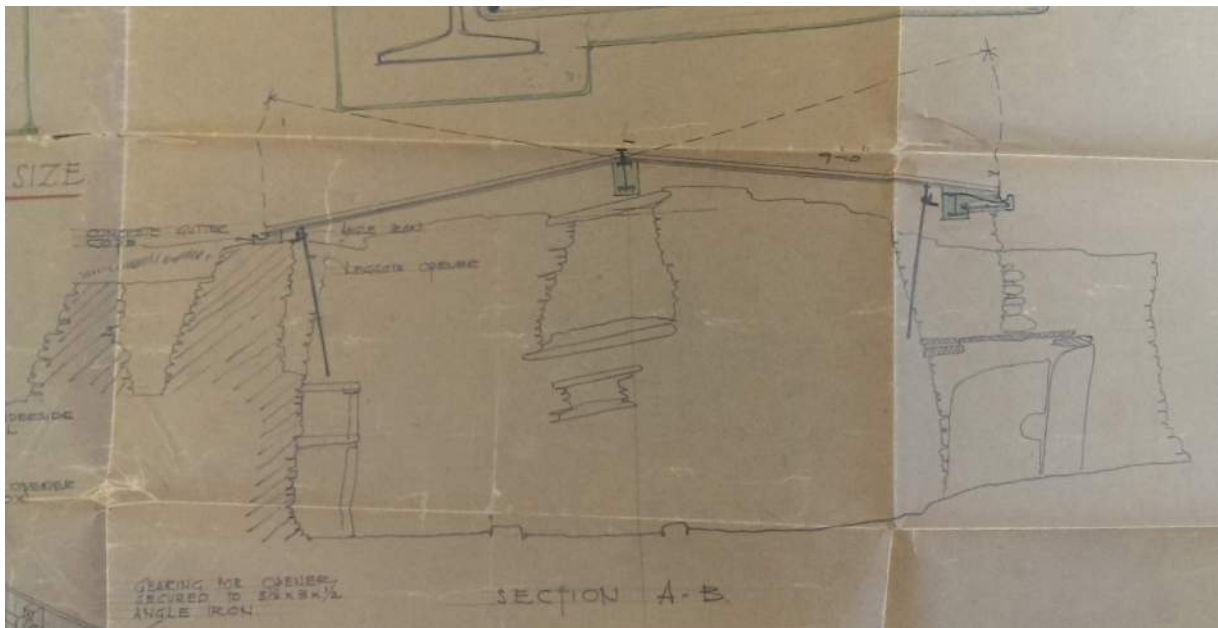
Figure 2.6a-b: Above: HMMOW Design proposal for glass roof with opening hatches over House 7 of Skara Brae, comprised of steel joists with a covering of patent glazing and reinforced glass, plus detail of associated mechanism, Dated 28/7/1931, Image courtesy of National Archives

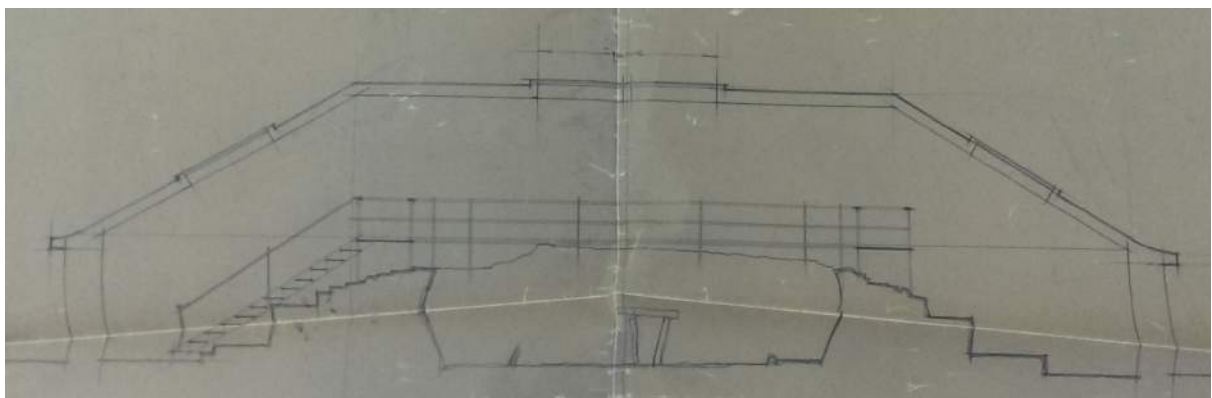
Figure 2.7: Above: HMMOW Design proposal for free-standing cover house with elevated gangways over Unstan, No Date, Image courtesy of National Archives

At this point a further suite of cover houses were designed which offered elevated positions from which to view the Neolithic tombs, without physical access to their interiors. Unexecuted plans survive for this stage in the design development of Unstan, (Figure 2.7) which show that it was intended that the whole cairn be enclosed by a free-standing structure, with an elevated gangway above the remains<sup>35</sup>.

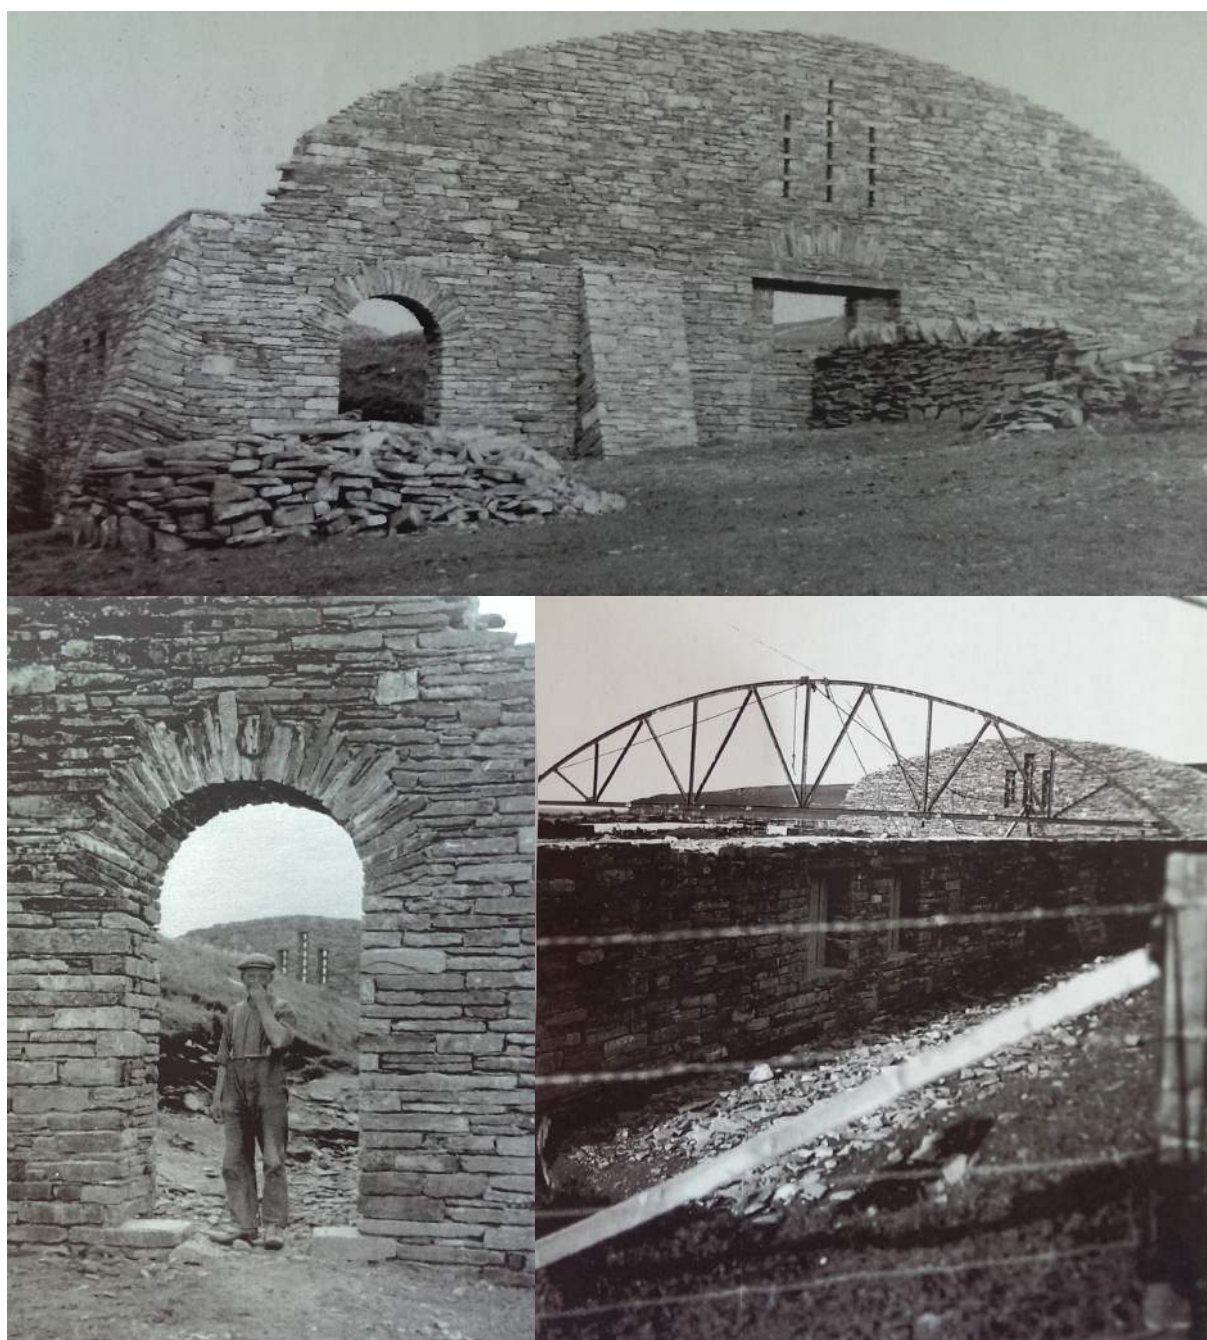
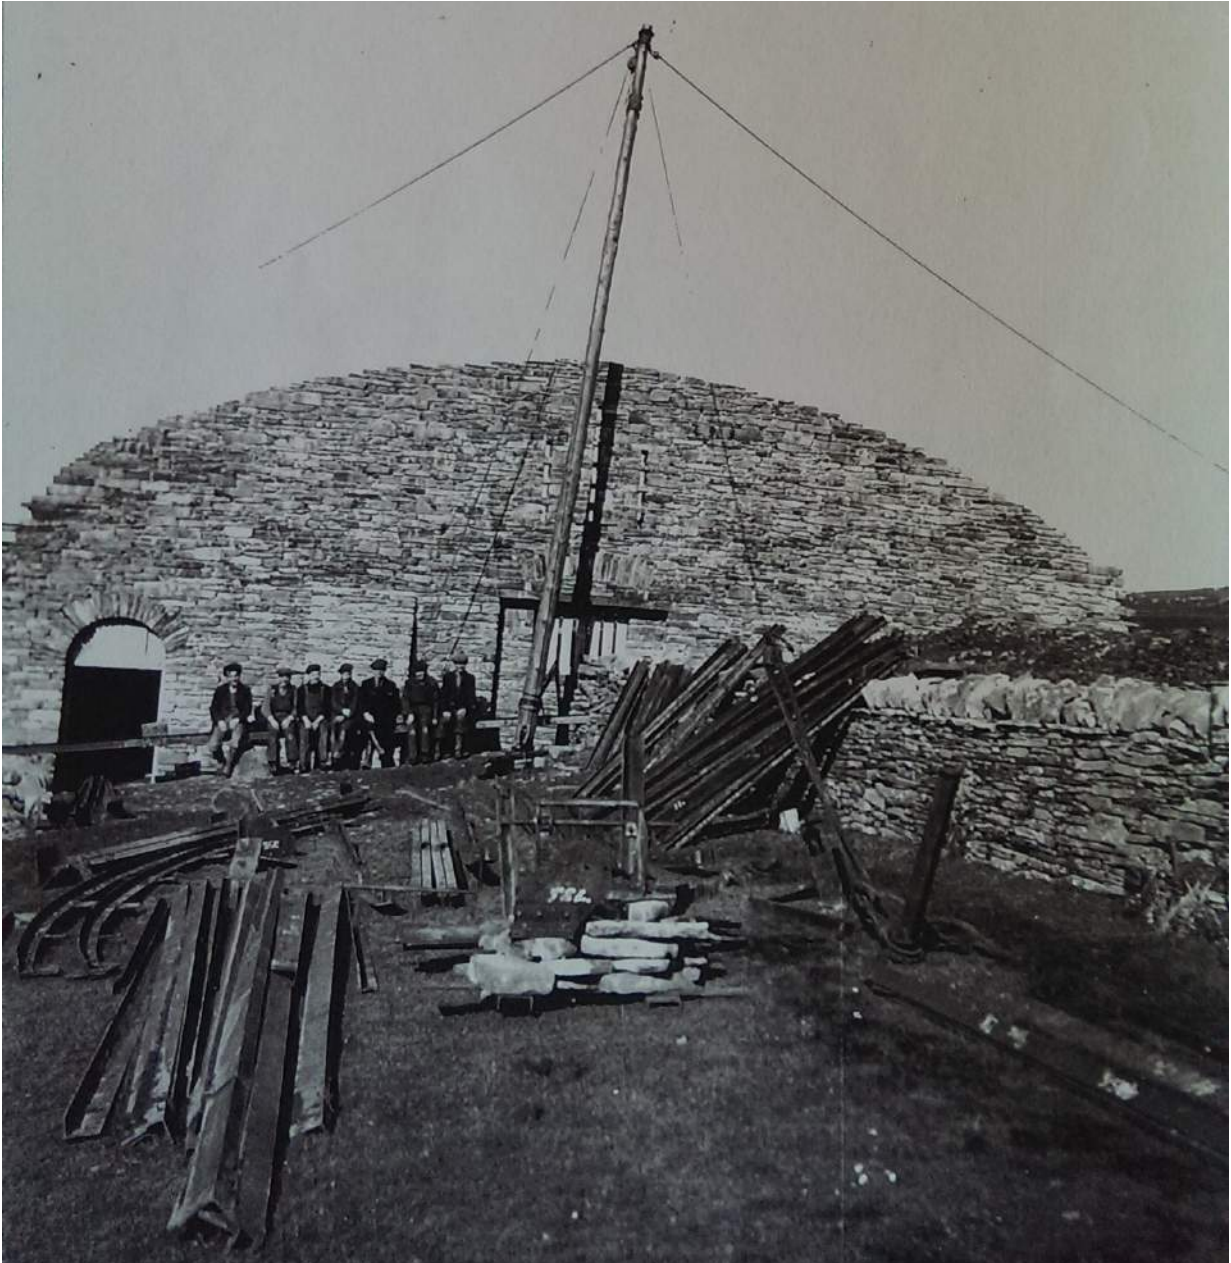
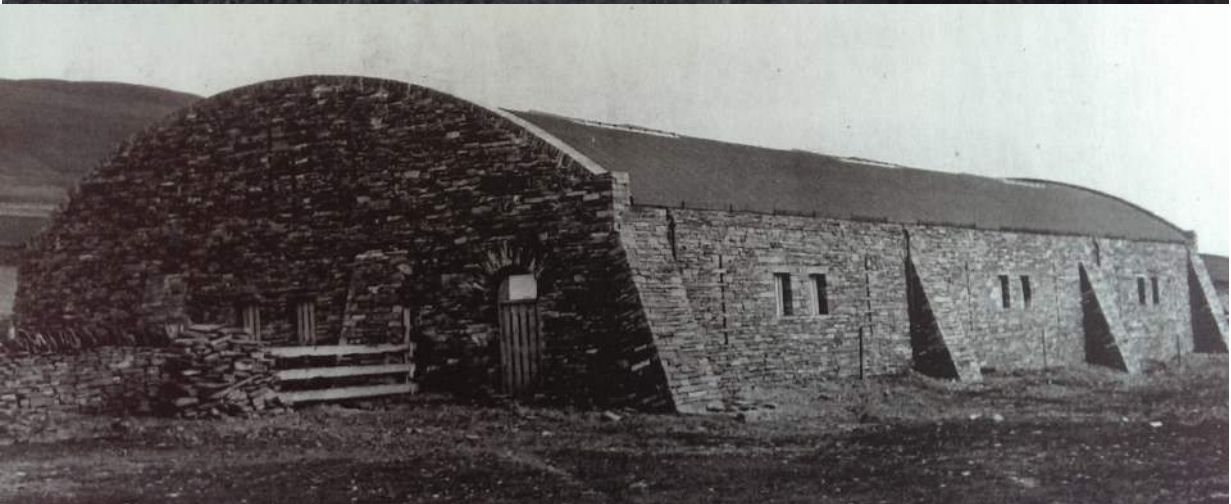
Figure 2.9a-e: This and following page: Images of Midhowe cover house under construction, Undated but likely between 1935-1936

Figure 2.9a-e: This and previous page: Images of Midhowe cover house under construction, Undated but likely between 1935-1936

No specifications are given for the positioning of the galleries on this drawing but it should be noted how remarkably similar this unexecuted design is to the enormous structure that was erected over Midhowe<sup>36</sup> (Figures 2.9 below and overleaf), with masons active on the latter job in 1935-1936<sup>37</sup>.

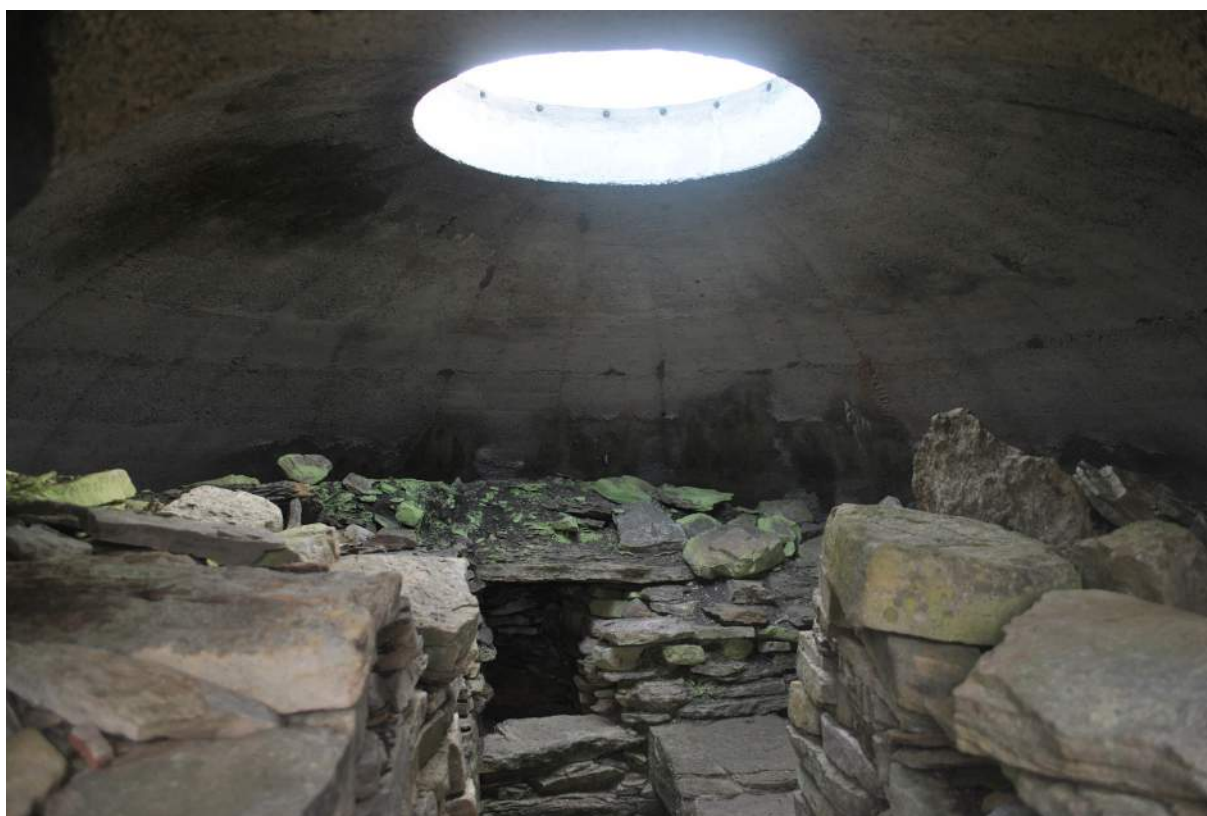
Figure 2.10: The upper storey of Taversoe Tuick was capped by a reinforced concrete dome with a circular skylight in 1937

Whilst relevant drawings were unavailable, it is known that the upper storey of Taversoe Tuick was capped by a reinforced concrete roof in 1937<sup>38</sup>, taking the form of a skylit curving dome directly on top of the circular chamber (Figure 2.10). It was following the perceived success of the technique here employed<sup>39</sup> (and presumably it's flat-topped predecessor at HoPW), that the designs for Blackhammer and Yarso were amended to be capped by similar concrete forms. These were installed at both sites in 1938<sup>40</sup>, [although substantial later amendments were made at Blackhammer – see Chapter 5], with entrance to Blackhammer provided via an entrance hatch and low ladder aligned with the original passage. The plans for Yarso (Figure 2.11) are not quite as executed, since the intended timber extension to the south east (allowing the elaborate external walling to be viewed on this side) was ultimately executed in concrete, creating a pre-tomb antechamber which is accessed through a full-height door.

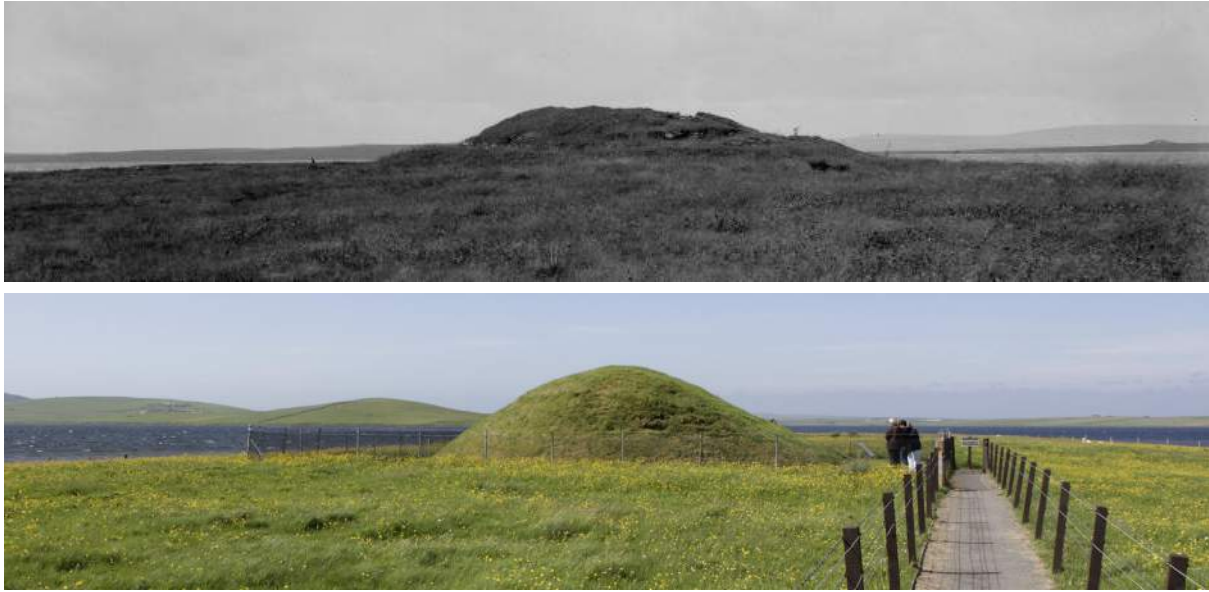
Figure 2.12: The mound of Unstan pre-installation of the HMMOW concrete dome, and now. Their forms were thought to be “inconspicuous” and “in harmony” with their monuments below. Top image courtesy of RCAHMS CANMORE archive, no date

Whilst such practical records are generally scanty, we do have some detail regarding the method of construction employed; the roof of Blackhammer, designed in consultation with structural engineers<sup>53</sup>, was constructed of reinforced concrete ‘6” thick’<sup>54</sup>. Its Neolithic wall heads were cleaned to permit the foundation for the dome, shuttering made and set in position and steel reinforcement rods, dispatched from Leith, were then positioned and the concrete added. The formwork was removed once the concrete had fully set, and the outer shell turfed at this point<sup>55</sup>. Such cappings were apparently considered to be a straightforward “piece of elementary construction”<sup>56</sup> [in relation to Blackhammer this was apparently misguided – again see Chapter 5], and the resulting outward appearance of the domes thought to be inconspicuous and “in harmony” with their monuments below<sup>57</sup>, the whole clad in turf or heather<sup>58</sup> permitting a “natural outline”<sup>59</sup> (Figure 2.12).

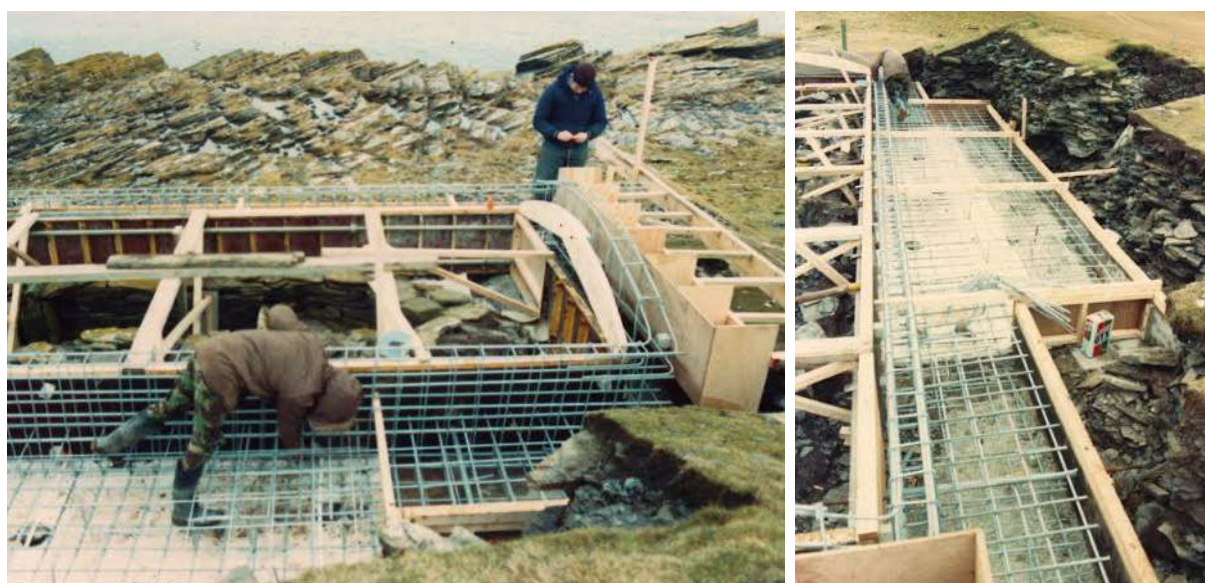
Figure 3.1: Reinforced concrete dome of Isbister under construction in 1987, Image courtesy of Rob Thomson

Fifty-six years after the installation of the first in situ reinforced concrete capping at HoPW, the same approach was employed in 1987 to protect the Neolithic chambered tomb of Isbister on South Ronaldsay, following its gradual excavation begun in the 1950s<sup>143</sup>. Photographs survive from this process (Figure 3.1), revealing the method of installation in which the same materials<sup>144</sup> employed by HMMOW were utilised in a remarkably similar configuration.

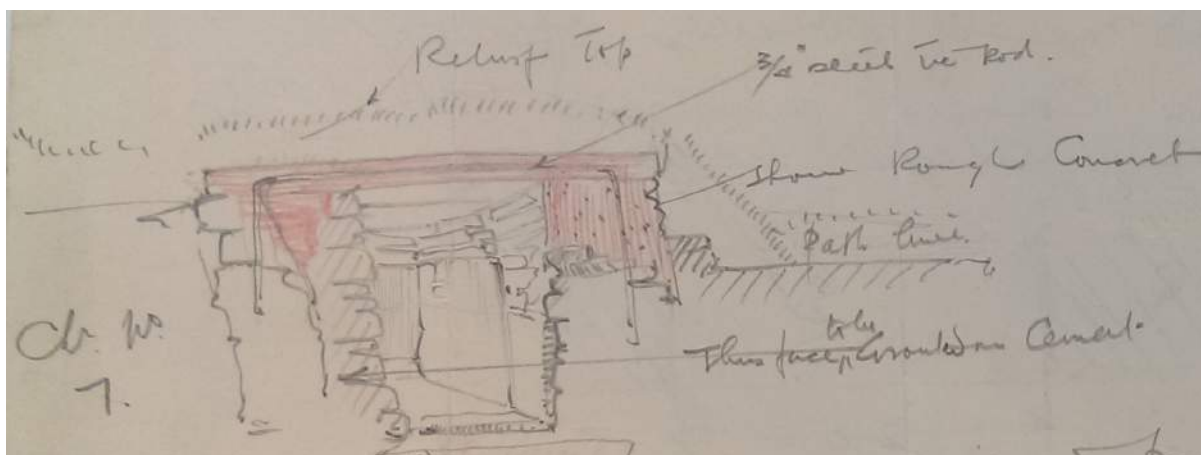
Figure 4.1: Sketch diagram of proposed consolidation works to west of House 7, Skara Brae, bottom right reads “This face to be grouted in cement”, Image courtesy of National Archives

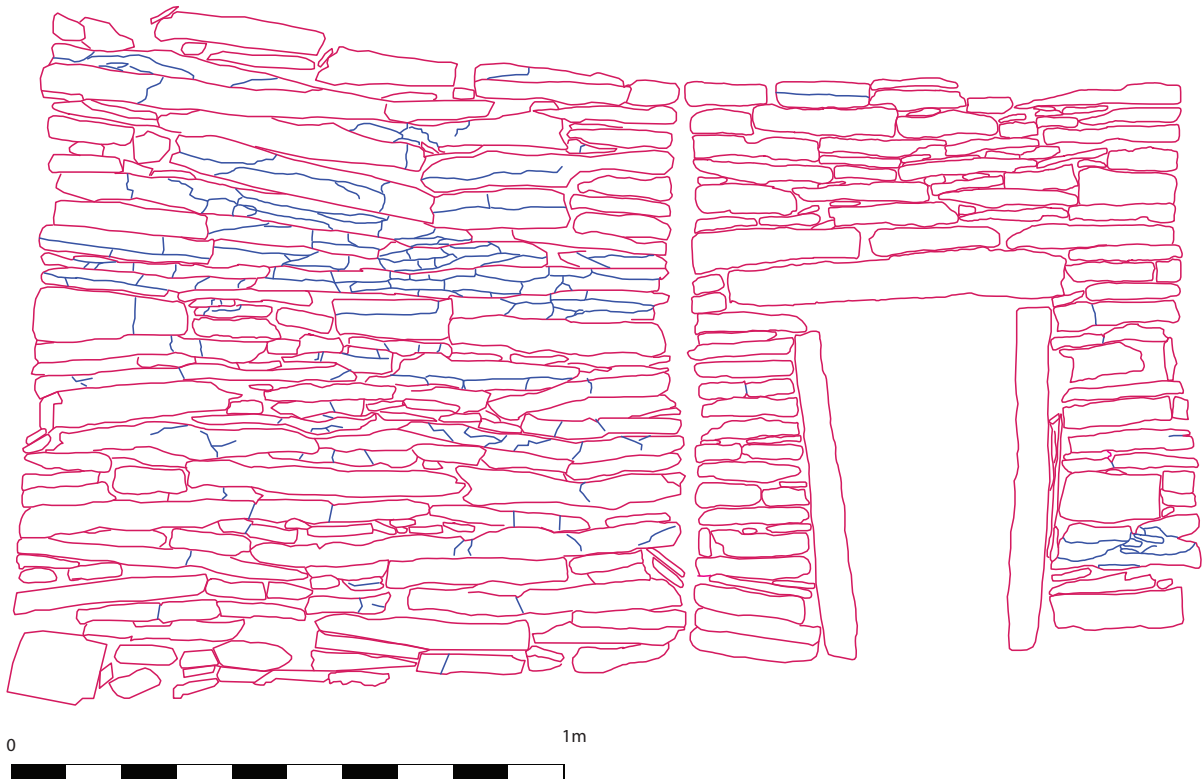
Figure 4.2: Scaled partial elevation drawing detailing two neighbouring areas of walling in very different condition, in southwest internal wall of Unstan either side of orthostat-slot. Blue lines denote cracking. In light of the image below, it was determined that the majority of the stonework around the cell opening was rebuild, hence its notably better condition.

The consequences of this lack of recording can be very real. During the surveys that inform Chapter 5, a discrepancy in condition was identified between two adjoining areas of stonework in the interior of Unstan, with the resulting conclusion drawn that a mechanism of deterioration was causing the disaggregation of stone in one area, but was not affecting its neighbour (Figure 4.2). Subsequent examination of early post-excavation photographs revealed, however, that the seemingly undamaged area was actually erected several millennia later, as a section of modern rebuild by HMMOW following the exposure of the tomb (Figure 4.3). This example goes some way to illustrate the importance of fully documenting conservative interventions for the benefit of future generations, since remedial action might have been recommended for the apparently damaged area. In reference to this work the HMMOW files simply state that the "small mural cell [was] made good", but also that "the entrance passage [was] restored"<sup>236</sup>, the extent of which is also revealed through a contemporary photograph (Figure 4.4).

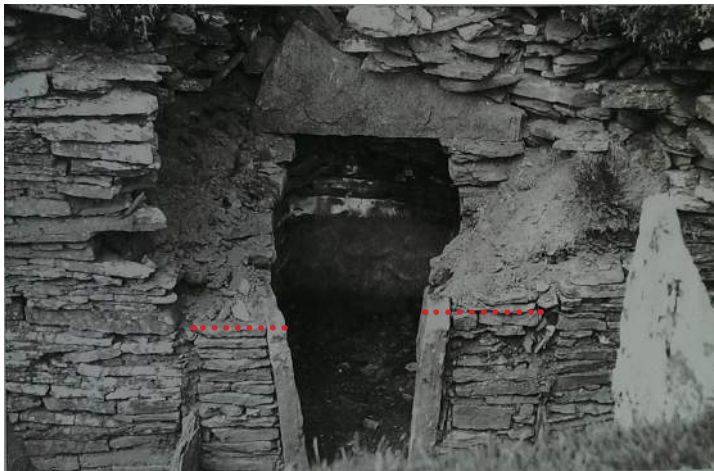
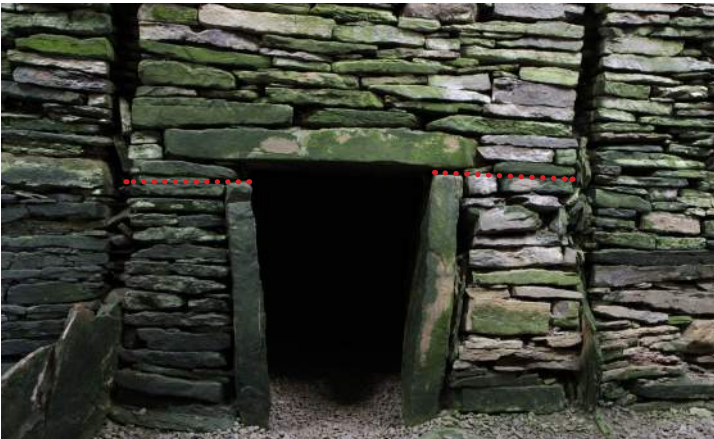
Figure 4.3a & b : Before the “small mural cell was made good”, and condition now: red line shows line of rebuild,  
 Top Image Courtesy of RCAHMS photographic archive, No Date

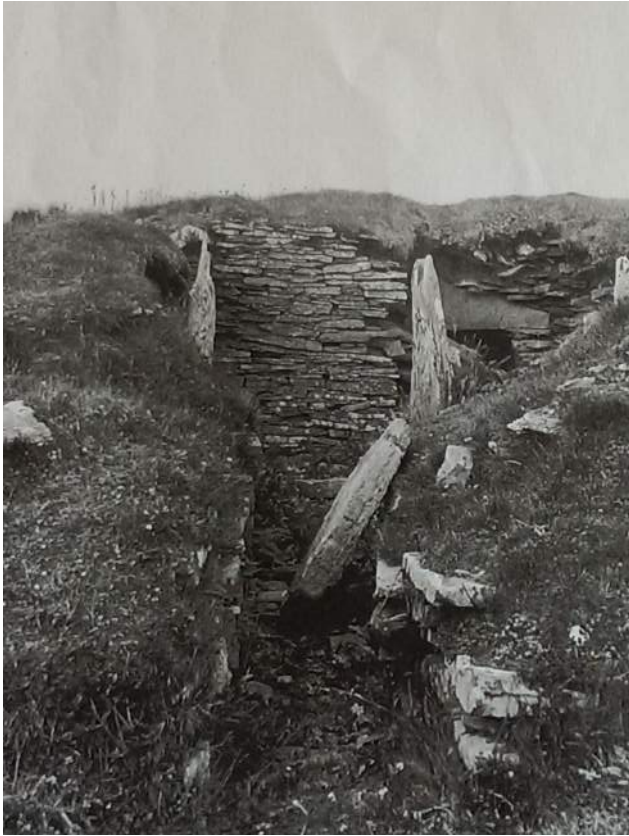
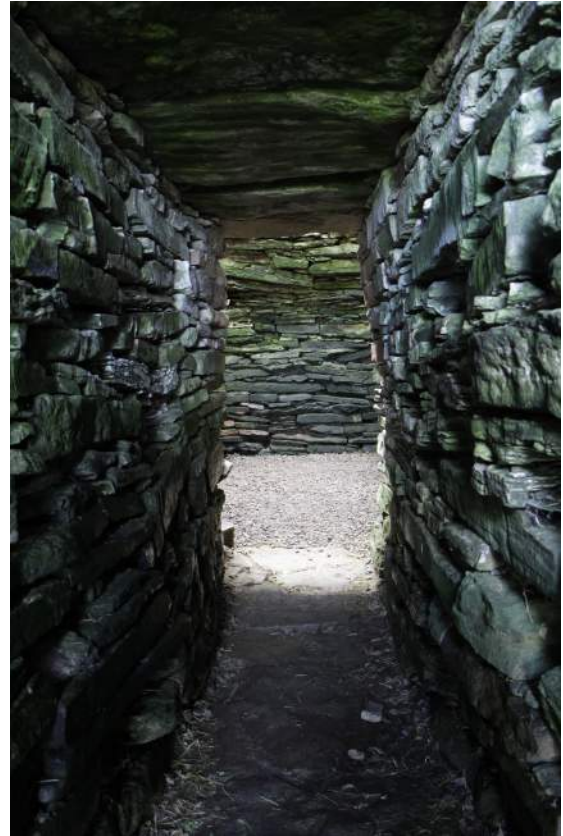
Figure 4.4a-c : Before the “entrance passage was restored” and the roof installed, compared with the passage configuration and roofing now

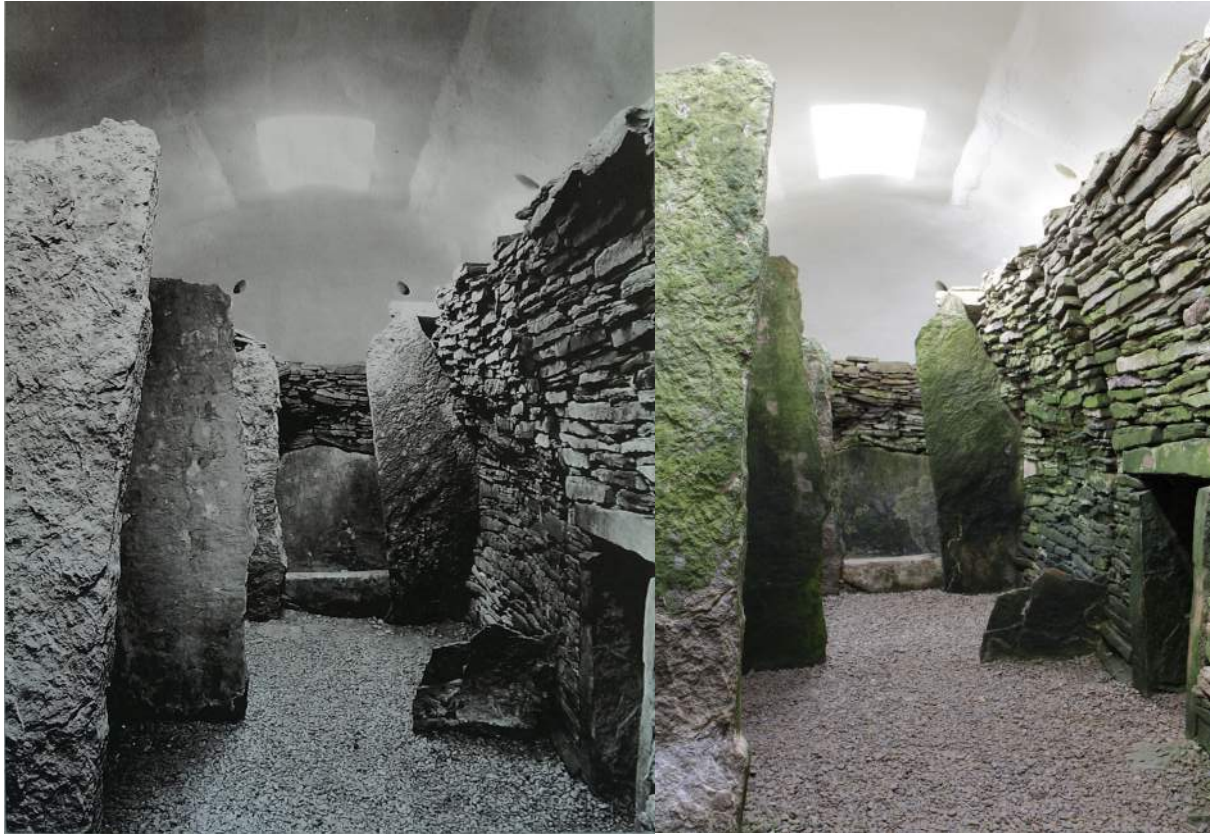
Figure 5.1a-d: Comparison of condition of stonework in Unstan between 1957 and now, revealed few changes, Top and Bottom Left Images courtesy of RCAHMS photographic archive

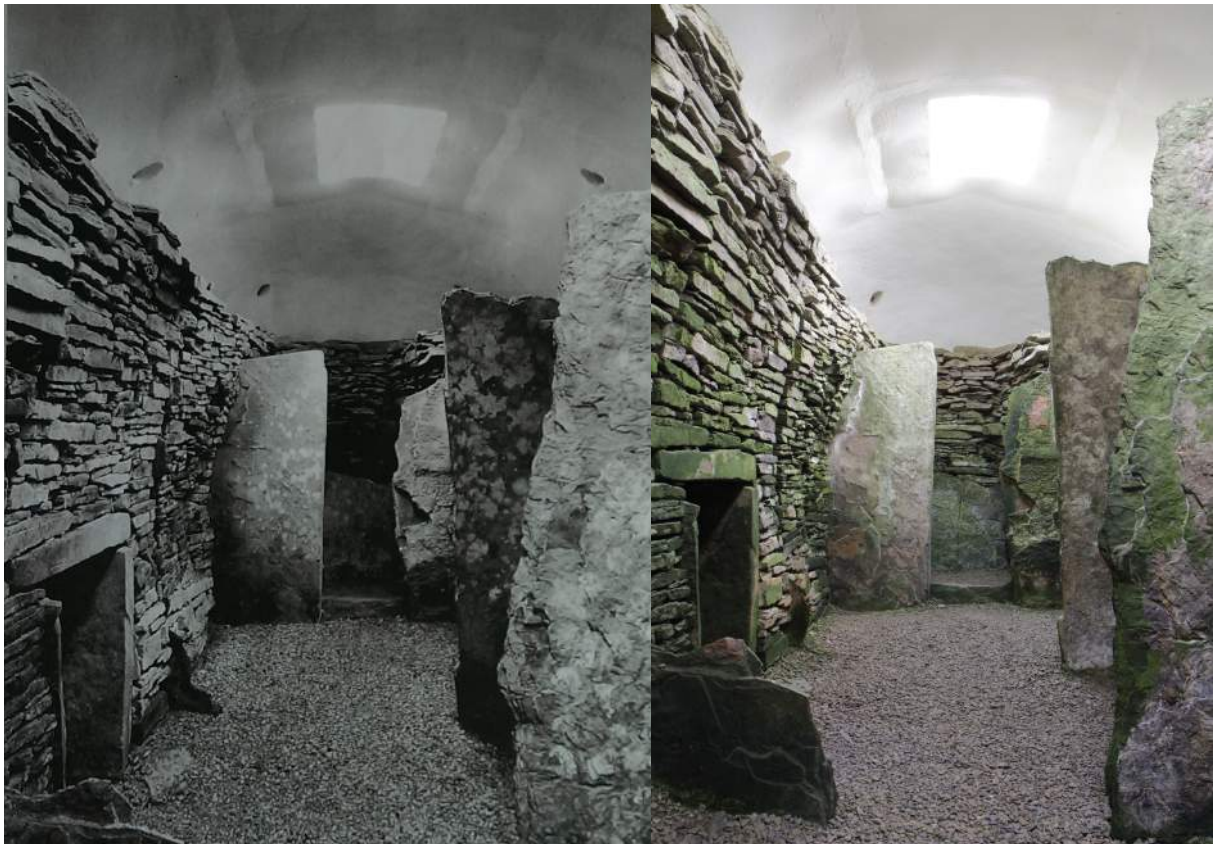
Figure 5.2a-b Above: : Comparison of condition of stonework in Midhowe, upon excavation and now, revealed few changes. Left Image: No Date, courtesy of Orkney Library Photographic Archive

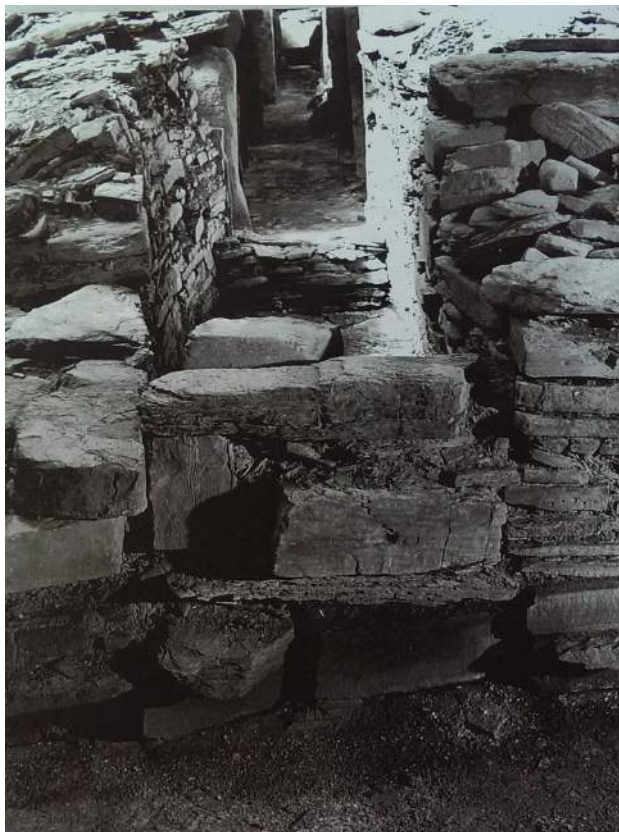
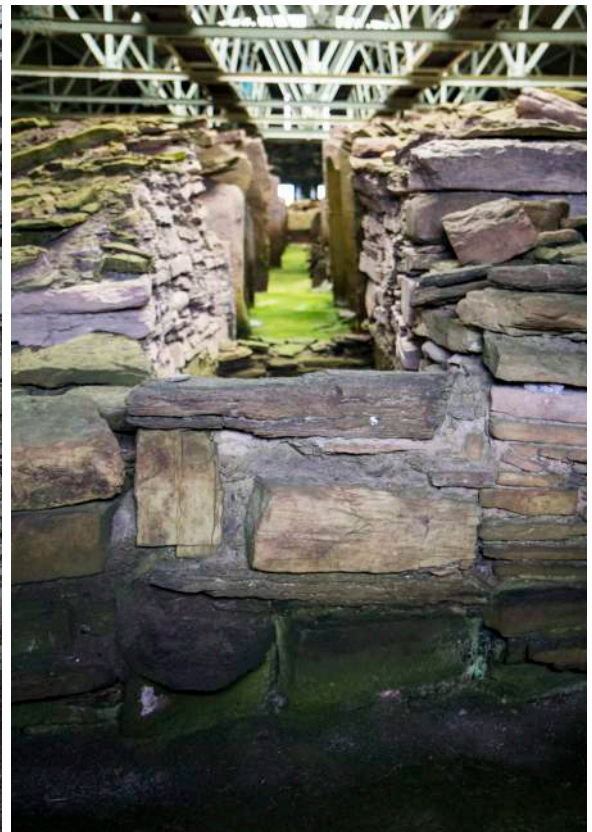
Figure 5.3a-b Above: Comparison of condition of stonework in Midhowe between 1956 and now, revealed few changes, Left Image courtesy of RCAHMS photographic archive, 1956

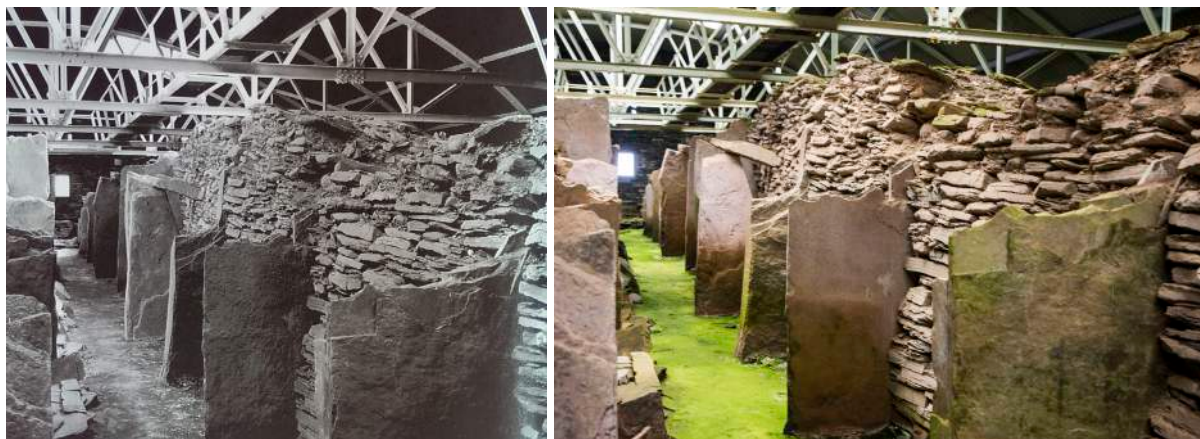
Figure 5.3a-b Above: Comparison of condition of stonework in Midhowe between 1956 and now, revealed few changes, Left Image courtesy of RCAHMS photographic archive, 1956

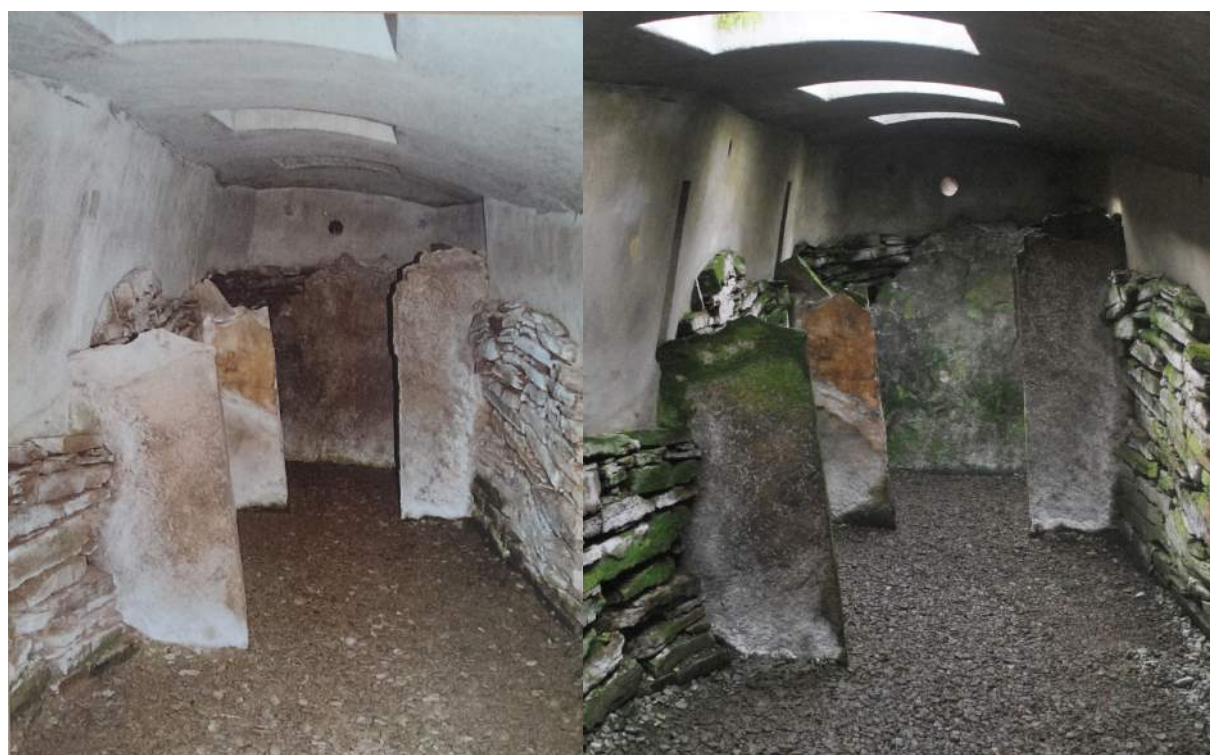
Figure 5.4a-b Above: Comparison of condition of stonework in Blackhammer between 1994 and now, revealed few changes beyond increased algal growth Left Image courtesy of RCAHMS photographic archive, 1994

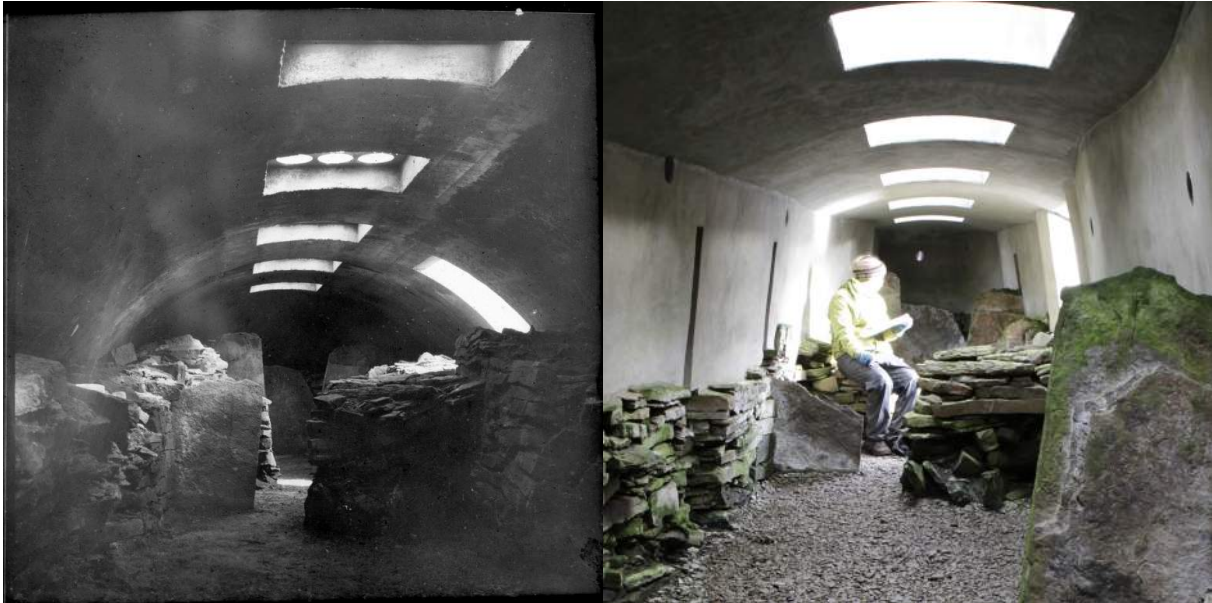
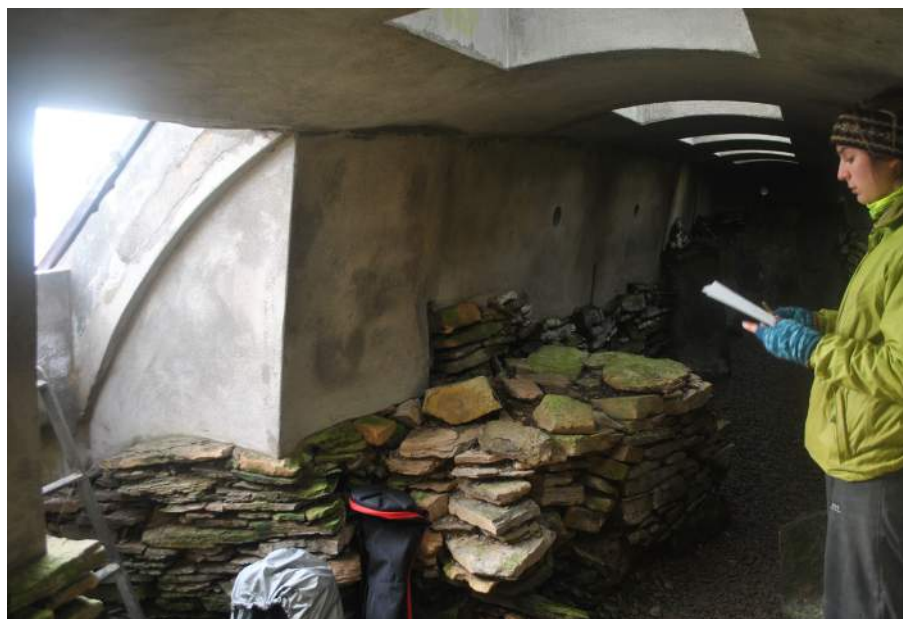
Figure 5.5a-c The dome at Blackhammer itself appears to have undergone modification, Image on Left shows the reinforced concrete dome as it was initially installed with a barrel-vaulted profile and the impression of the shuttering still visible. Image courtesy of RCAHMS CANMORE archive, No date. In contrast, the image on the right shows the current configuration of the roof having undergone substantial alterations, now with a smoother surface and far steeper sides which project deeper over the wallheads below

Below image shows the curve of the original dome still visible, with profile of later insertion beneath, working shot from Condition Survey in Appendix Z

Without further detail we can only assume that this major alteration was necessitated by a serious structural flaw within the concrete dome, and note the heavy concentration of algal growth that has resulted directly beneath the deeper wall. But is there any proof that the roofs are actually creating the adverse microclimates in which algae thrive?

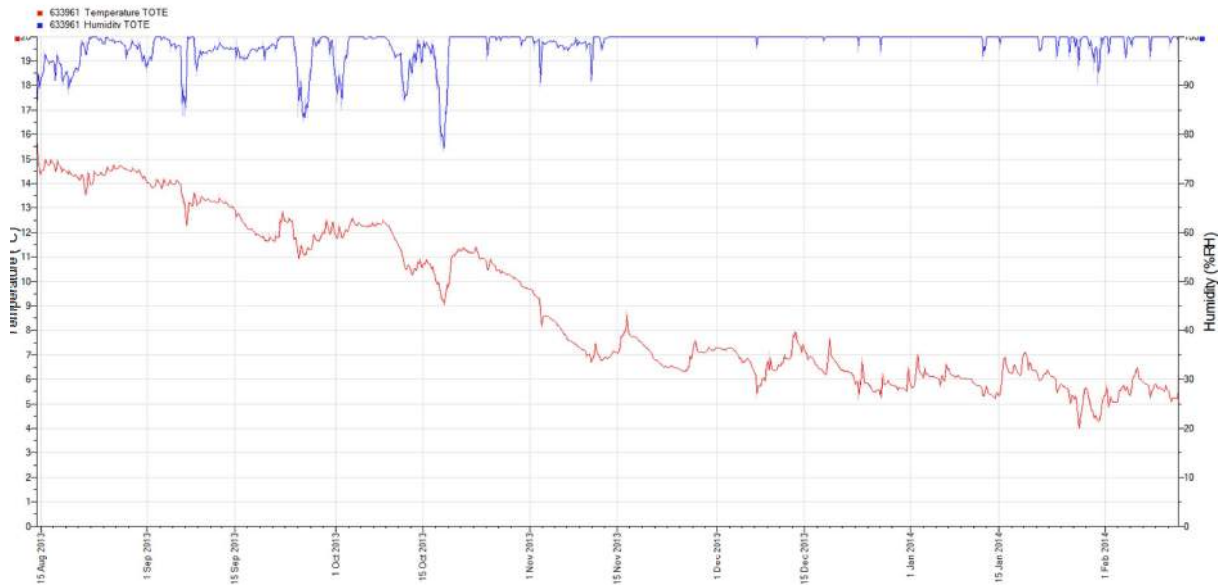
Figure 5.6 Above: Graph plotting environmental data from Isbister between August 2013 and February 2014, Temperature shown in Red, Relative Humidity in Blue, Data Courtesy of OIC
