# **Monumental Misjudgements?**

## **Early Conservative Interventions and their Impact on Orcadian Neolithic Sites**

**A Dissertation submitted for  
MSc in Architectural Conservation  
University of Edinburgh**

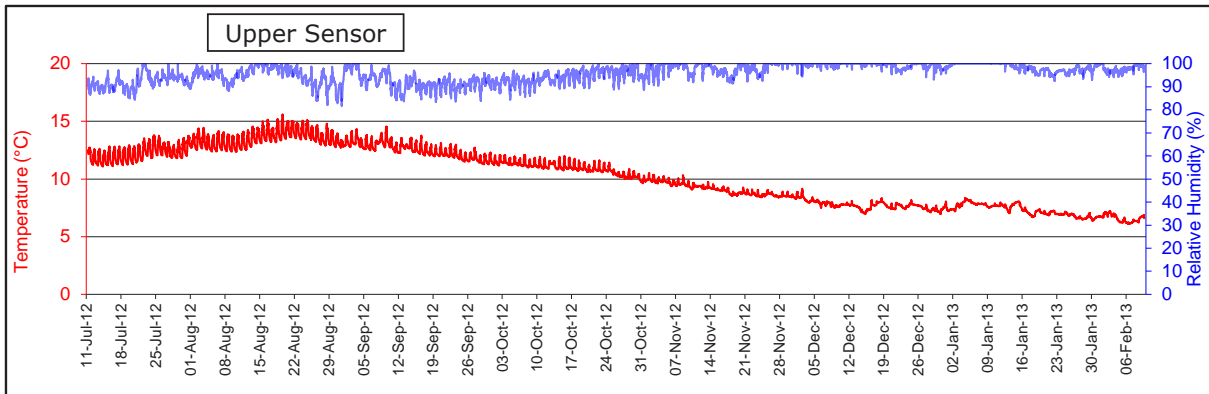
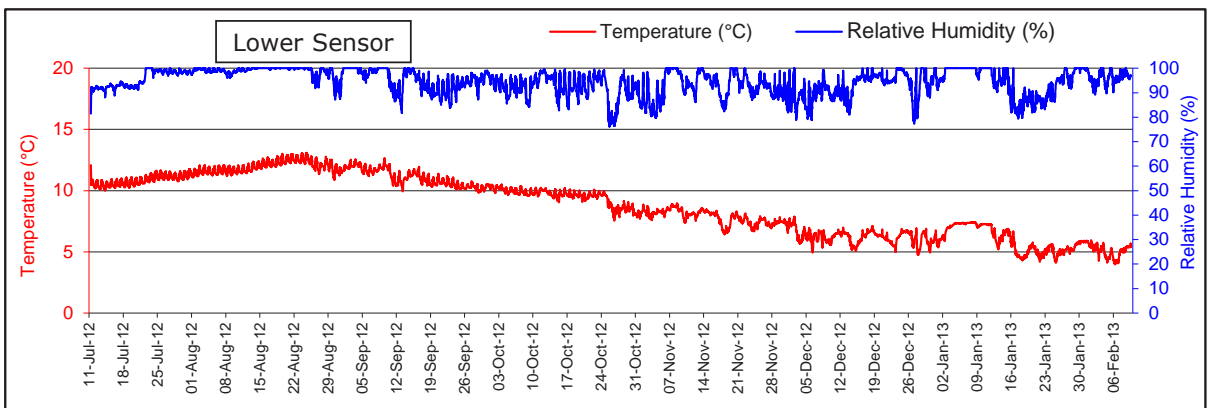
Figure 5.7a-b Below: Graphs plotting environmental data from an upper and lower sensor within Maeshowe between July 2012 and February 2013, Data Courtesy of Rob Thomson

**Statistical Summary of upper sensor (top graph)**

<u>Mean</u>	<u>Minimum</u>	<u>Maximum</u>	<u>Range</u>
<b>T (°C)</b>	10.2	6.1	15.6	<b>9.5</b>
<b>RH (%)</b>	96	81	100	<b>19</b>

**Statistical Summary of lower sensor (bottom graph)**

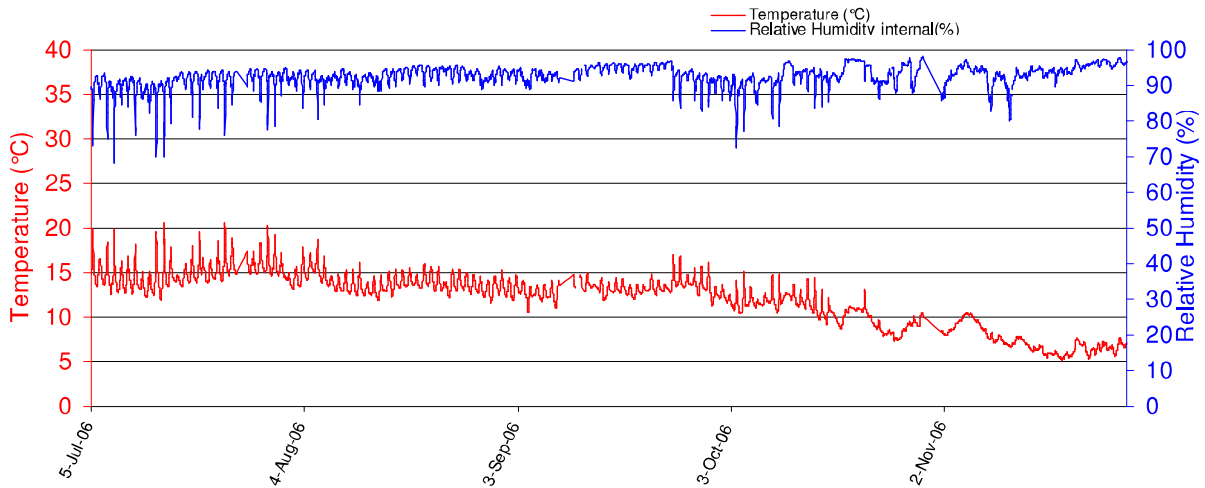
Figure 5.8: Graph plotting environmental data from within House 7 of Skara Brae in 2006 when the HMMOW glass roof was still in place, Data Courtesy of Rob Thomson

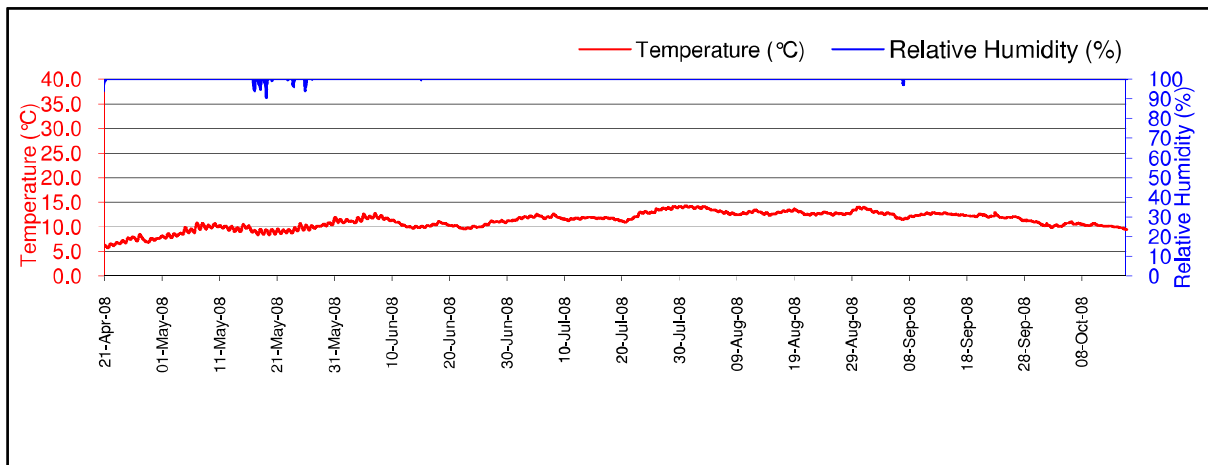
Figure 5.9: Graph plotting environmental data from within House 7 of Skara Brae in 2008 following the replacement of the original roof with one constructed of timber, Data Courtesy of Rob Thomson

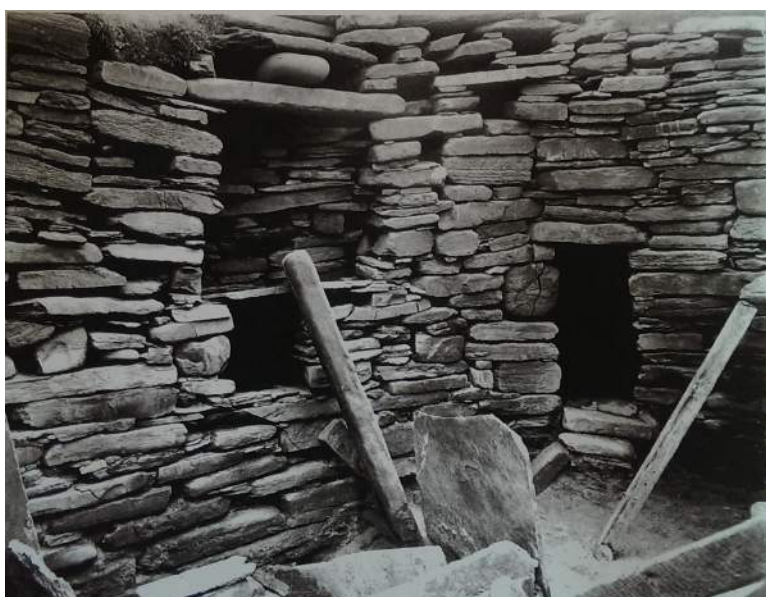
Figure 5.11: Early image of House 7 of Skara Brae during excavations in 1928,

Even having just been exposed the stonework looks notably rounded, perhaps suggesting that it was previously weathered prior to being used in construction. Image courtesy of RCAHMS photographic archive, 1928

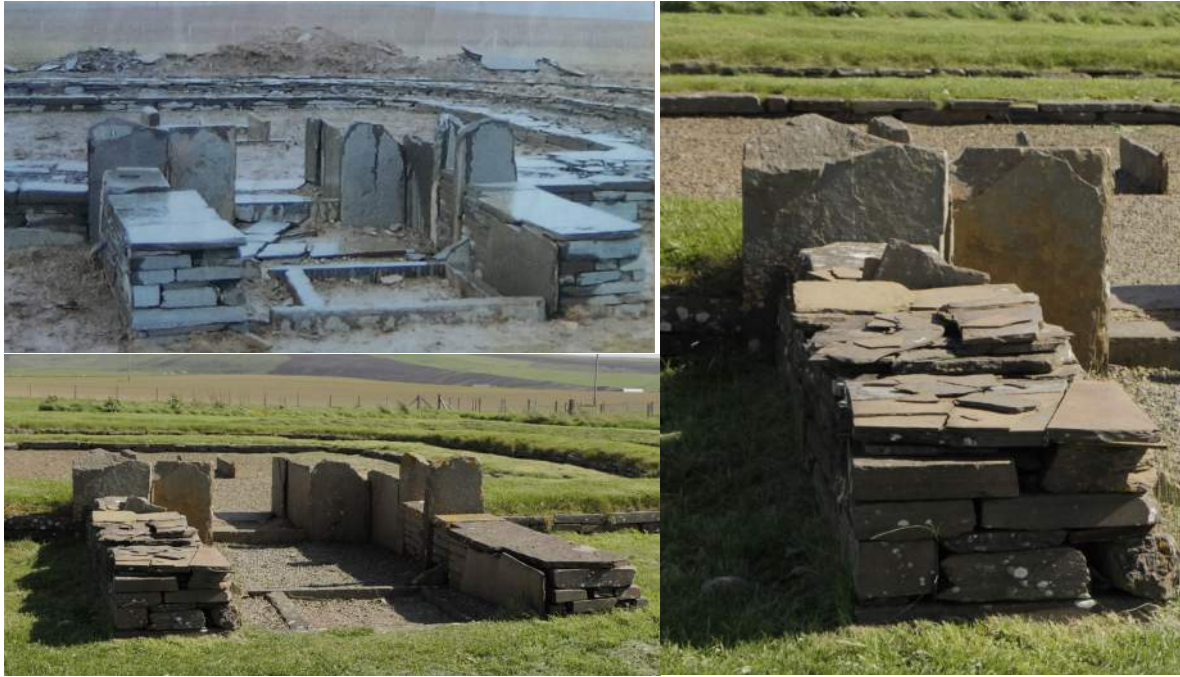
Figure 5.12a-c: Barnhouse Settlement, As initially reconstructed in 1994, and its condition today with detail of deteriorated stonework. Top left image Courtesy of RCAHMS photographic archive, 1994
