# THE UNIVERSITY *of* EDINBURGH

This work is protected by copyright and other intellectual property rights, which are retained by the thesis author, unless otherwise stated.

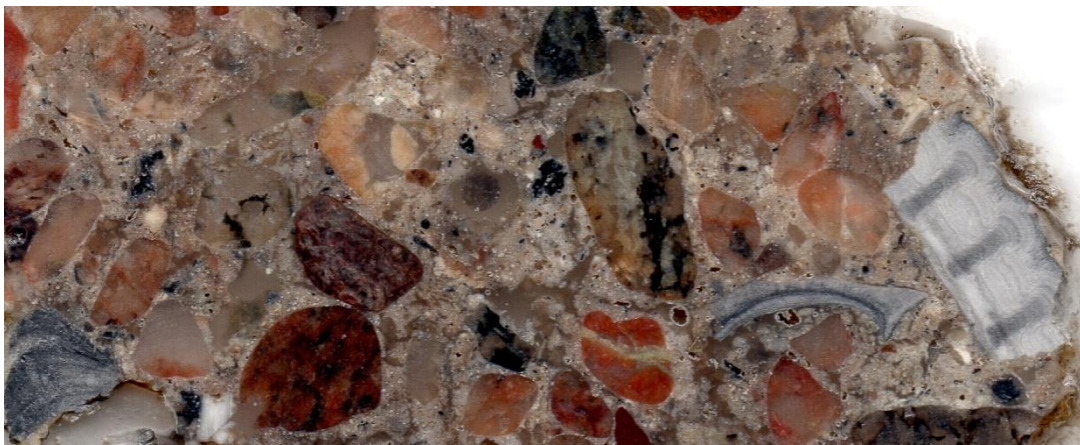
Figure 10 (above) – ENH.15. Heated *C. edule* clasts and quartz-rich lithic-tempered mortar. Thick-section; Field of view 25mm.

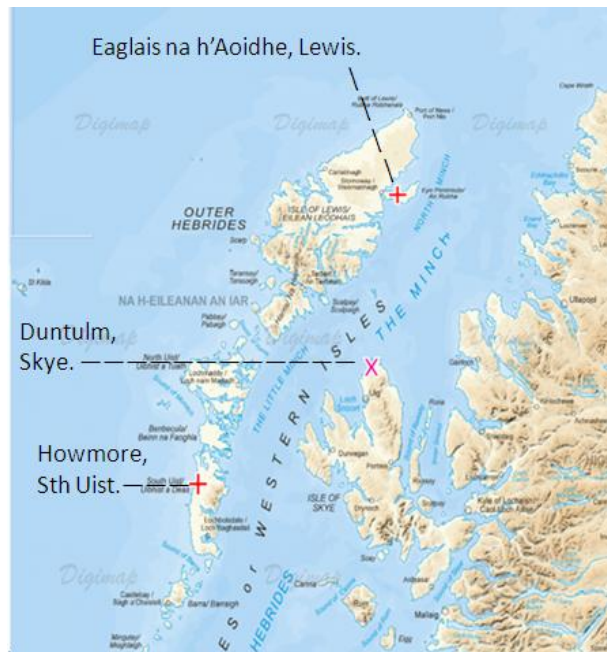
Figure 2 (above) – Location of Howmore burial ground, on the north-west of the island of South Uist, north-west of the mainland of Scotland. (© crown copyright and Landmark Information Group Limited 2016. All rights reserved).

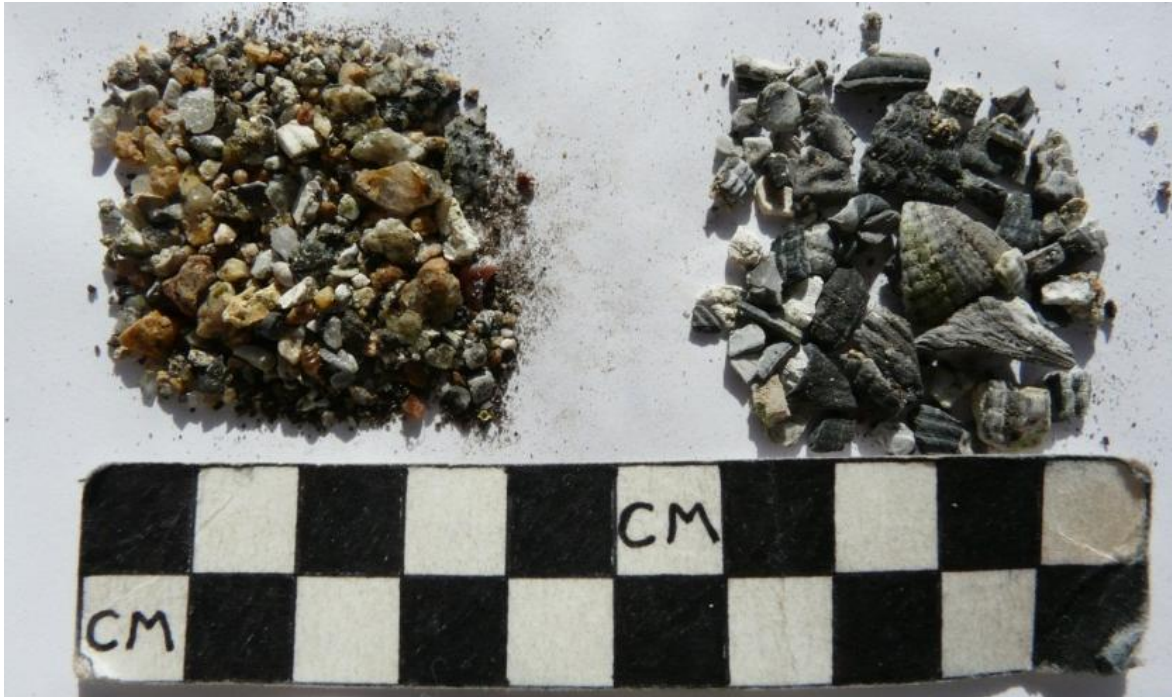
Figure 10 (above) – Separation of quartz-rich temper from Type 3 *C. edule* heated shell relicts in loose dissolute mortar remains from *Teampull Mòr*, Howmore (from Thacker 2011).

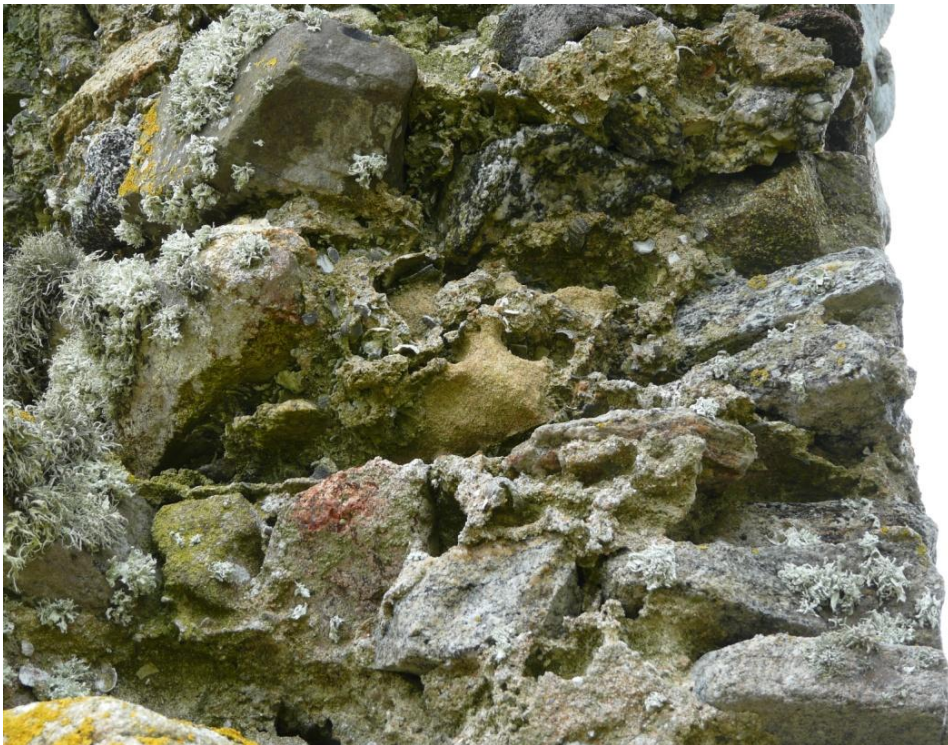
Figure 11 (above) – Eroded sandstone within the core of the surviving east wall of *Teampull Mòr*, Howmore. No scale; photograph Mark Thacker.

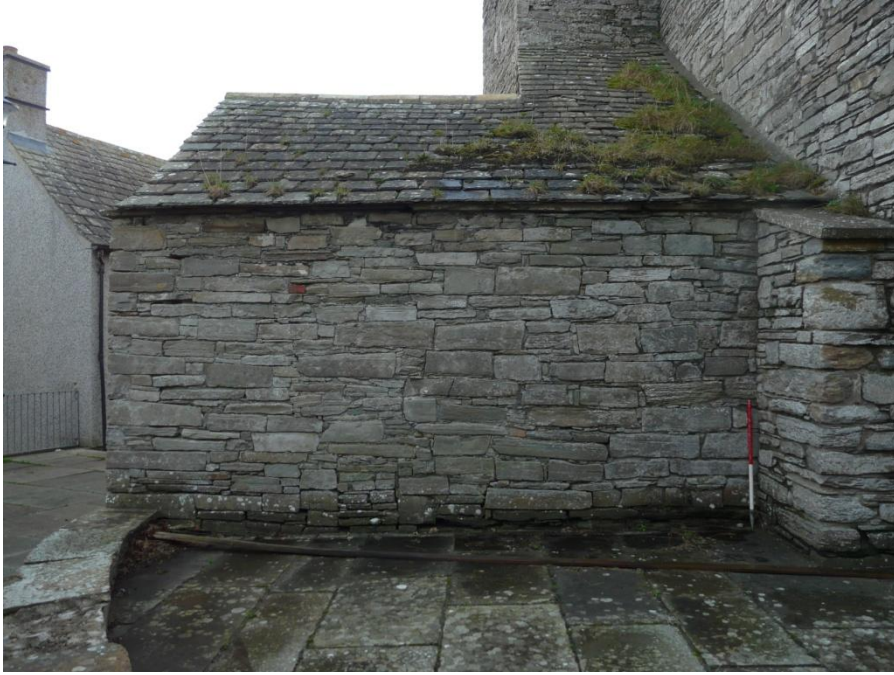
Figure 6 (above) – North chancel wall; external face. Note blocked primary chance window.  
Scale 500mm; photograph Mark Thacker.

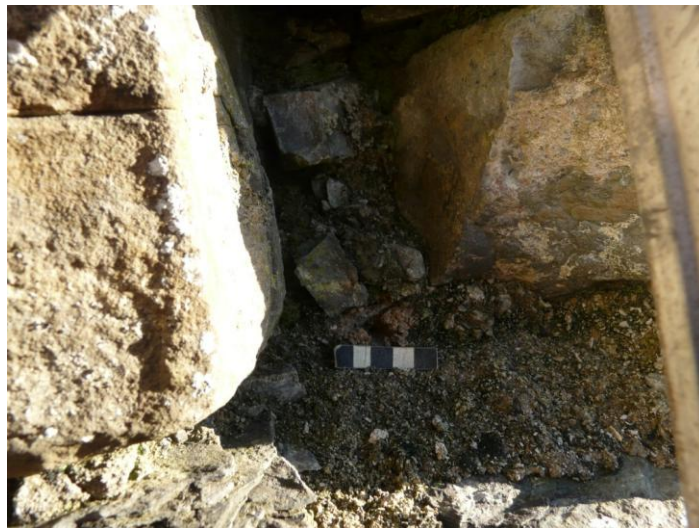
Figure 32 (above) – Degraded Mortar 3; deep bedding and core; external face north-west nave wall. Dissolute clay and fine shell. Scale 10mm; photograph Mark Thacker.

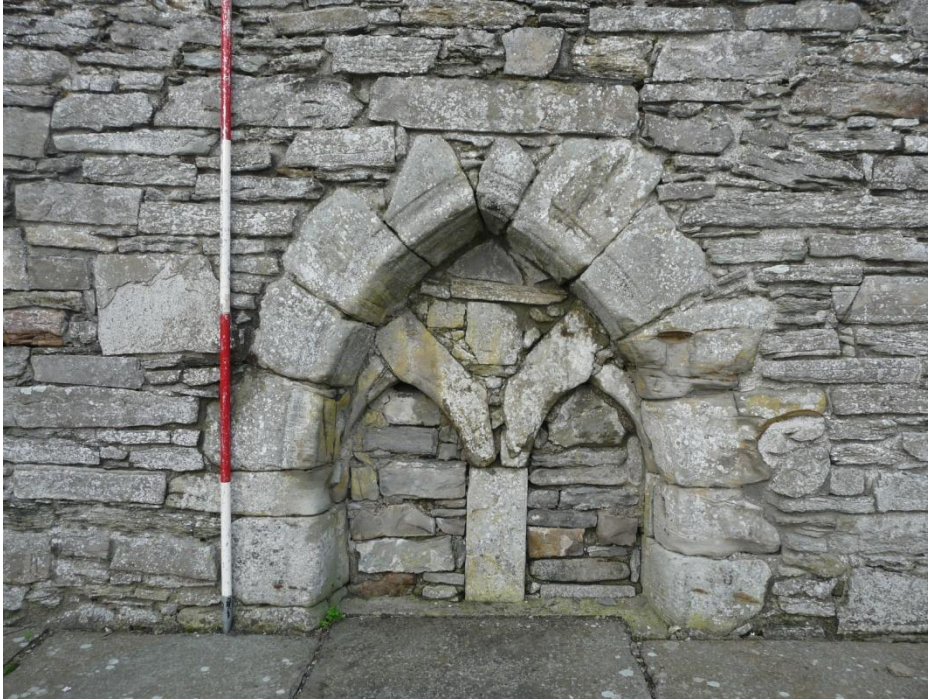
Figure 33 (above) – North aisle; external east face of wall, traceried window. Scale 500mm; photograph Mark Thacker.
