Non-destructive Testing of Metal Ducted Post-tensioned Bridge Beams using Sonic Impact-Echo Techniques

Julia Martin

PhD - The University of Edinburgh - 1997

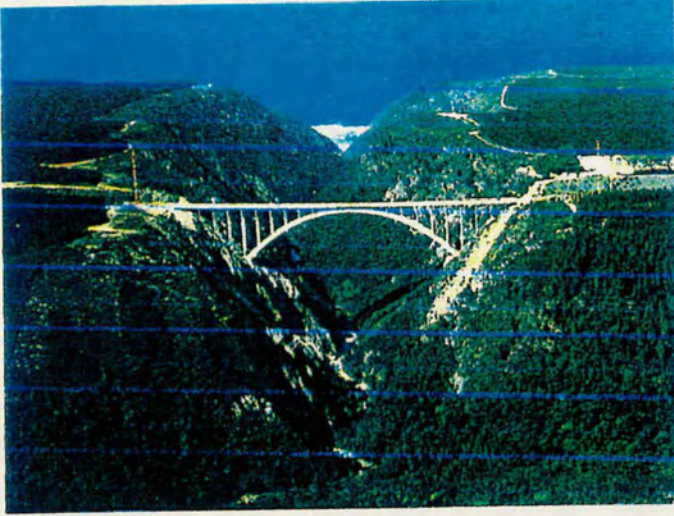
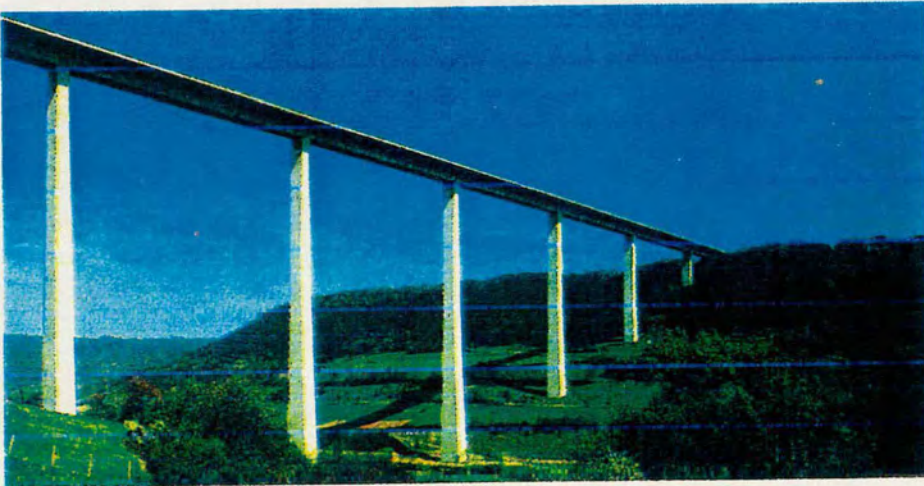
Figure 1.1 Examples of Post-tensioned bridges

a) Bloukrans Bridge, South Africa

b) Kocher Viaduct, Germany

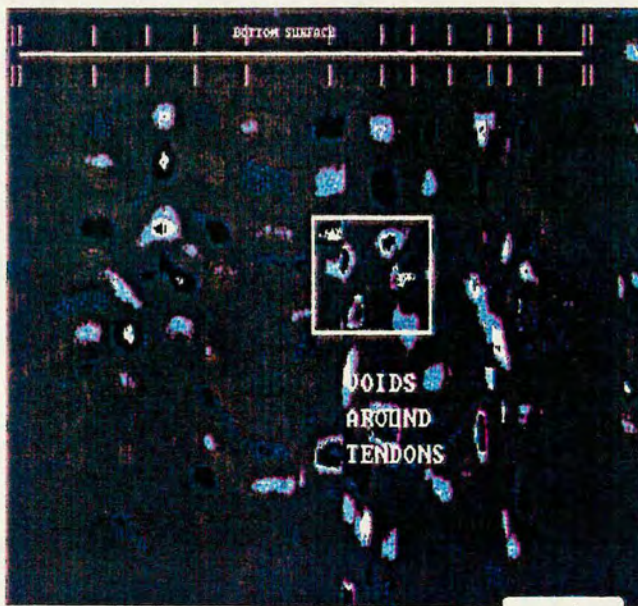
Figure 4.6 Bank lane footbridge radar plots

b) Filtered Data, section across the base of the beam

A section of this post tensioned concrete box beam was surveyed. The post tensioning system consisted of four separate tendons formed using steel ducts. Therefore it was not possible to investigate the condition of the actual tendons using the radar system as the electromagnetic wave was totally reflected by the steel ducting. The position of the cables could be found from surveys on the base of the beam, figure 4.6a (taken near the centre of the span with a 1 MHz antenna). However, because of the shape of the beam, it was more difficult to locate the outer tendons as they rose up the sides of the box beam. Although it was not possible to determine the condition of the tendons inside the metal ducts some voiding around the ducts was detected, see figure 4.6b (taken 5 m from the end of the span with a 1 MHz antenna.)

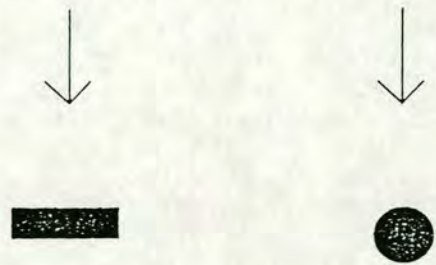
Figure 2: Circular Defect Causing Wave Scattering

The impact-echo method is very successful in detecting planar flaws¹⁰ as the wave-front is reflected back to the surface (see fig. 2a). Most ducts used in post-tensioned bridge beams are circular in section. This causes scattering of the wave reflection (see fig. 2b); less energy reaches the response transducer and the reflection may not be measured. However, if the duct is voided the base reflection will arrive later than the base reflection for a grouted duct. This occurs as the wave has to propagate around the void.

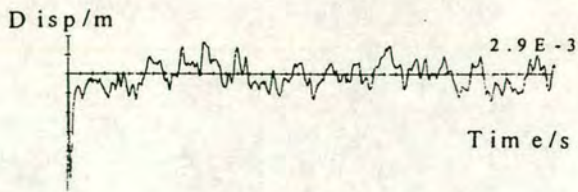
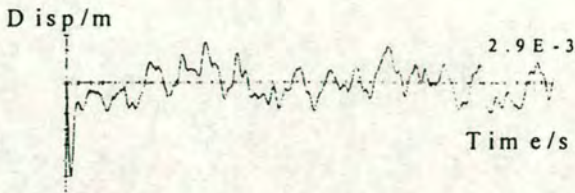
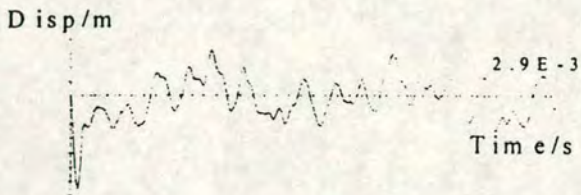
Figure 10. Series3, Set1, Displacement/Time Traces

(a) Contact time = 30 us

(b) Contact time = 50 us

(c) Contact time = 70 us

Figure 10 shows the vertical displacement-time traces for the model containing a 100 mm diameter void at 125 mm from the beam surface - figure 10a with an impulse contact time = 30μs, figure 10b with contact time = 50μs and figure 10c with an impulse of contact time = 70μs. The expected arrival time of the compression wave from the base of the beam is approximately 160μs causing the surface of the beam to drop at this time. This can be seen on each displacement-time trace. A compression wave reflected from the top surface of the void would be expected to reach the surface of the beam at 60μs. This wave arrival would again cause the surface of the beam to

rop. The plot shown in figure 10a shows a clear drop in the surface at the expected time. Figure 10b also shows a definite drop in the beam surface but it is not as large as that with a 30us impulse. The plot shown in figure 10c shows a discontinuity at about 70us but the magnitude is much reduced. Frequency spectrum plots were also calculated for this analysis. This was done by performing a four point moving average on the results from the finite element analysis, extracting every 4th point and performing a 1024 point FFT on the data. The spectrum plots are shown in Figure 11. The frequency peak corresponding to the base reflection can clearly be seen on each plot. The peak corresponding to the reflection from the void can be seen at approximately 14.5 kHz. This peak is clearly seen in Figure 11a, can be seen in Figure 11b and is difficult to identify in Figure 11c. This is because the longer pulse length does not input sufficient energy at these higher frequencies.
