The Dalmarnock Fire Tests: Experiments and Modelling
Edited by G. Rein, C. Abecassis Empis and R. Carvel

9. The Performance of Fibre Reinforced Polymer Strengthening in the Fire

By Tim Stratford, Martin Gillie and Jian-fei Chen

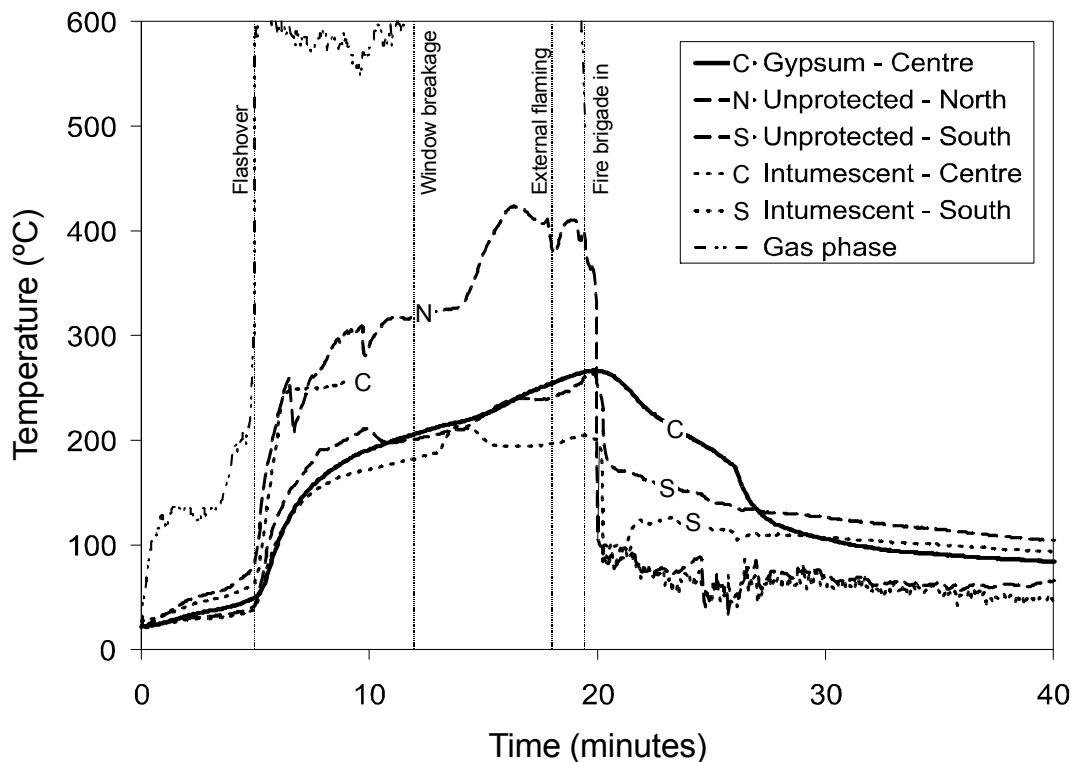
Figure 6a: Bondline temperatures - plates

Figure 6 shows the temperatures recorded by the bondline thermocouples, for each strengthening type and at each position (north, centre and south). There were a few inactive thermocouples (not shown), and the readings for 3 thermocouples (gypsum-centre, intumescent-north and intumescent-centre) are erroneous. It should be noted that some of the readings in Figure 6 would have been taken after a plate had separated from the ceiling. Figure 6 also shows gas phase temperatures from a single thermocouple in the centre of the strengthened region, but it should be noted that the temperatures varied across the compartment, as described in Chapter 3.

In all cases the bondline temperature was well above the glass transition temperature of the adhesive. As expected, the bondline temperatures are highest in the unprotected plates; however, even with gypsum-board protection, the glass transition temperature was reached within a minute after flash-over. This is was much more rapid than previous furnace-based research (eg: Blondtrock *et al.* 2001). Although the protection is not directly comparable, these furnace-based tests suggest that it takes in the order of 20 minutes for a similar temperature rise.

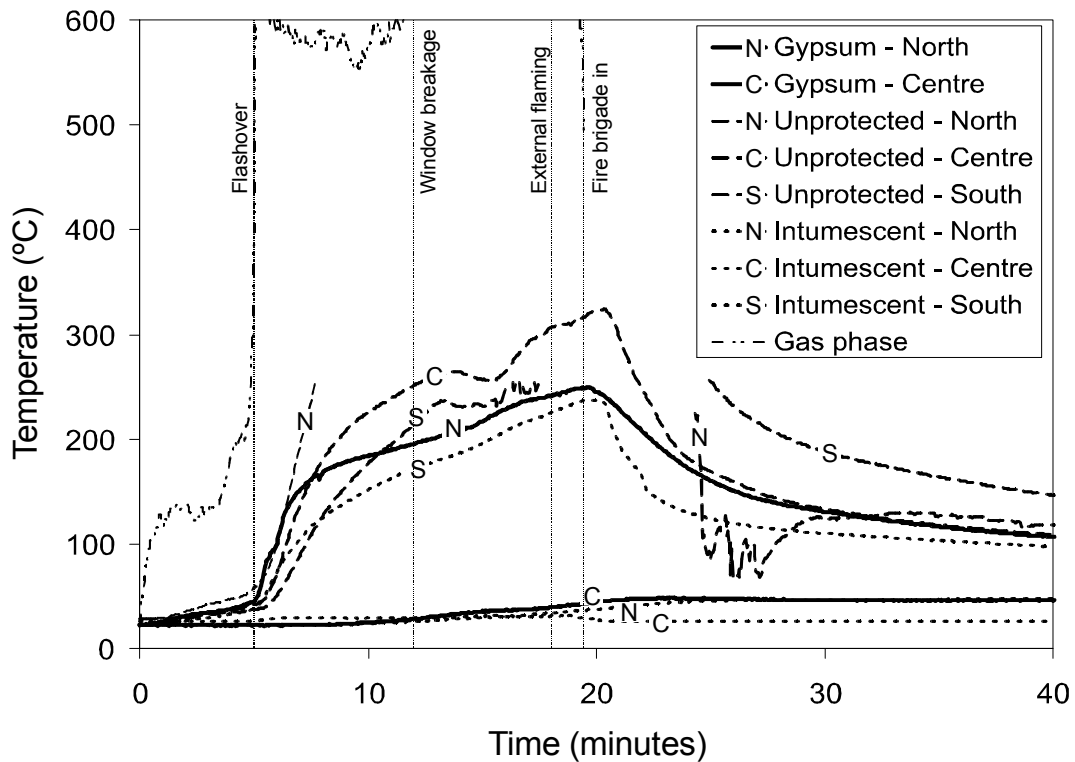
Figure 6b: Bondline temperatures - NSM

Without further analysis it is not possible to draw comparisons between the plate and NSM temperatures.

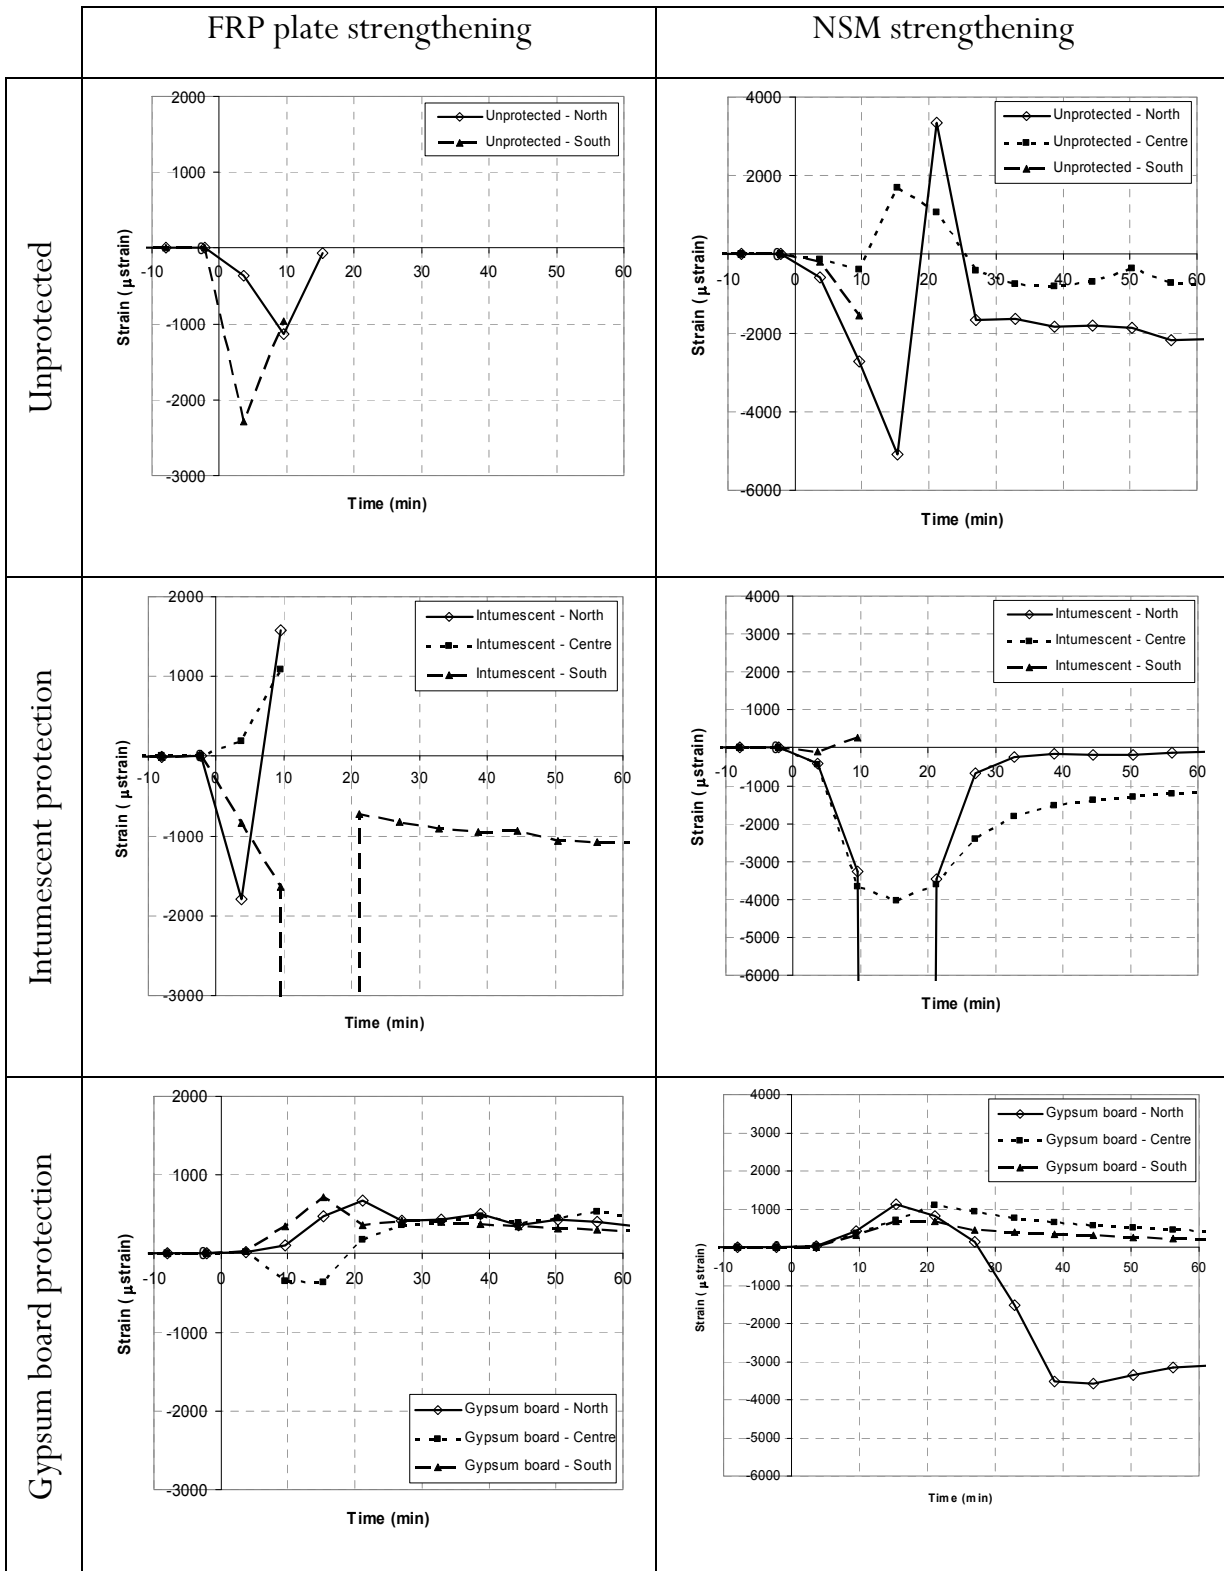
Figure 7: Uncorrected FRP strain measurements

Figure 7 shows the strain gauge results, presented here before correction for temperature effects. These strain results are all due to thermal effects: (a) thermal expansion of the FRP component, possibly in composite action with the concrete, (b) differential thermal expansion between the gauge and the FRP, and (c) apparent strains due to electrical effects in the gauge. Future work will use thermocouple readings adjacent to the strain gauges to remove components (b) and (c), but this has not yet been carried out with sufficient rigour to present the results here. It is important to note that the strain gauges and gauge adhesive were only intended for use up to 200°C, consequently the correction will not be accurate and there may have been slip in the gauge adhesive above this temperature. Also, the time resolution of the data is poor, and the negative strains for the intumescent-protected NSM are anomalous.

Nevertheless, the uncorrected strain evolutions in Figure 7 are useful. Separation of the intumescent plate from the concrete, for example, occurred about 10 minutes from the start of the test, but the plate remained in contact at the southern end (confirmed by Figure 5b). The gypsum board protected strengthening have complete strain traces. The negative strains for the north gypsum-protected NSM gauge suggest the FRP has slipped relative to the concrete slab due to adhesive viscosity at high temperatures, but solidified during cooling. Further work, however, is required to analyse these results.
