EXPLOSION AT SIX BELLS COLLIERY  
MONMOUTHSHIRE

# EXPLOSION AT SIX BELLS COLLIERY, MONMOUTHSHIRE

On the causes of, and circumstances  
attending, the explosion which occurred at  
Six Bells Colliery, Monmouthshire,  
on 28th June, 1960

T. A. ROGERS, C.B.E., M.I.Min.E.  
H.M. Chief Inspector of Mines and Quarries

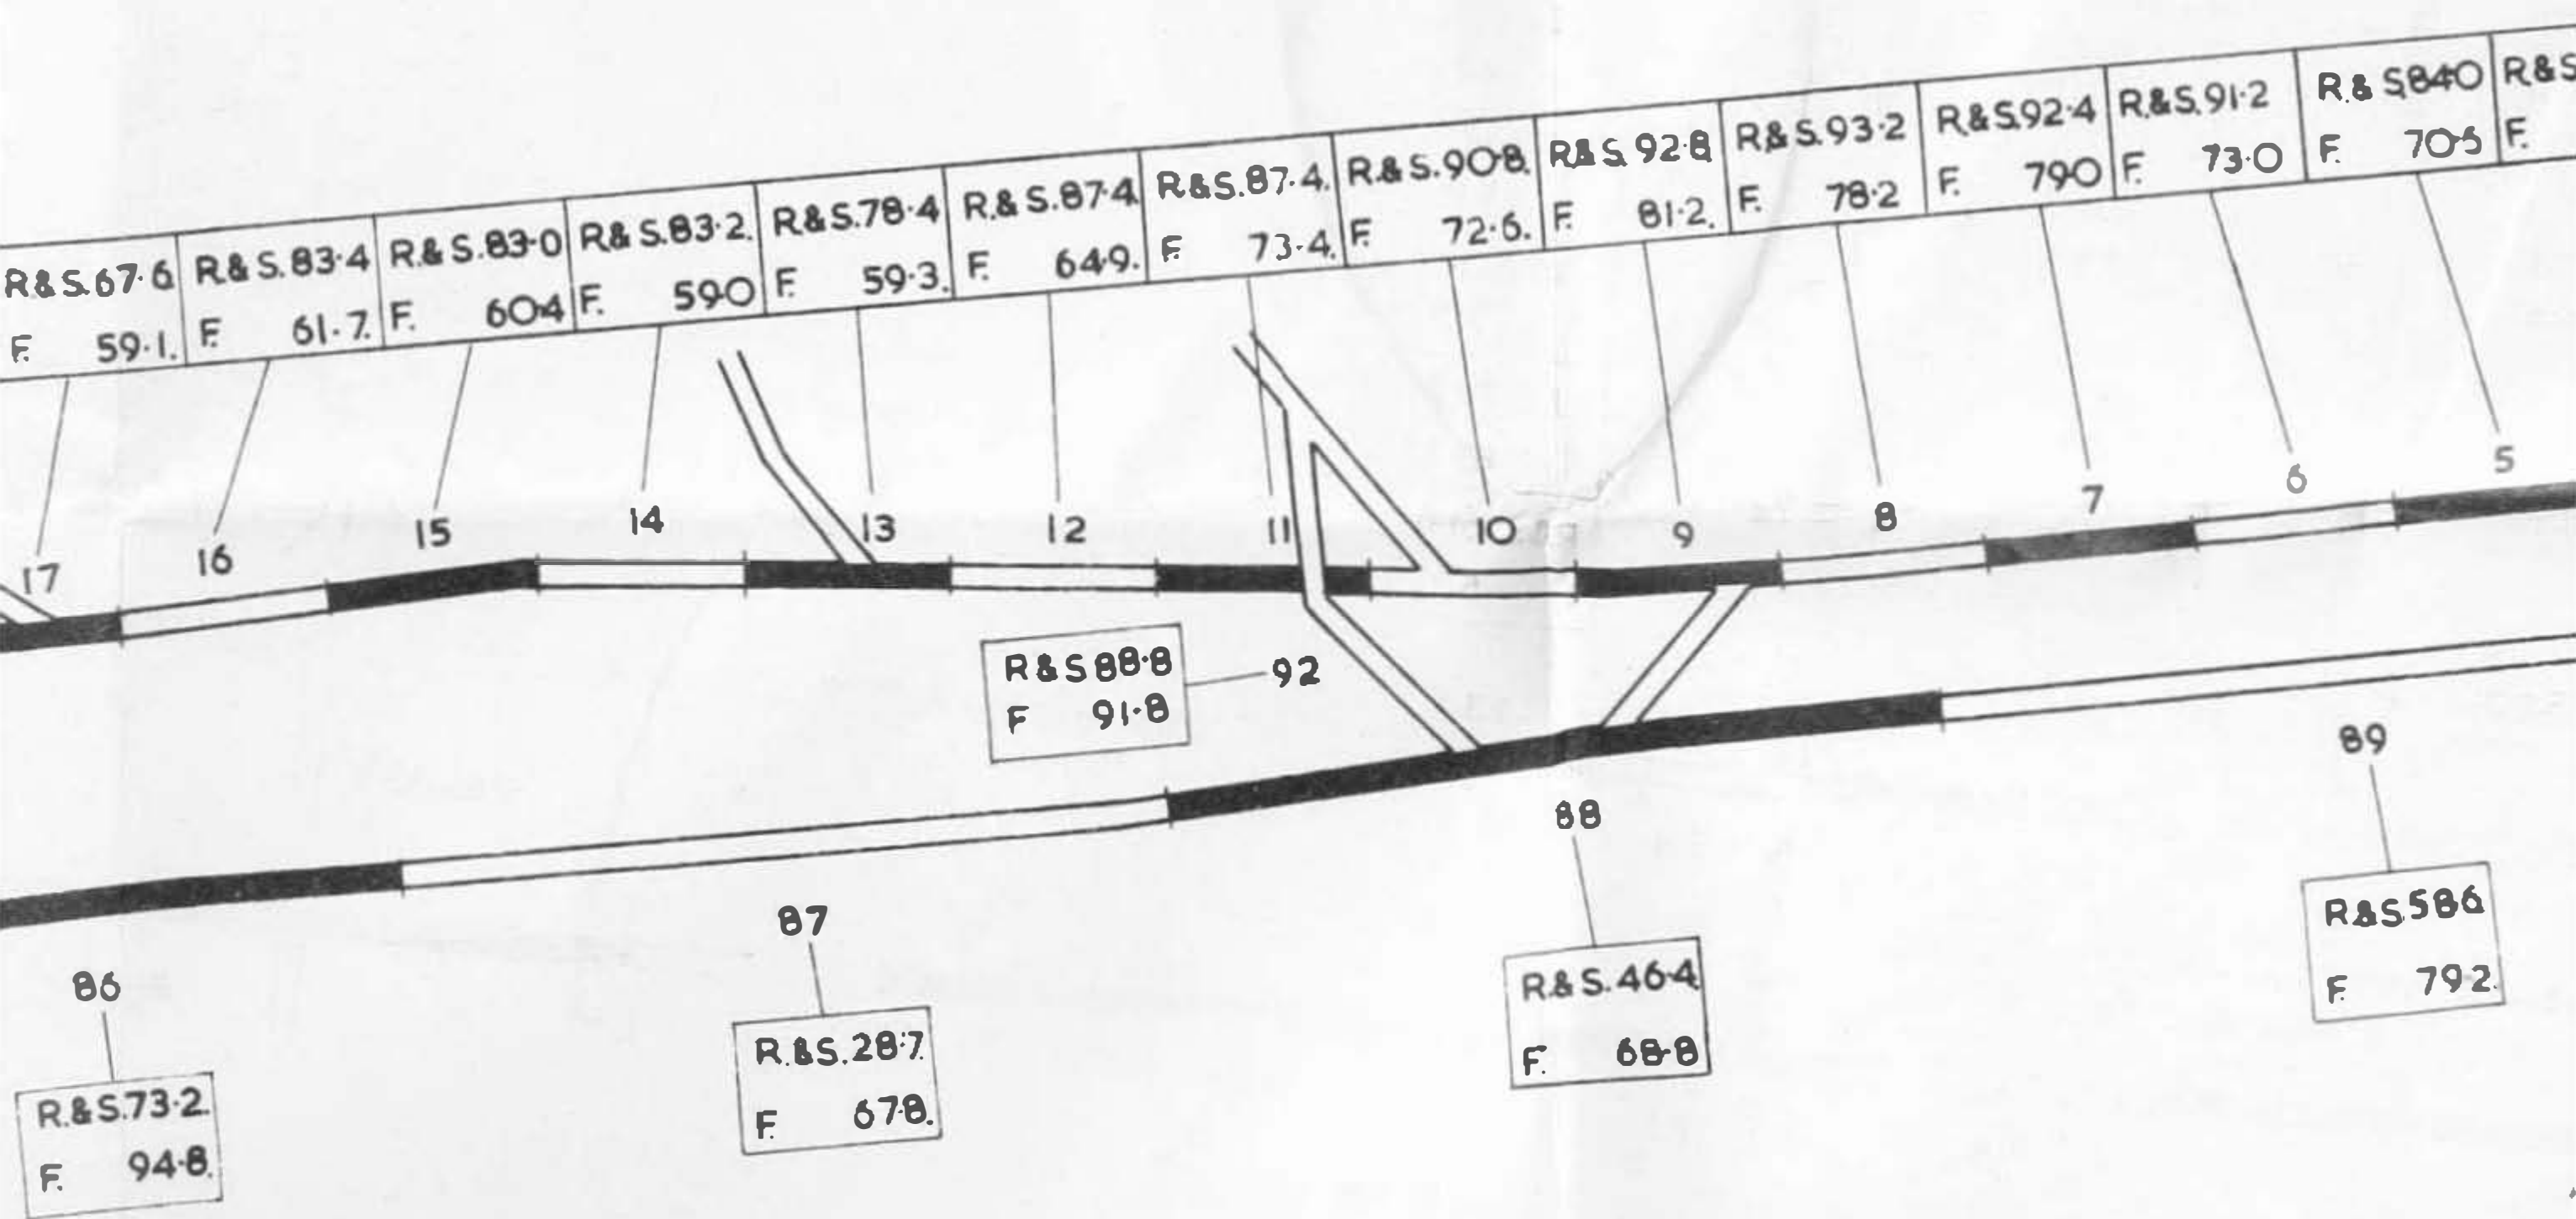
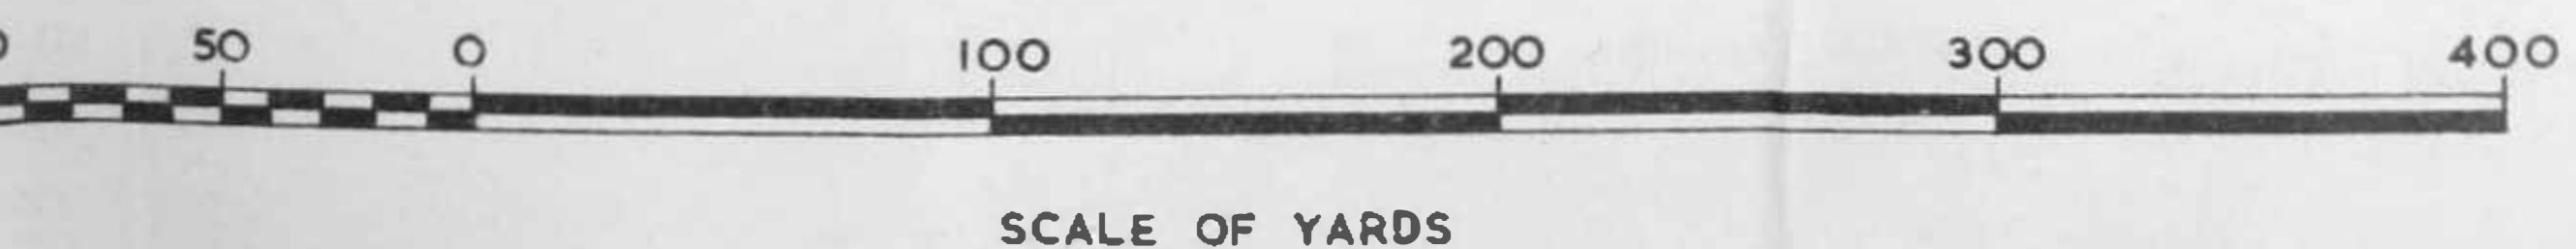
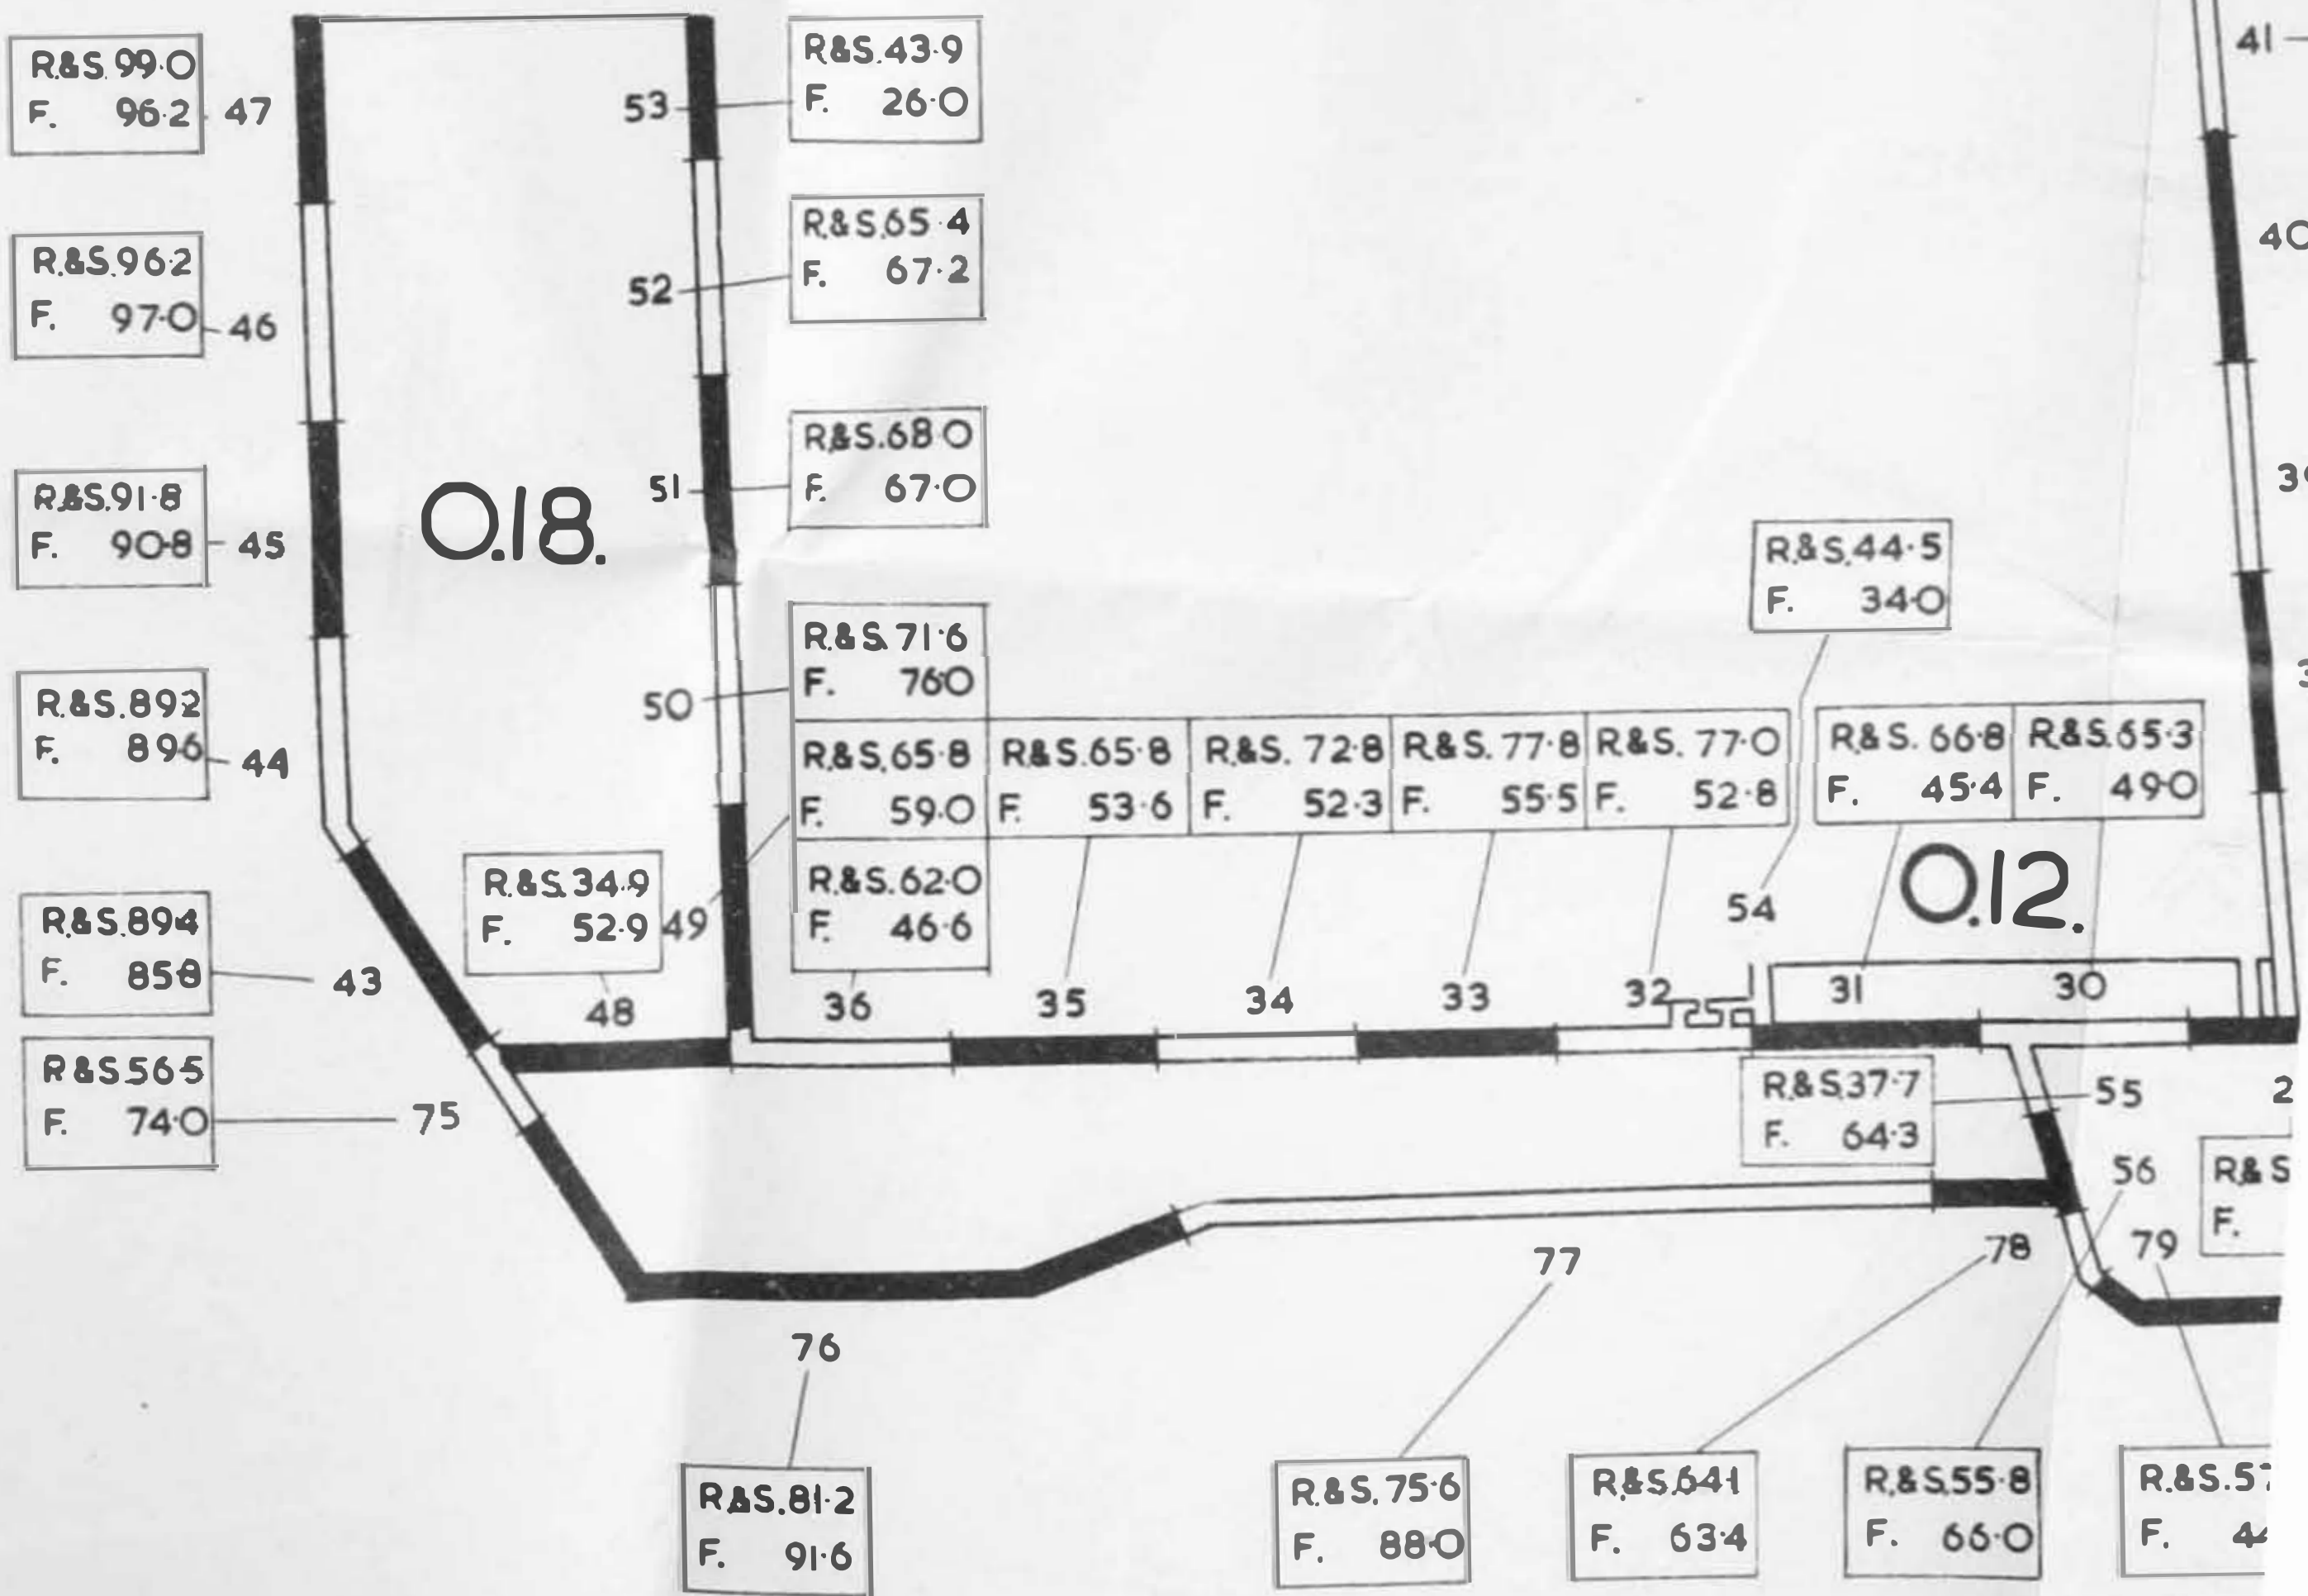
# PLAN No. 4

SIX BELLS COLLIERY, W DISTRICT  
 OLD COAL SEAM  
 POST EXPLOSION DUST SAMPLES

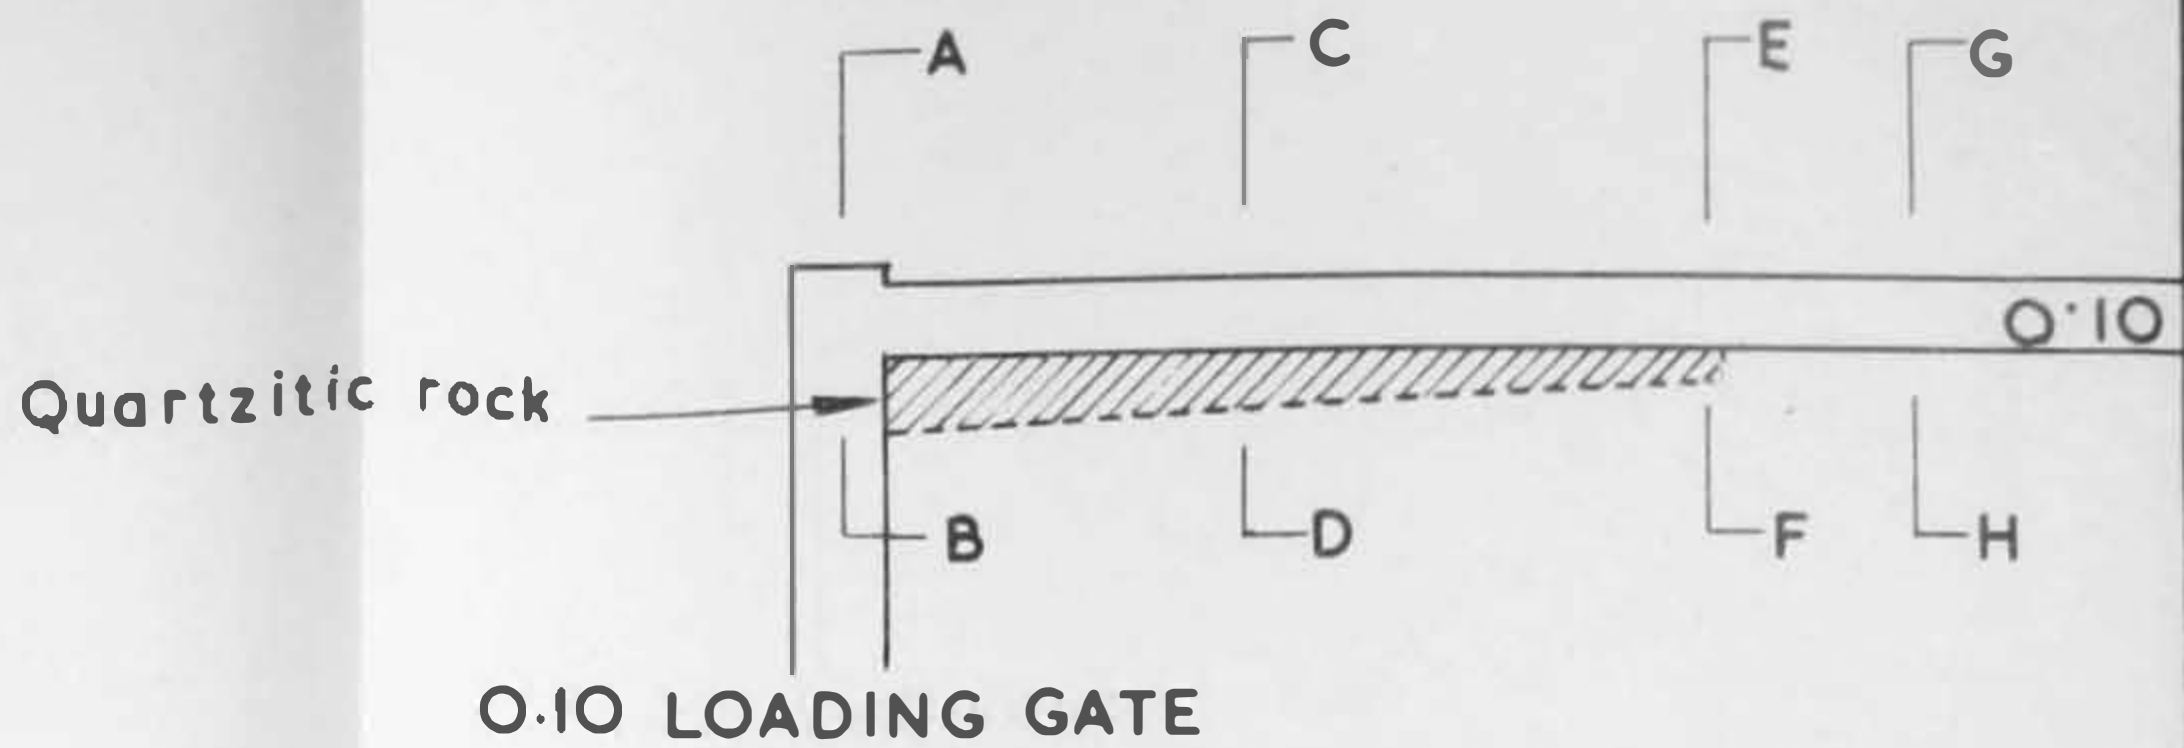
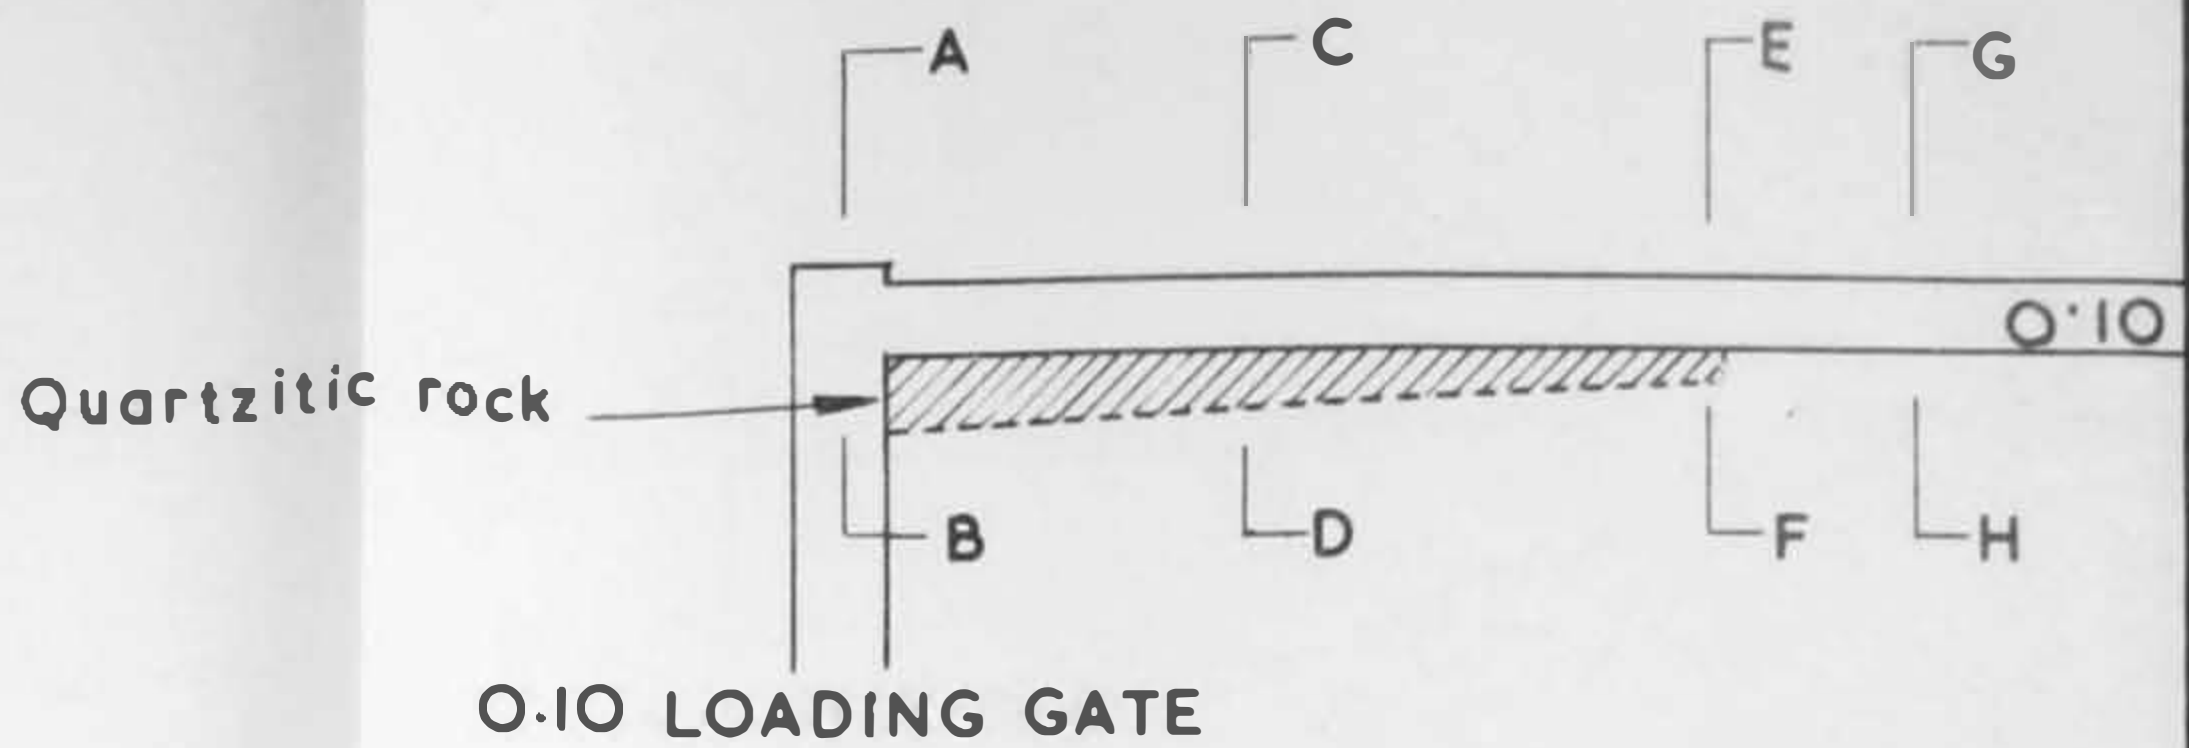
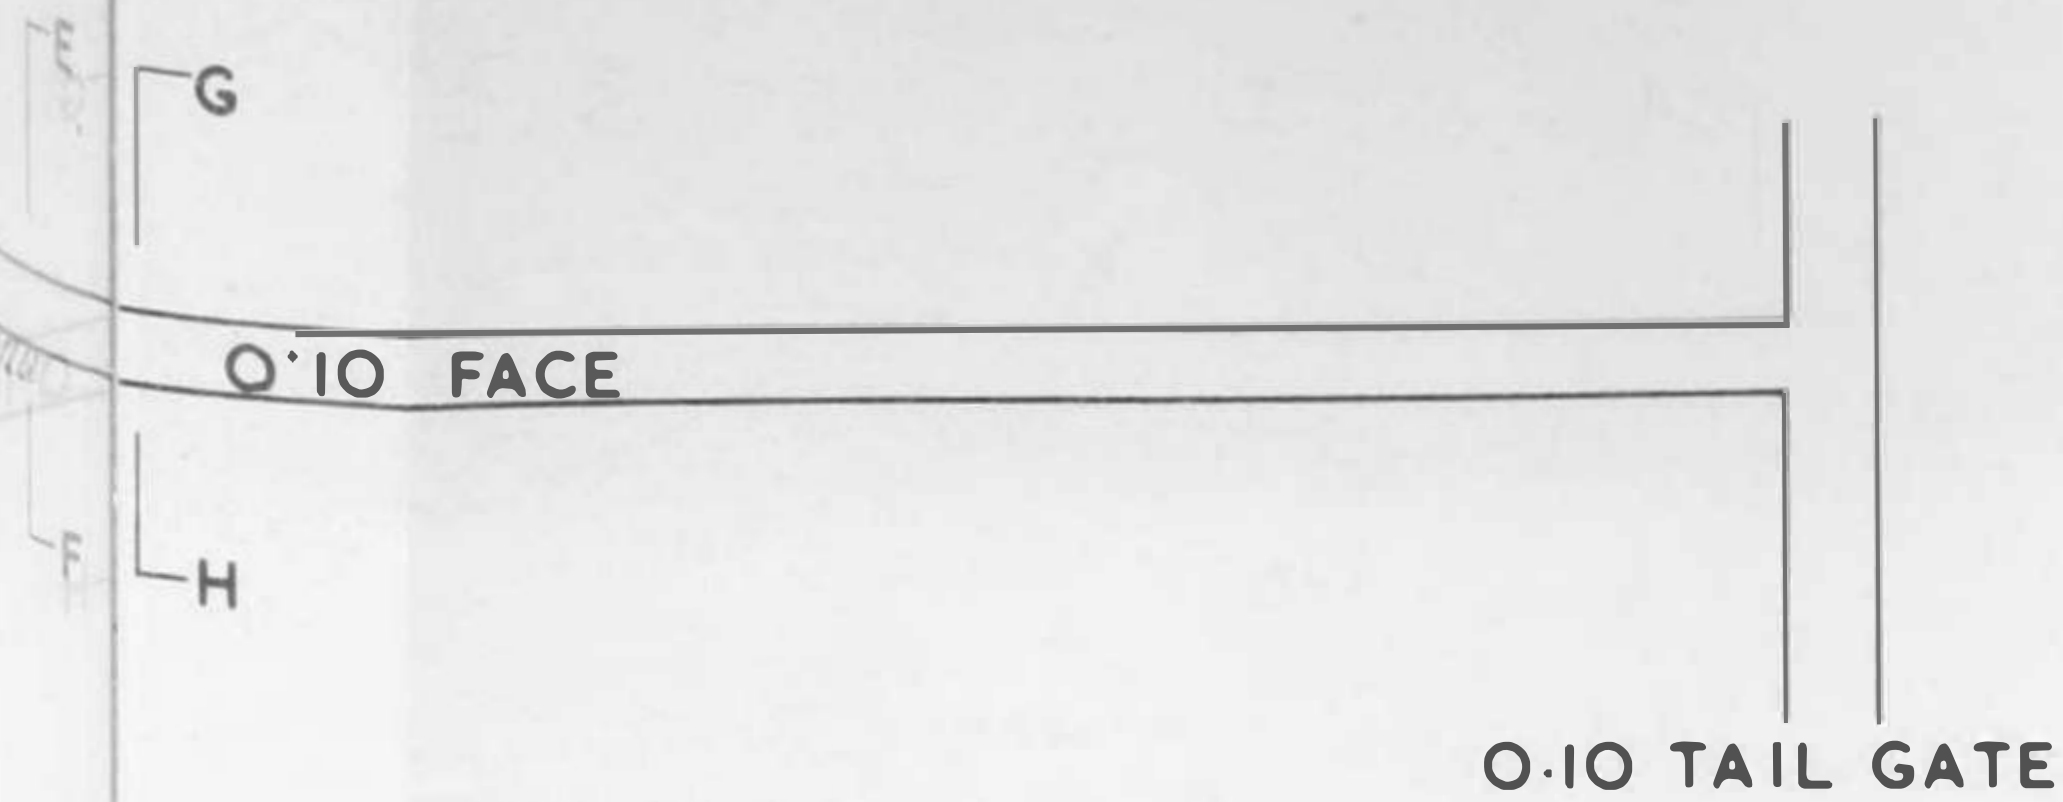
Cross section A - B at loading gate.

CROSS SECTIONS SHOWING EXPOSURE AND EXTENT

EXTENT OF AN INTRUSION OF A HARD QUARTZITIC TYPE ROCK.

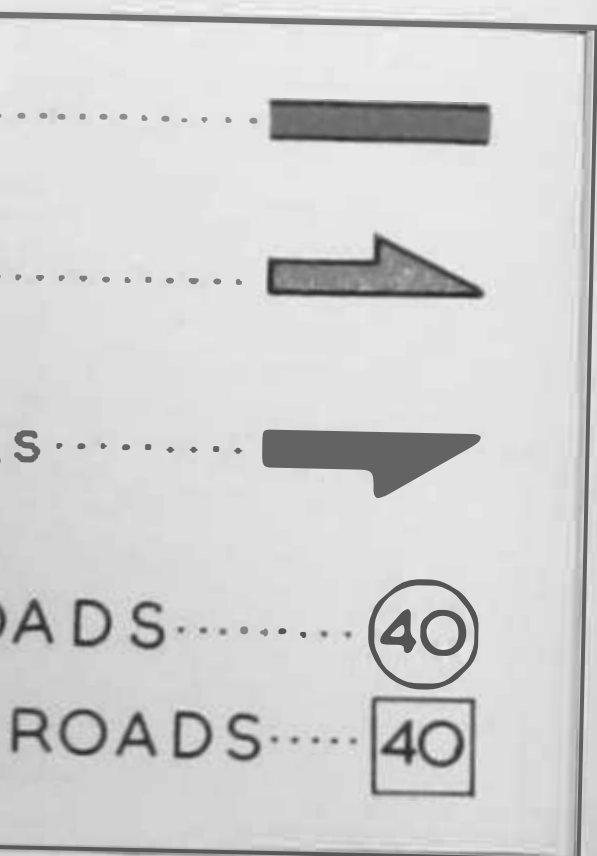
PLAN No.3  
 SIX BELLS COLLIERY 'V'  
 EXPLOSION INVESTIGAT

DIRECTION OF FLAME suggested by coked dust deposits

INCOMBUSTIBLE MATERIAL IN	}	ON CONVEYOR ROAD
EXPLOSION DUST SPECIMENS		ON TUB HAULAGE ROAD
PER CENT
