EXPLOSION AT SIX BELLS COLLIERY  
MONMOUTHSHIRE

# EXPLOSION AT SIX BELLS COLLIERY, MONMOUTHSHIRE

On the causes of, and circumstances  
attending, the explosion which occurred at  
Six Bells Colliery, Monmouthshire,  
on 28th June, 1960

T. A. ROGERS, C.B.E., M.I.Min.E.  
H.M. Chief Inspector of Mines and Quarries

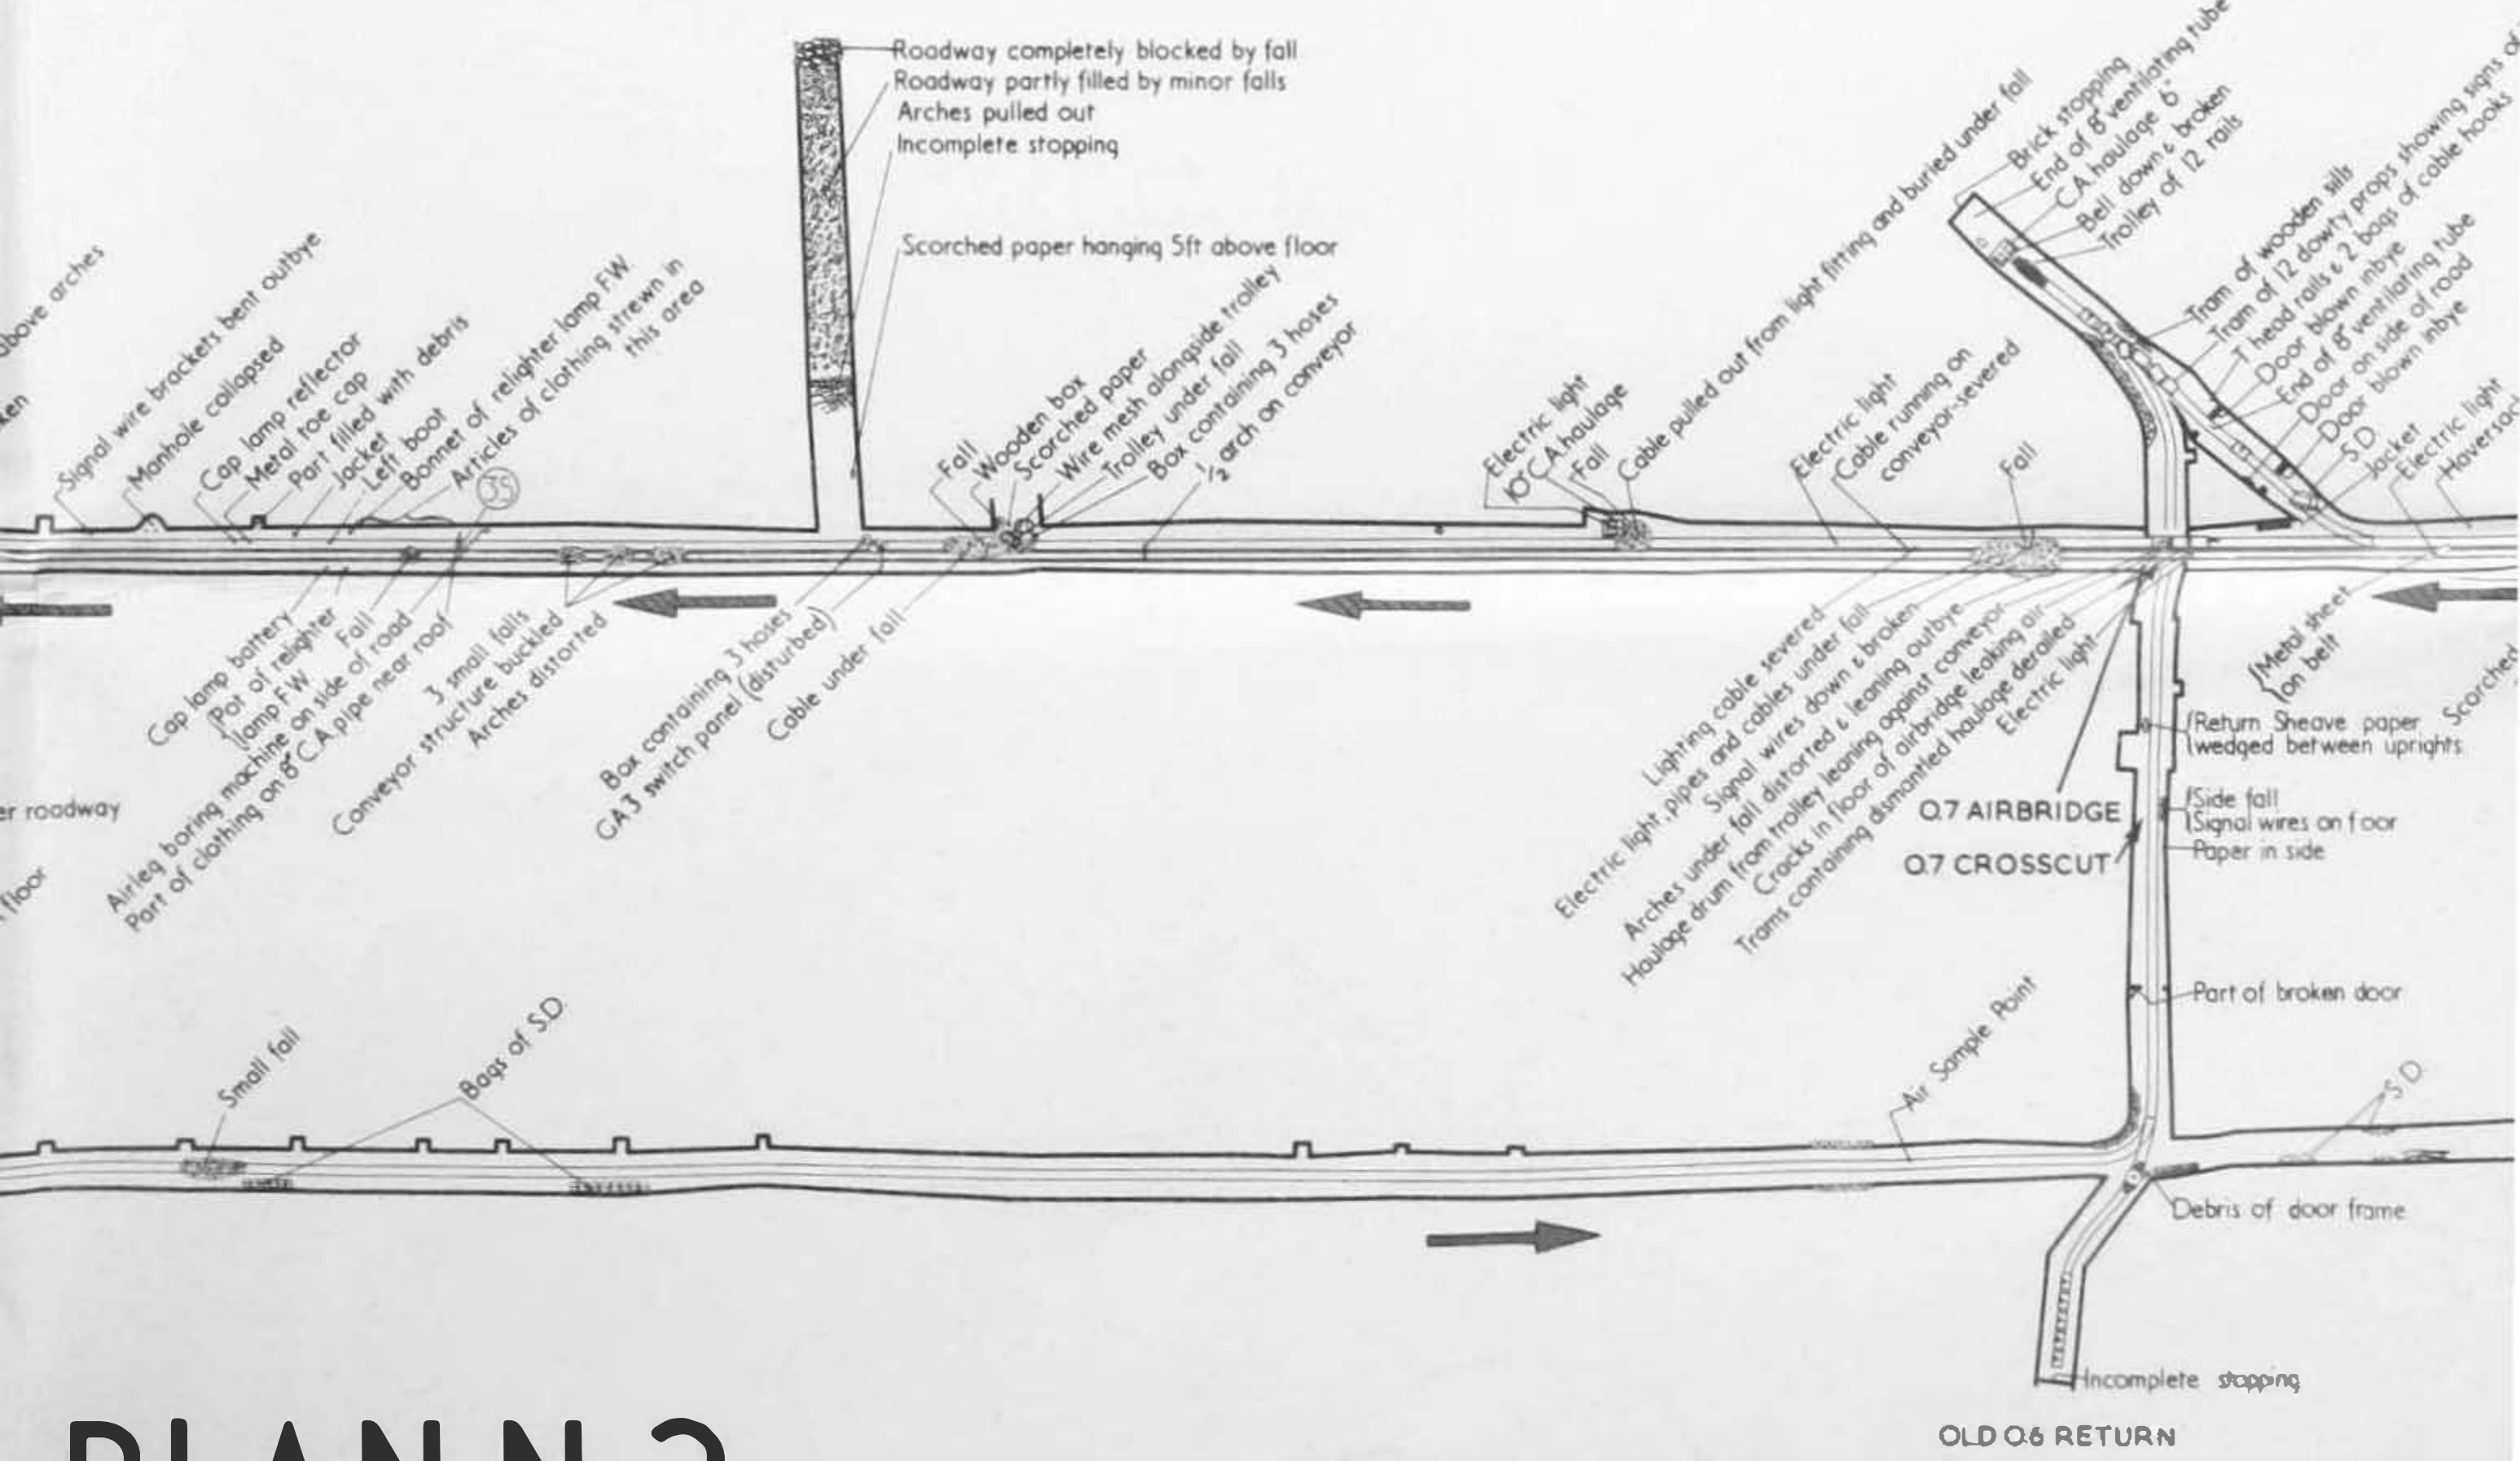
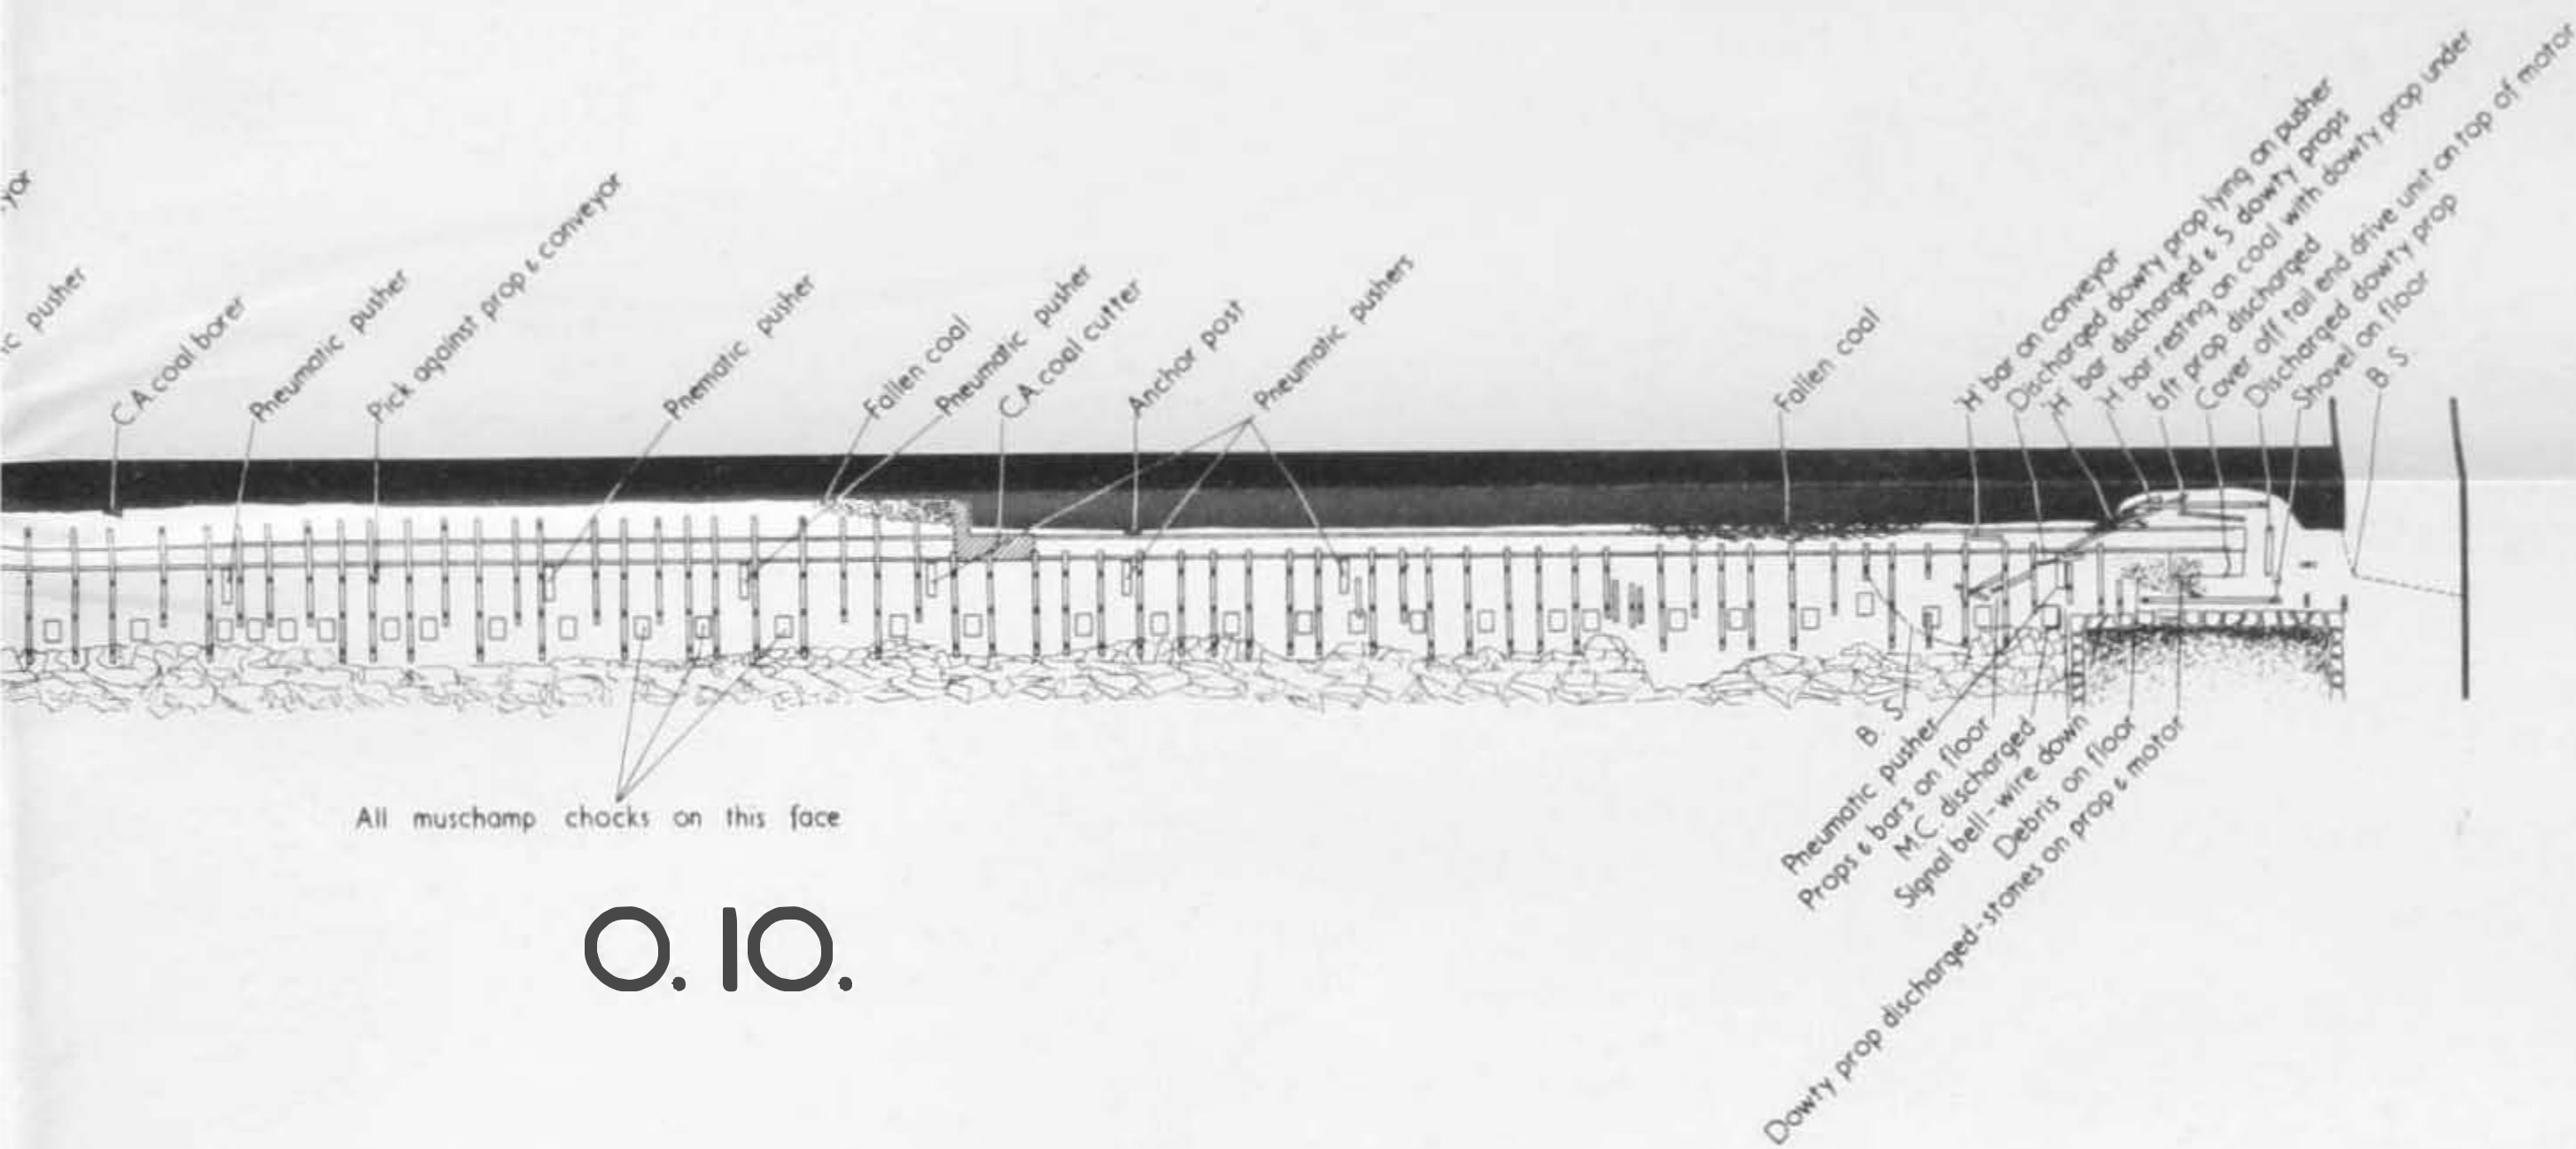
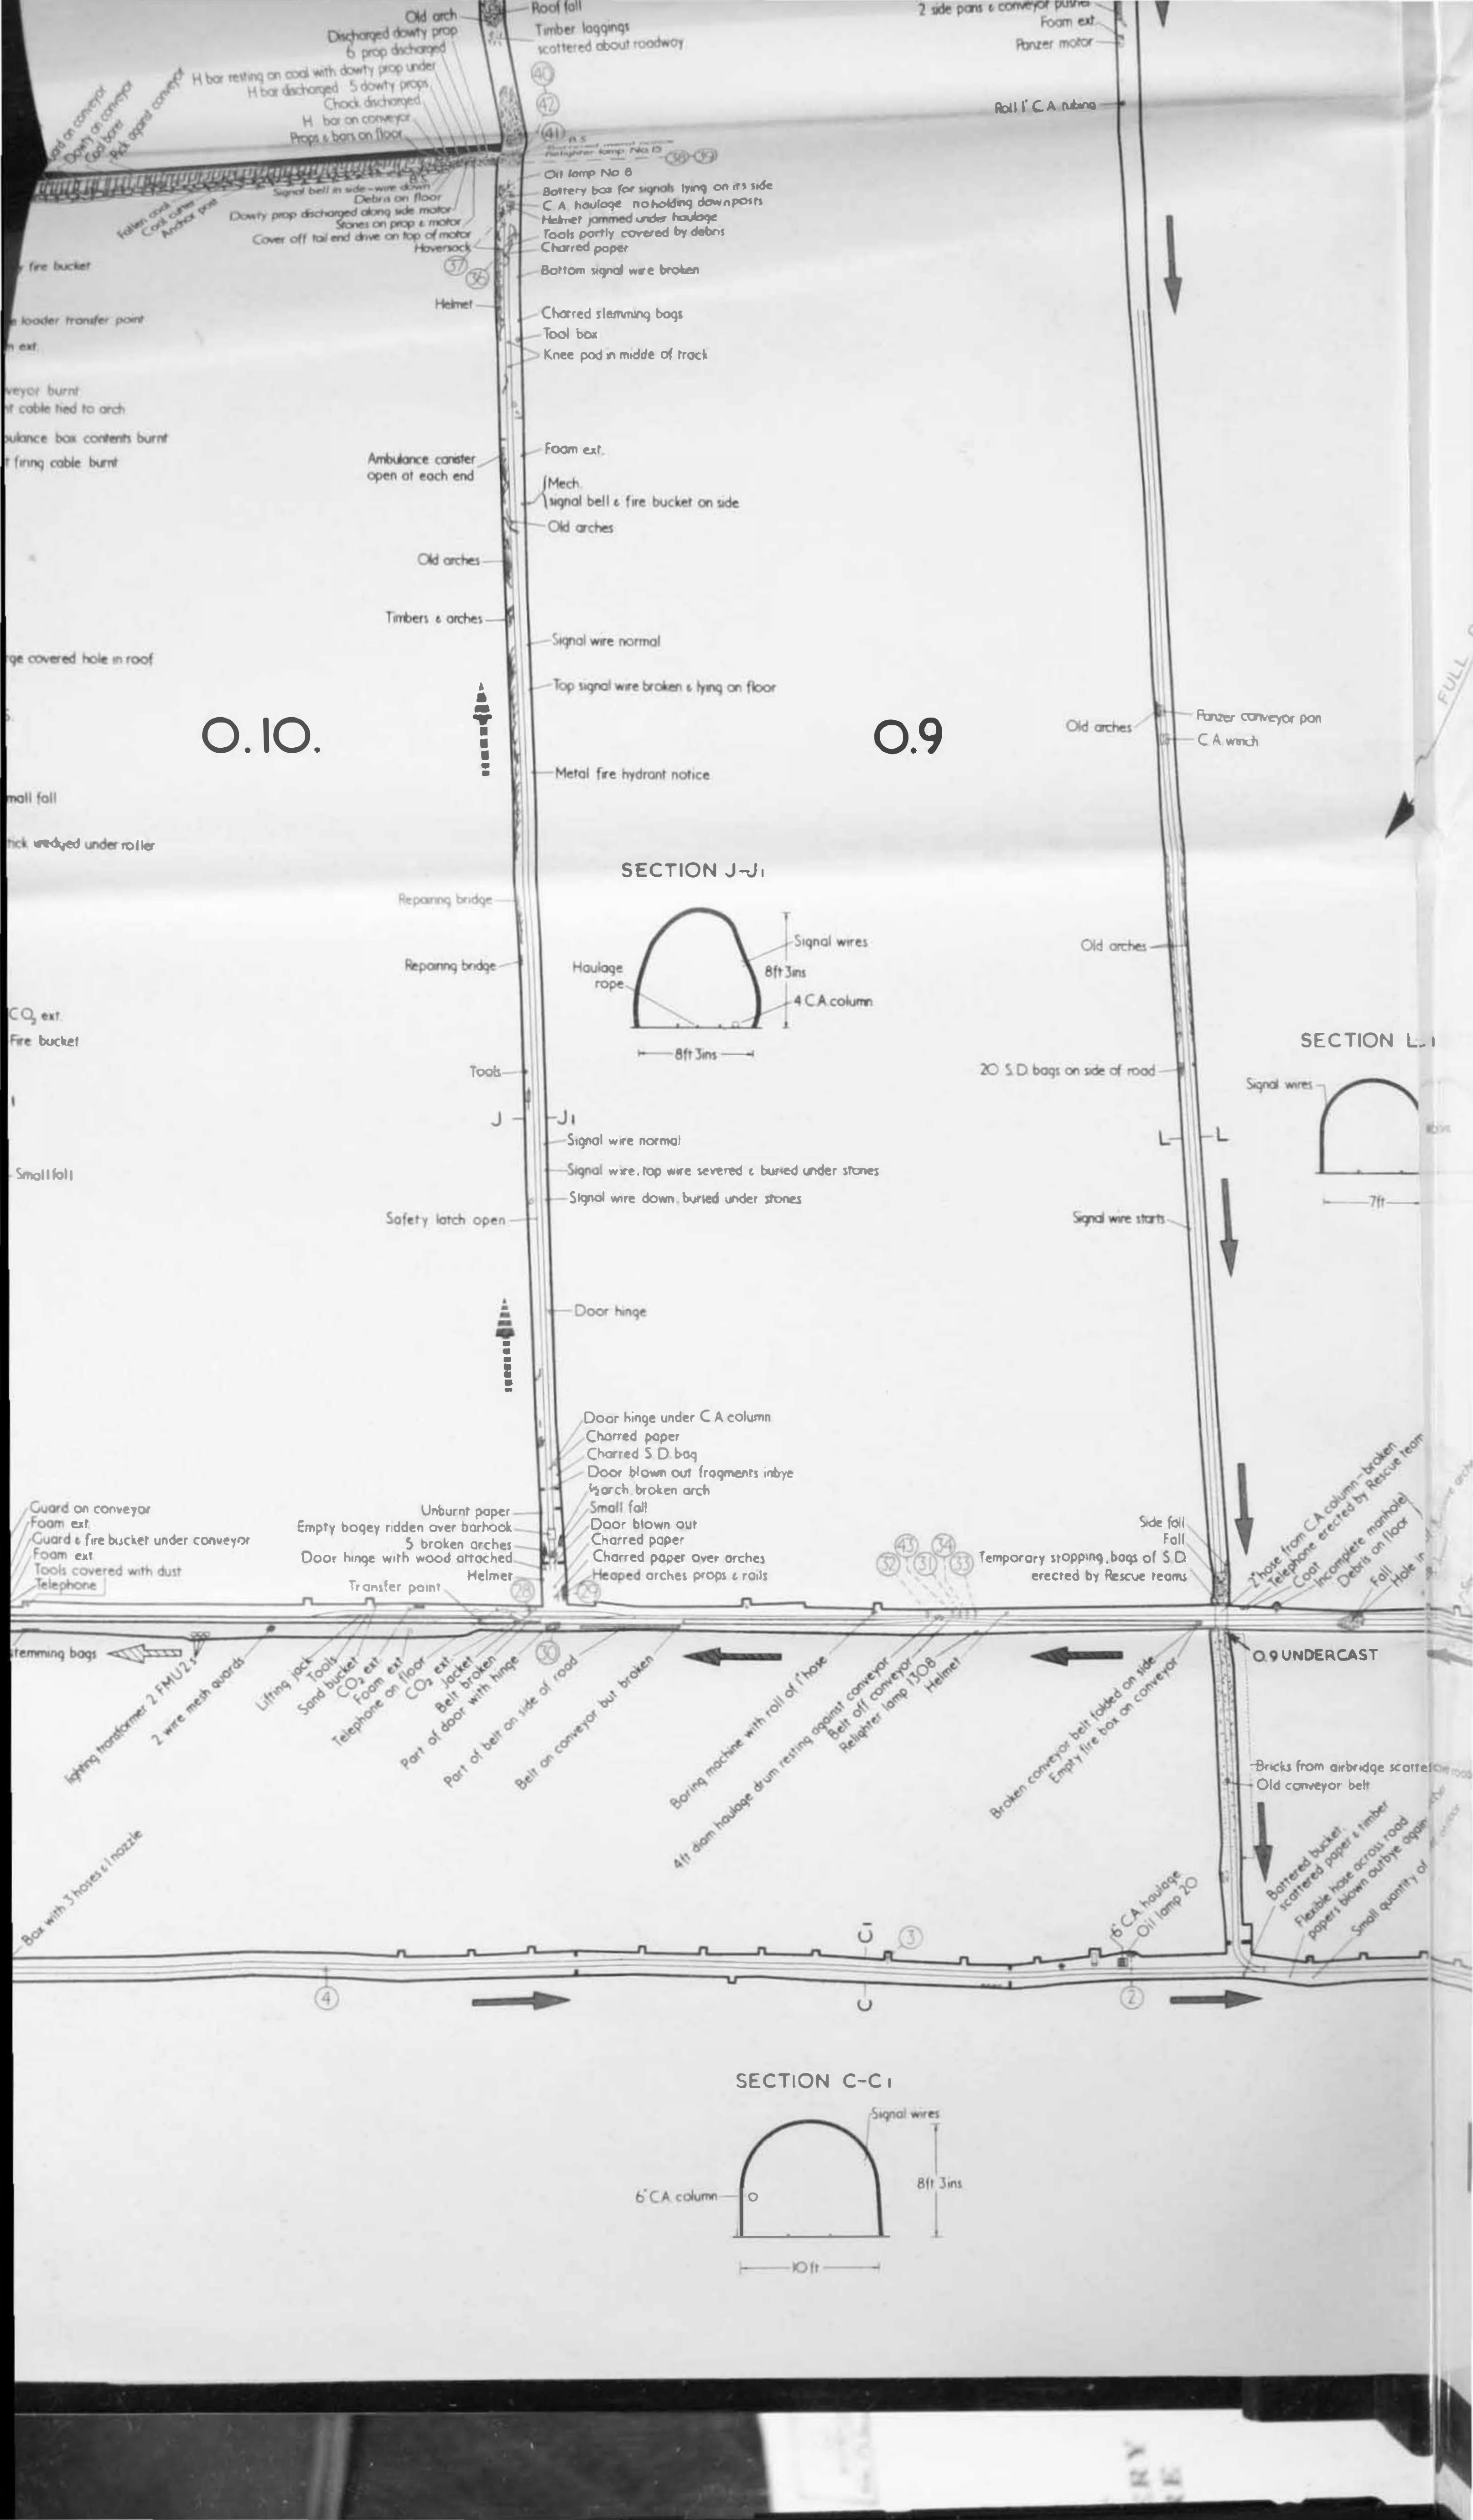
PLAN No.2

18. The directions of the main ventilating currents are shown by coloured arrows on Plan No. 2. A little more than 5,000 cubic feet of air per minute entered O.10 face from its loading gate and about another 1,500 cubic feet per minute of controlled leakage air passed along the supply gate. The firedamp content at the statutory observing point, 30 feet on the return side of the face, averaged about 0.25 per cent. About 9,500 cubic feet of air per minute reach O.18 face and the percentage of firedamp 30 feet from the face averaged 0.8. There was no express provision made to deflect air into O.12 face, but some—measured after the explosion to be 3,300 cubic feet per minute at the lower end of the face—naturally took this course and, to this extent, the with that of O.12.
